GM TECHNICAL ASSISTANCE CENTER (TAC)

Dealer Tips and New Information Newsletter

MARCH 23, 2023

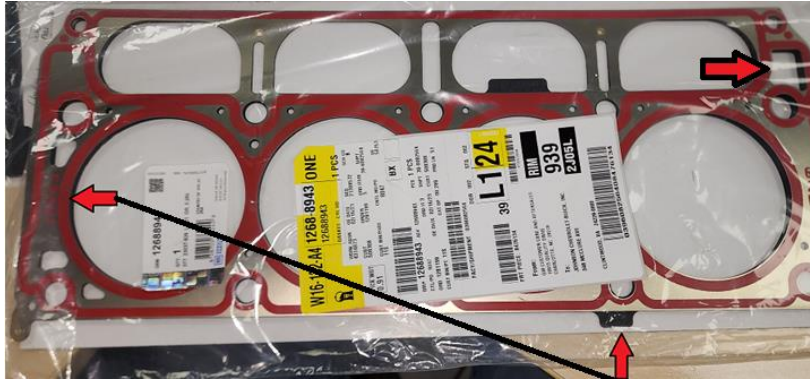
Incorrect "front" indicator/orientation show below. Note that the locating tab is 3 cylinders back from the "front" marking; it should be 1 cylinder back from the "front" marking.

If the new gasket is installed by following the incorrect "front" marking, it may lead to a ticking noise/overheating issue.

When installing head gasket (P/N 12688943) on a 6.2L GEN5/GEN5+ engine (RPO L86, L87, LT1, LT2, LT4), ensure the head gasket "front" marking and locating tab are in the same position as the original.

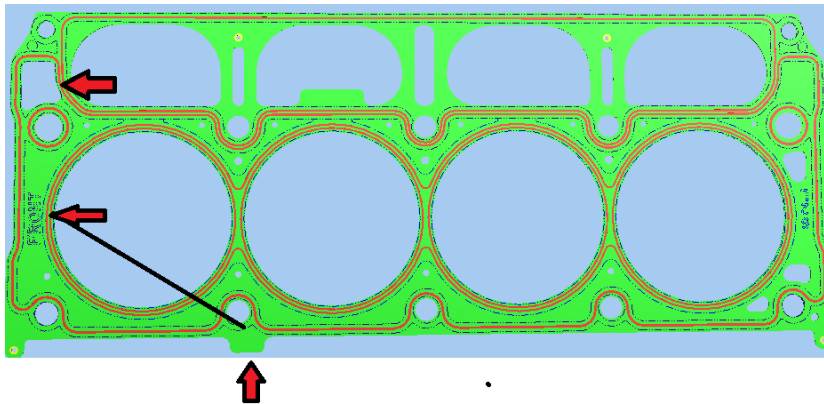
Correct "front" indicator location/orientation shown below. The tab is 1 cylinder back from the "front" marking.
