GM TECHNICAL ASSISTANCE CENTER (TAC)

Dealer Tips and New Information Newsletter

MAY 19, 2023

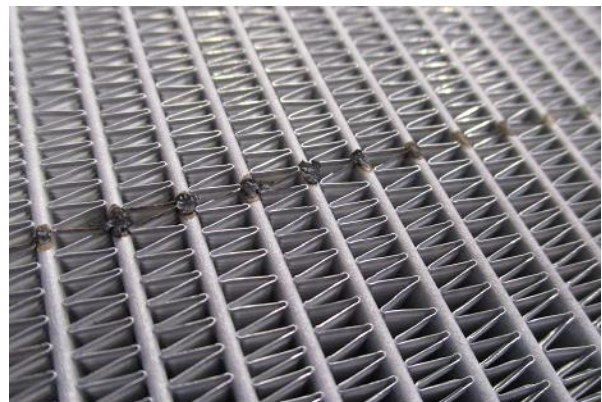
If you see odd/burn markings on a radiator core, per engineering, these marking are from flux deposits left over from the brazing process and will not affect the integrity of the radiator. It is more of a cosmetic issue.

The image pictured is for a 6.6L engine RPO L8T on a Silverado HD, but could potentially be seen on others.

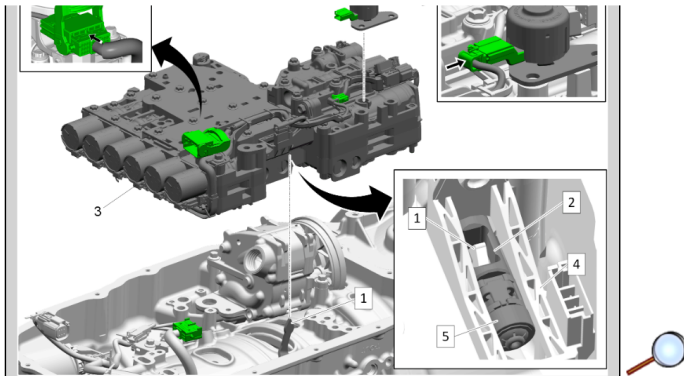
DTCs P187E and/or P18AB setting after valve body assembly replacement on any vehicle equipped with a 10LXX transmission assembly with electronic shift, PRO EPH, and/or may have harsh garage shifts will need to be checked to ensure that the park release lever is correctly oriented into the B316 Transmission Park Valve Position Switch. SI Document# 5677604.

Note: DTC P187E may have been present prior to VB assembly as well.

Note: Ensure the automatic transmission fluid pump seal is in the control valve body.

Caution: The Park Pawl Actuator Lever must be in the park position, fully forward position, and aligned with the slot in the piston servo prior to lowering the Control Valve Assembly into place. Contact between the switch housing or magnet carrier and the end of the Park Pawl Actuator Lever during installation can damage these components and lead to failure. This damage may not be immediately apparent and may occur during subsequent vehicle operation.

9. Place park pawl actuator lever (1) in the park position, fully forward position. The piston servo (2) opening must be positioned with the slot in the vertical position as shown. Use appropriate tool to reposition if necessary. Carefully place the control valve (3) into the transmission while avoiding contact between the switch housing (4), magnet carrier (5), and the end of the park pawl actuator lever (1). Ensure the park pawl actuator lever (1) is aligned inside the piston servo (2) opening.
