# USING THE COAX FAKRA Cable Adapter Kit

New Design Intake Manifold Addresses Poor Engine Performance

GM TechLink is published for all GM retail technicians and service consultants to provide timely information to help increase knowledge about GM products and improve the performance of the service department.

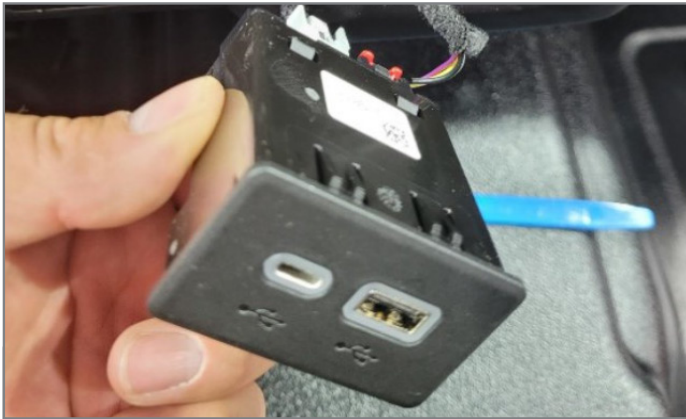
Many 2020-2023 GM models feature USB ports for mobile device charging and data connection. If a smartphone or other device does not charge or transfer data properly when connected to the USB port in the vehicle, one possible cause may be a faulty USB hub.

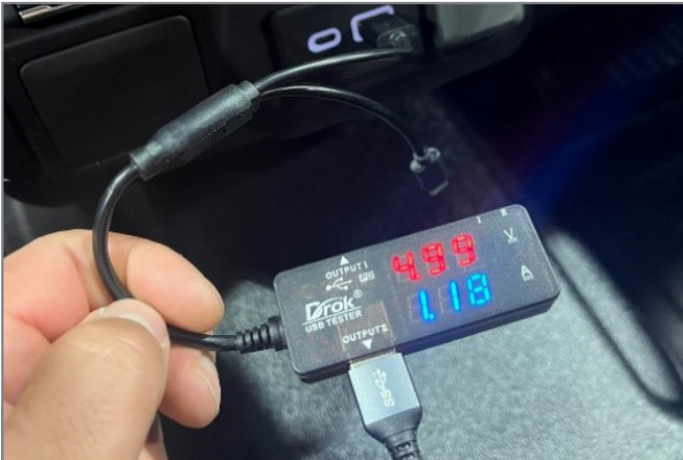
Check for proper voltage using a USB meter.

Check for proper voltage using a USB meter connected at each port. A properly functioning USB port will supply approximately 4.40 V – 5.25 V. If voltage is present, use a known good cable with the USB meter and connect a phone to see if the phone will charge and if there is an Amp draw on the meter. With the USB meter disconnected, verify if music can be played from the phone (not Apple CarPlay or Android Auto) and from a USB storage device.

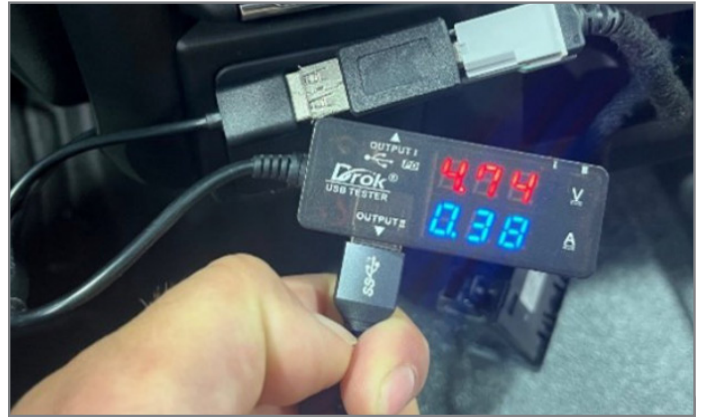
With a USB-A female to mini-B female adapter connected to the mini-B connector, verify if music can be played.

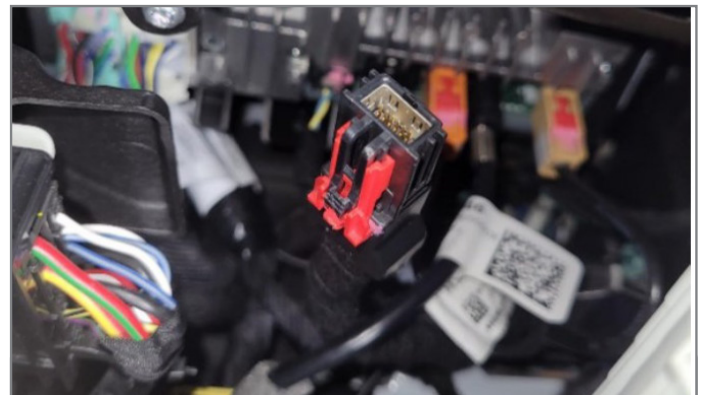
Mini-B USB or 6-pin power connector from the back of the radio

If the phone cannot be charged or music cannot be played, unplug the mini-B USB or 6-pin power connector from the back of the radio, wait a few seconds, and then reconnect.

Some radios may have a mini USB connector that can be plugged into directly behind the module to verify if the issue is due to the cable or radio.

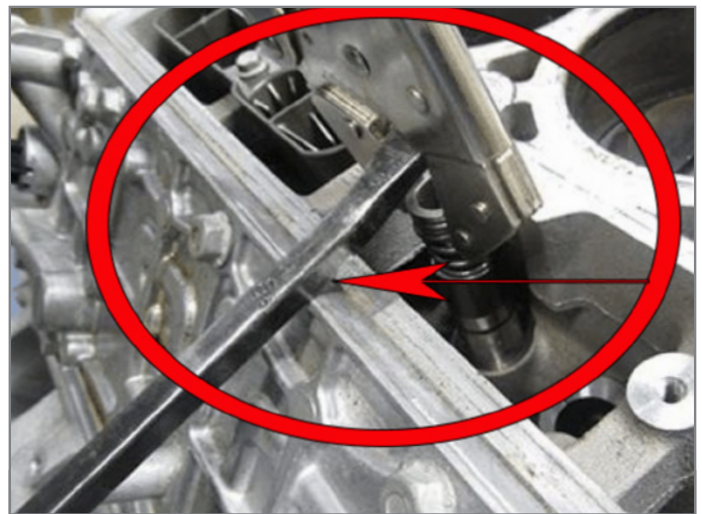
If a lifter is stuck in the bore, use vice grips with a slide hammer or a small pry bar to remove the lifter. Do not pry on the sealing surface of the block when removing a lifter.

Do not pry on the sealing surface of the block when removing a lifter.

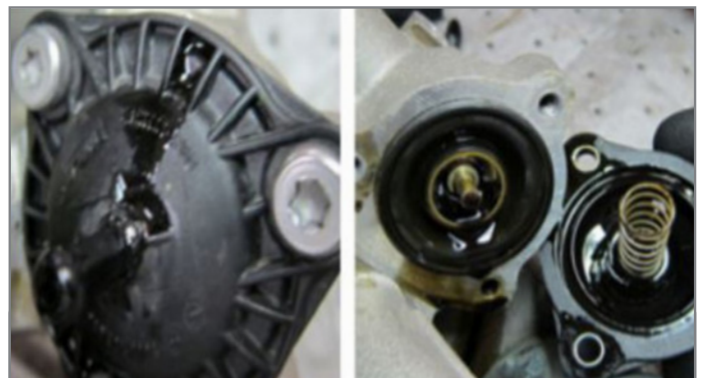
Charge air bypass valve

Inspect the charge air bypass valve for ice, water, oil or sludge build-up in the vacuum side port. If there is only oil or water build-up in the valve port, disassemble and clean the components. Replace the components only if necessary.

If the desired boost pressure vs. the actual boost pressure is not within limits, but there is not any trouble found with the turbocharger wastegate actuator or turbocharger, do not replace the turbocharger. Clean the charge air bypass valve in the vacuum side port and replace the intake manifold.

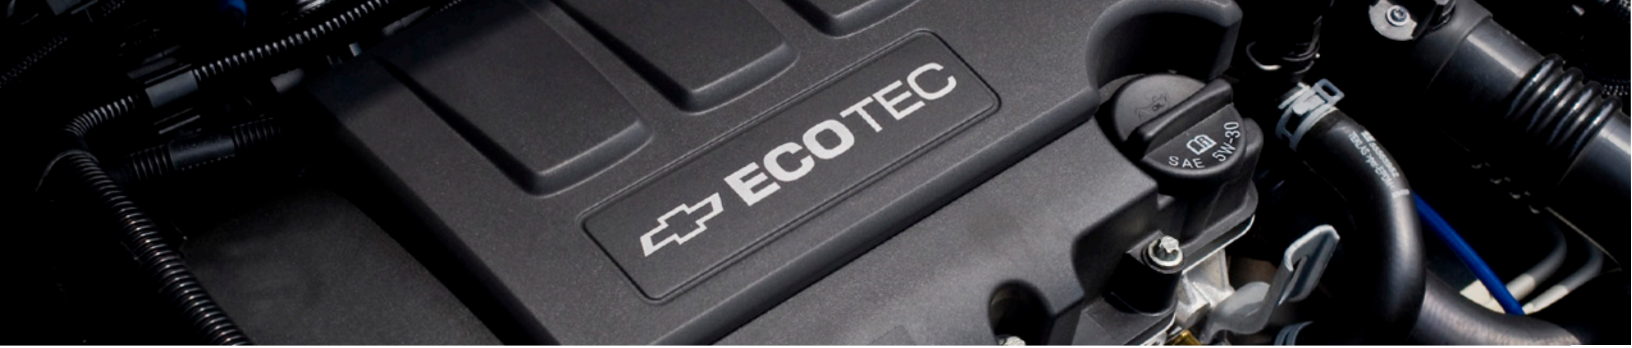
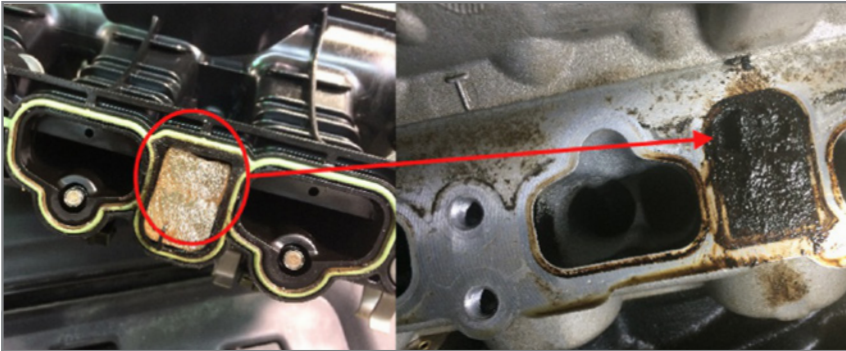
In addition, inspect the PCV intake runner for any sludge/water/ice blocking the cylinder head. Clean the cylinder head, cam cover and PCV pipes. If any contamination is found, replace the intake manifold.

Inspect the PCV intake runner for build-up blocking the cylinder head.

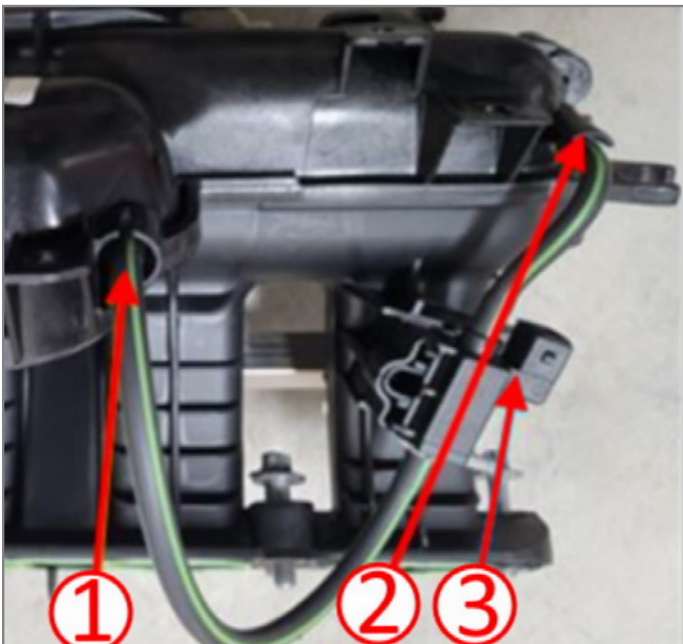
The new intake manifold has a redesigned intake positive pressure port location. Solenoid location is forward of the

New design intake manifold:  
1. Bypass valve vacuum  
2. Intake positive pressure port  
3. Solenoid/electrical connector

If contamination is found at the charge air bypass valve, disassemble and clean the charge air bypass valve and replace the intake manifold with the updated design part. Vehicles with the old design intake manifold should have the updated design intake manifold installed. In addition, replace the charge air bypass valve if necessary.

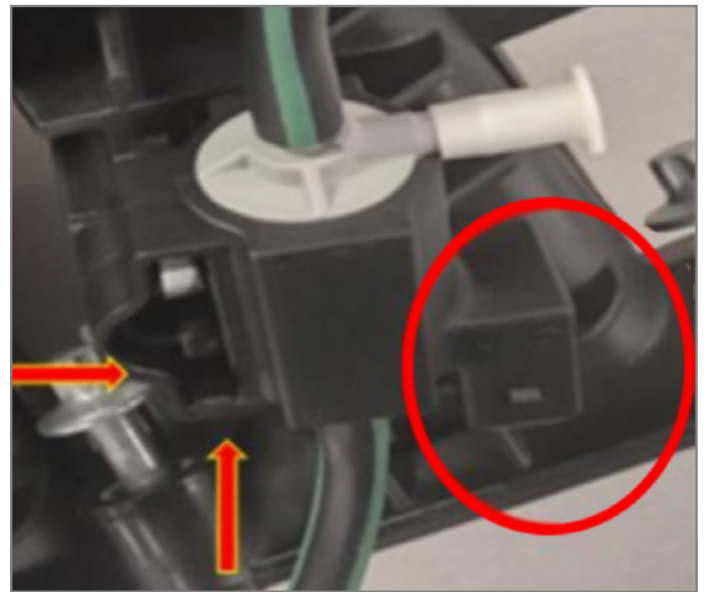
If the solenoid is loose, review the location of the electrical connector. If the connector is facing the cylinder head, it is installed backwards and should be removed and installed correctly. The solenoid is keyed and, if the tabs are reversed, the retainers will not be seated.

New design intake shown with incorrect solenoid installation.

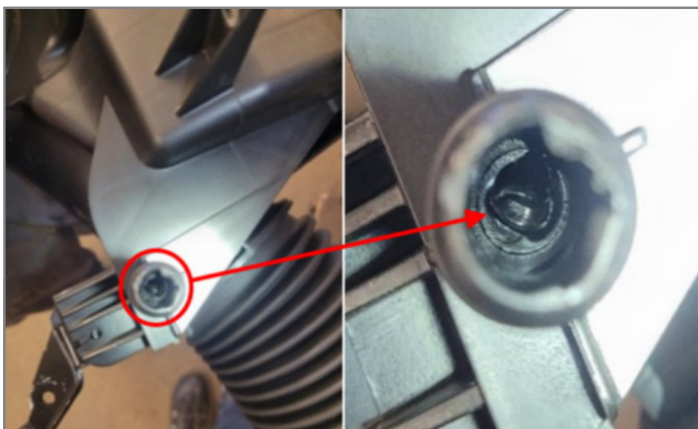
The whistling sound may be caused by excessive crankcase vacuum from a restriction at the Positive Crankcase Ventilation (PCV) tube of the air cleaner outlet duct.

Restriction on the PCV of the air cleaner outlet duct.

Replace the air cleaner outlet duct if a restriction is found. Refer to Air Cleaner Outlet Duct Replacement in the appropriate Service Information.

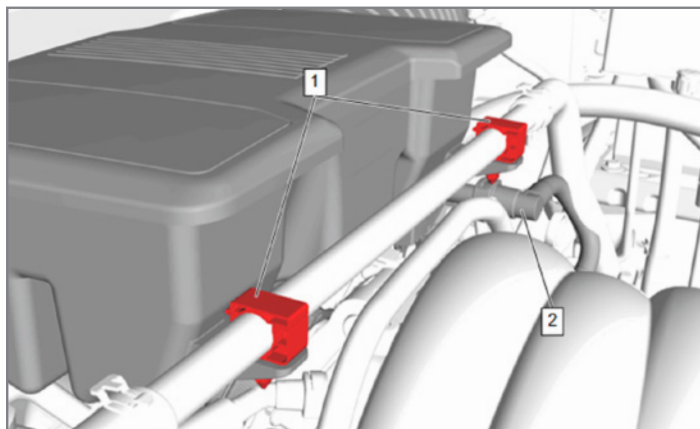
PCV tube (#2) at the air cleaner outlet duct.

Remove the oil cap or oil level indicator and verify if the sound is eliminated. If the sound is no longer heard, check for a restriction at the PCV tube.
