Testing for Diesel Fuel System Contamination

TECH LINK

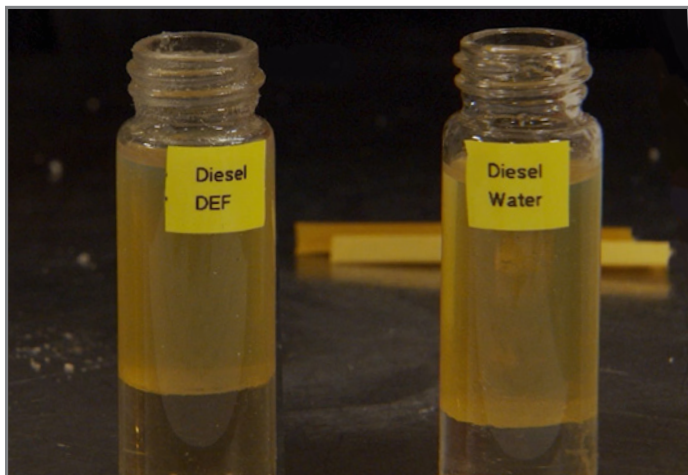
Diesel fuel mixed with DEF (left) and diesel fuel mixed with water (right).

If contamination in the fuel system is suspected, refer to the updated Fuel System Cleaning and Contaminants-in-Fuel Diagnosis procedures in the appropriate Service Information. Bulletin #18-NA-361 also includes additional fuel system contamination diagnosis information.

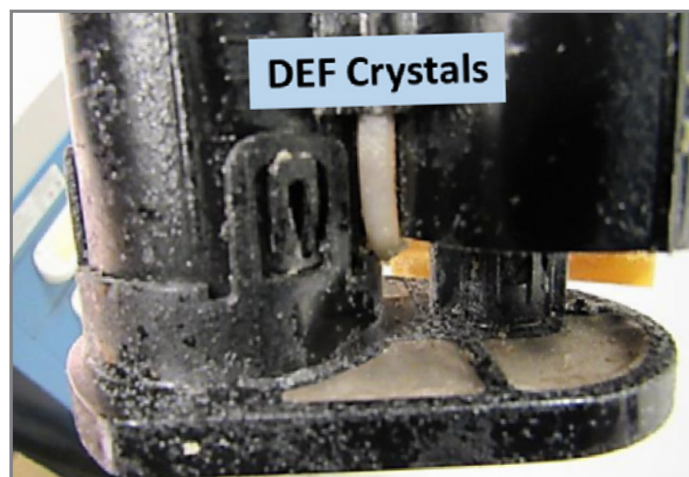
DEF contamination will often appear as white crystals, in the form of residue (similar in appearance to salt), when it dries on the fuel pump or other components. Of course, the residue cannot be seen in the contaminated fuel. But without removing the fuel pump module, it may be difficult to recognize DEF in the fuel tank.

DEF residue

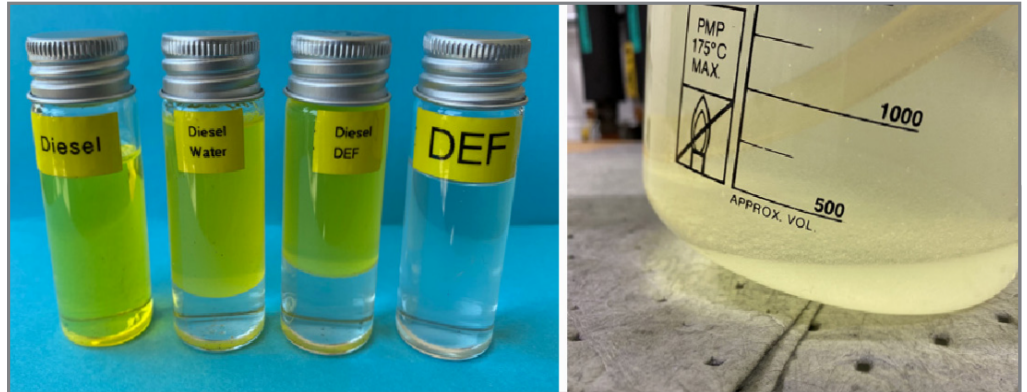
A fuel sample will show a separation of DEF and water from diesel fuel.

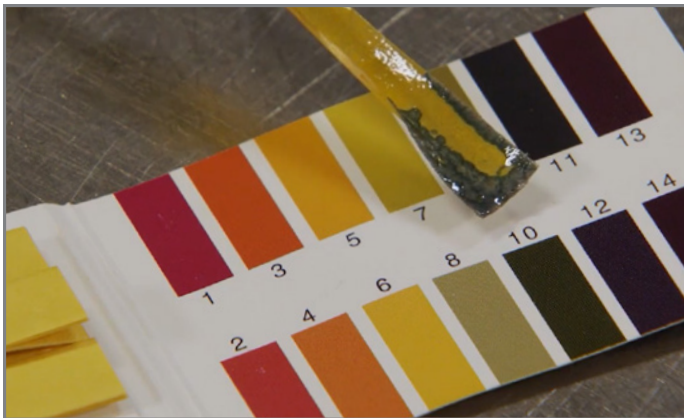
If the litmus paper shows a pH level of approximately 10–11, it is likely DEF. Compare the sample with a strip of litmus paper inserted into pure DEF to confirm. If there is DEF contamination, and the engine has been cranked, the entire fuel system from the fuel fill pipe to high-pressure fuel pump, fuel rail, injectors, injector return fuel lines, high-pressure fuel pipes and low-pressure return lines must be replaced. For complete information on addressing fuel system contamination, refer to Fuel System Cleaning in the appropriate Service Information.

Diesel fuel mixed with DEF

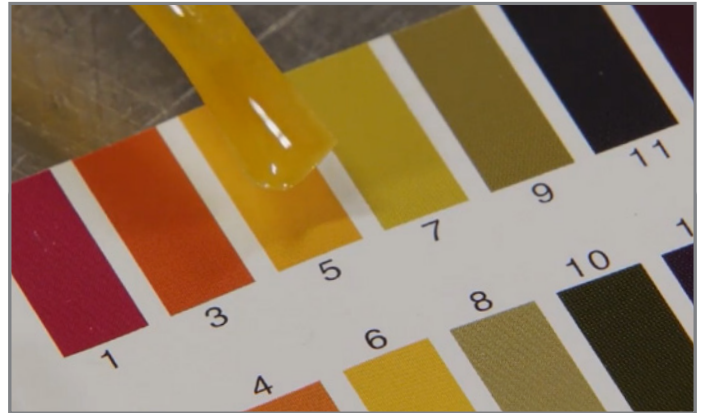
If the litmus paper shows a pH level of about 6–7, it is typically diesel fuel mixed with water. Both diesel fuel and water have a pH level of about 6–7 and, as a result, the color of the strip will not change much. To confirm, insert a strip of litmus paper into pure water, which has a pH level of about 6–7.

Remember, diesel fuel has a pH level of 5, so there should not be much change seen in a mixture of diesel fuel and water. If the fuel system is contaminated with water, inspect the fuel system components for rust or deterioration.

Diesel fuel mixed with water

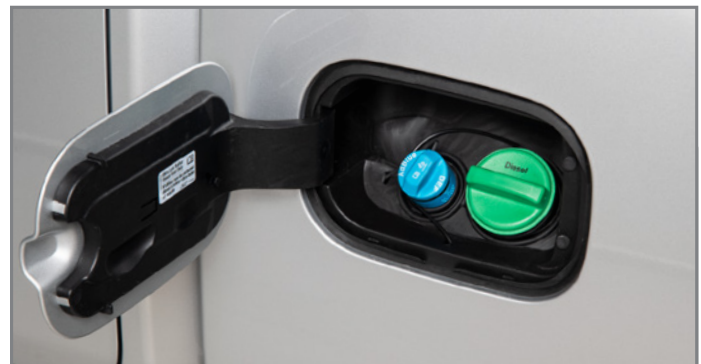
Owners may mistakenly add DEF to the fuel system.

As soon as the ignition is turned on, the fuel pump will be engaged and contaminated fuel will be sent into the fuel system, which may potentially damage the entire system. DEF is a corrosive fluid that tends to form deposits on components. If the in-tank fuel pump has been run, then contaminated fuel has been pumped through both the low-pressure system and high-pressure pump. Inform customers to have the vehicle towed to the dealership or a qualified service facility.

- Do not turn on the ignition.
- Do not start the engine.
- Do not drive the vehicle.

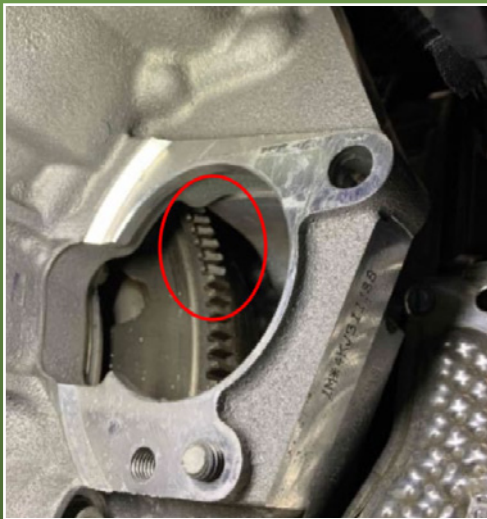
These conditions may be caused by a damaged automatic transmission flex plate. If there are missing or damaged flex plate teeth, the starter may not engage and there may be an open 350A starter mega fuse.

Check for damaged flex plate teeth through the starter mounting hole.

If these conditions are present, remove the starter and, through the starter mounting hole, inspect the automatic transmission flex plate.

Look for any damaged or missing flex plate teeth while slowly rotating the crankshaft. If

any teeth are damaged or missing, replace the flex plate. Refer to Automatic Transmission Flex Plate Replacement in the appropriate Service Information.

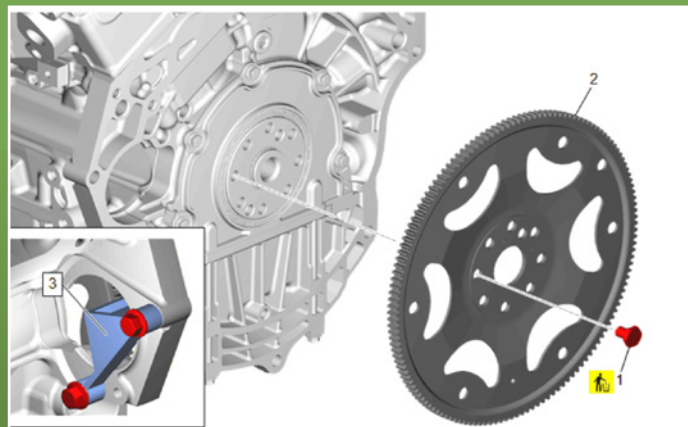
Automatic transmission flex plate

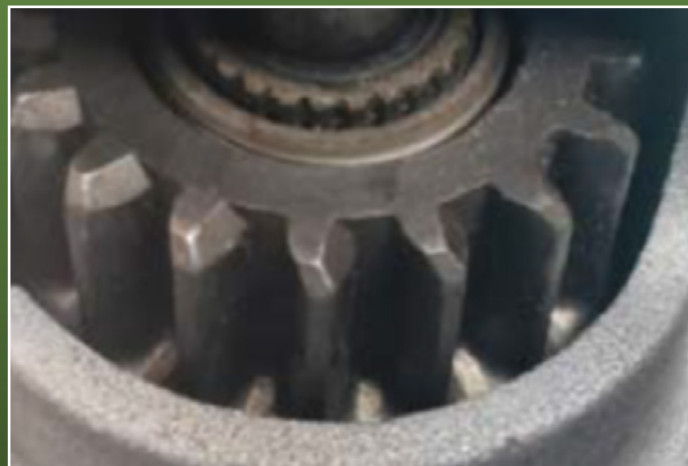
Starter pinion teeth damage is normally caused by broken or damaged flex plate teeth.

Starter pinion teeth without damage

Also inspect the starter pinion for any damaged teeth by rotating the starter pinion. If the starter pinion teeth do not show any damage, do not replace the starter.

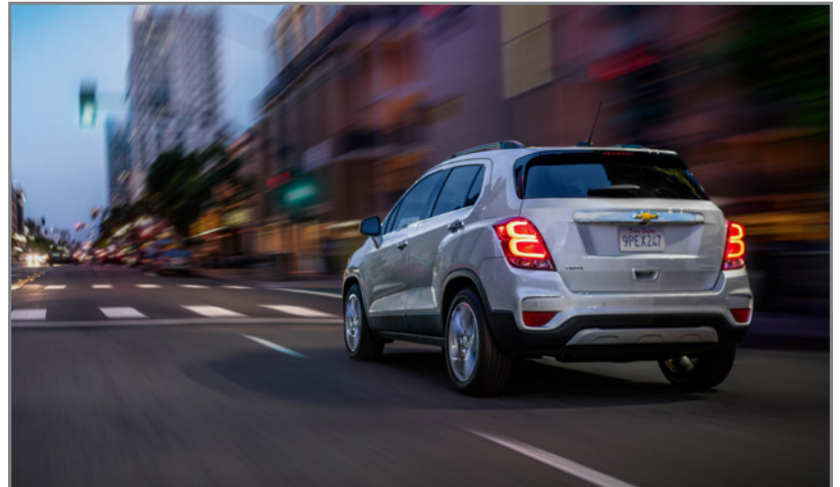
The slight bump condition is considered part of normal operation of the Neutral Idle Control feature that helps increase fuel efficiency. The condition will not be present if the transmission is shifted into Manual Mode, as Manual Mode disables the Neutral Idle feature. No repairs should be performed for this condition.

A single bump feeling may be felt when coming to a stop.
