GM TECHNICAL ASSISTANCE CENTER (TAC)

Dealer Tips and New Information Newsletter

JULY 19, 2023

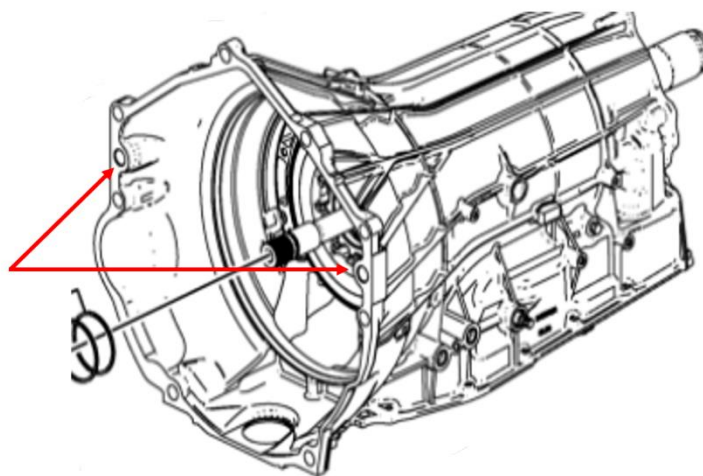
A large number of 8L45/8L90 transmissions are being returned with physical damage to the torque converter housing area. The damage may be caused by the transmission-locating dowels being frozen in the housing due to corrosion. We are asking that technicians take more care in removing these transmissions.

The transmission alignment-dowel holes, shown here, may be in different locations, depending on the engine platform.

To address the corrosion, use a rust or corrosion release agent prior to removal.

If the transmission is secured to the engine after all bolts have been removed, it may be necessary to rock the tail housing area of the transmission up and down to help release it. In extreme conditions, some form of heat may need to be applied to the area. It's recommended to use an inductive-type tool rather than an open-flame torch.

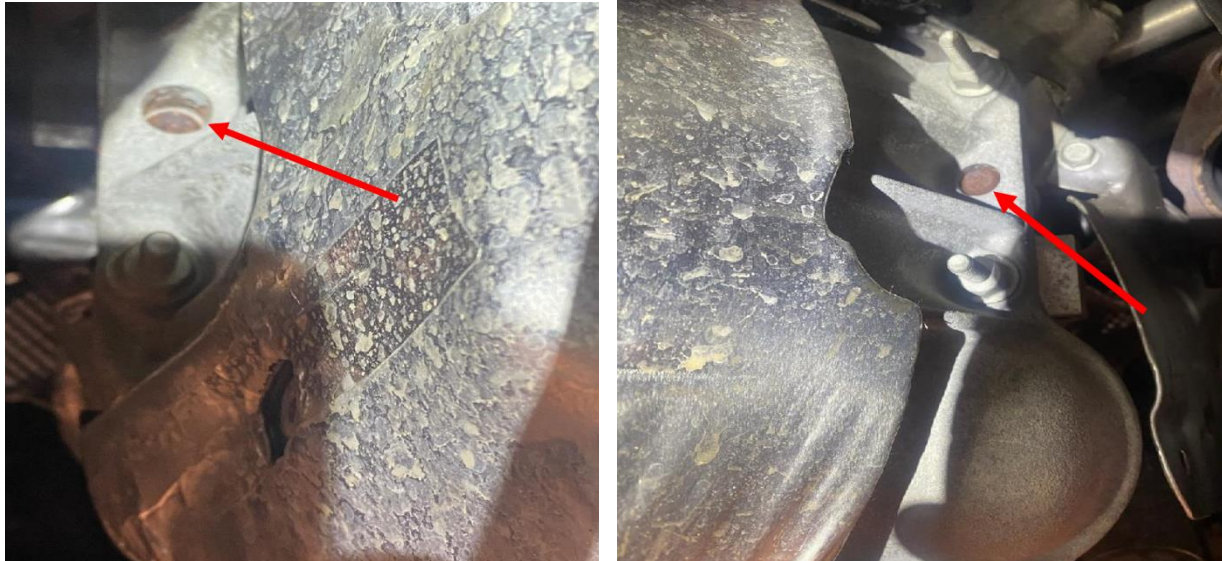
Access to the dowels, shown below, may be affected by how the vehicle is being used, along with environmental issues in northern states, which can add to the amount of corrosion.

These two photos are of different sides of the transmission on the same vehicle. Each shows different amounts of corrosion.

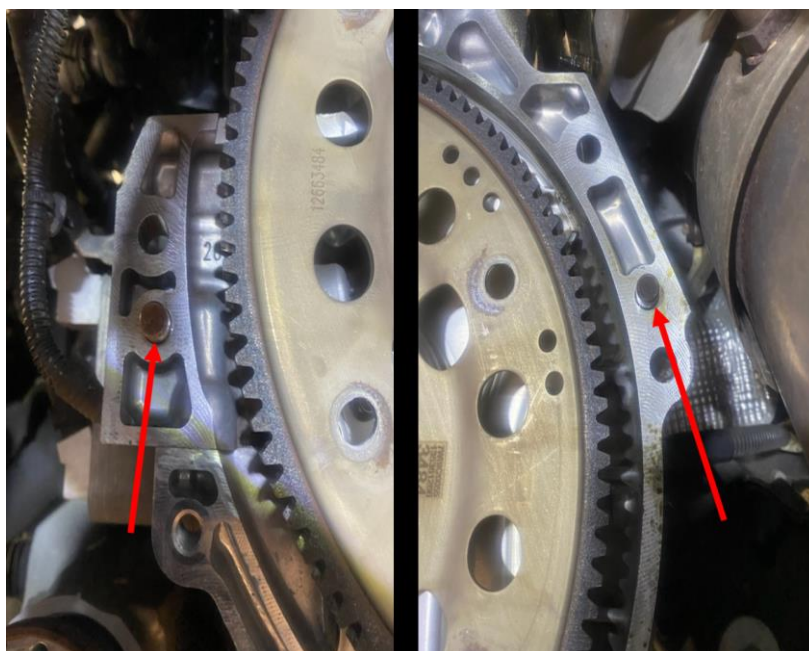
The alignment dowels are located on the left and right side of the engine block, shown below, where it mates with the transmission. In some cases, the dowels may come out of the engine block and need to be reinserted in the block. Always verify the dowels are in place prior to reinstalling the transmission.

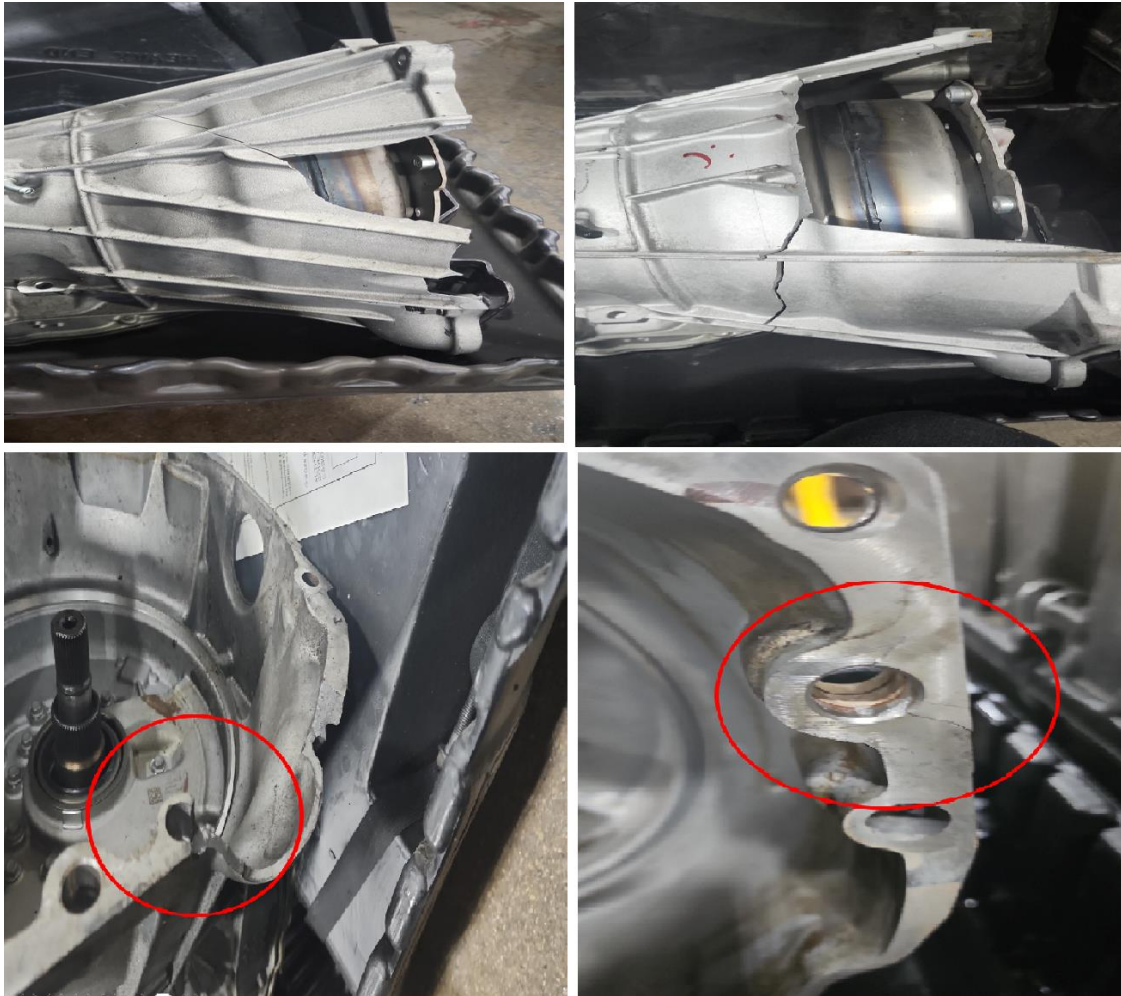
Following are several examples of returned cores that were damaged.
