Engine Performance in Extremely Cold Weather Conditions

TECHLINK

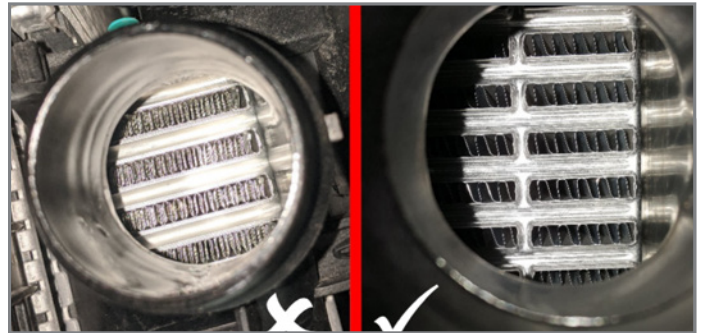
Older CAC design (left) and new design CAC (right).

Inspect the charge air cooler through the inlet to determine if the vehicle has the new or old design. If the charge air cooler is the old design (shown with an X below), replace the charge air cooler. If the charge air cooler is the new design (shown with a check mark below), which has wider fin spacing and a

division in the middle of the charge air cooler, replacement is not necessary.

If the revised charge air cooler has been installed, drain and reinstall the CAC.

If the CAC has not been replaced, install the new modified CAC.

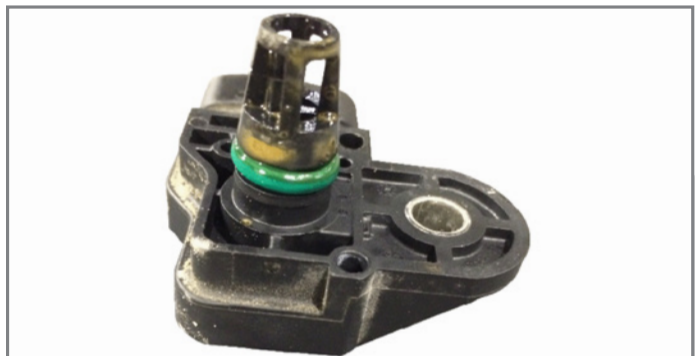
IAPT sensor

If all the components have been installed, remove the Intake Air Pressure and Temperature (IAPT) sensor and inspect for any contaminants.

Do not use any chemical cleaners or water, or use compressed air, to clean the sensitive IAPT sensor. Allow time for any ice build-up to melt by placing the sensor port down.

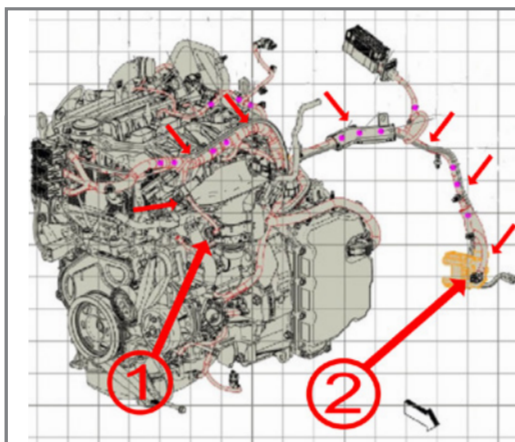
If the resistance is within range, manipulate the engine wiring harness between the oil pressure sensor and connector X125 and look for a change in the resistance reading. If the concern is not isolated to the engine wiring harness, reinstall all components.

Check the engine wiring harness between the oil pressure sensor (#1) and connector X125 (#2).

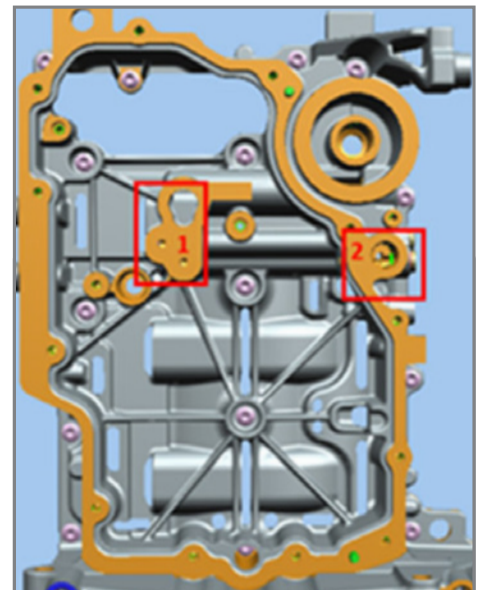
Ensure the three oil pump oil holes (Area 1) and OCV mounting hole (Area 2) are free of debris.

TIP: If oil pump replacement is needed, ensure the three oil pump oil holes (Area 1) and OCV mounting hole (Area 2) are free of debris before installing the engine oil pan

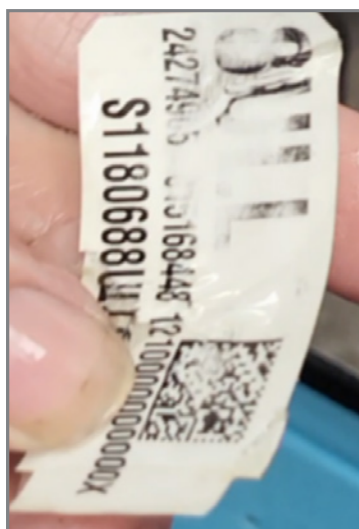
Recently, a number of 8-speed and 10-speed transmissions have been returned to the Warranty Parts Center with missing or unreadable Transmission Unique Label (TUN) labels. In some cases, the label is smeared or distorted due to how the case was cleaned before shipping.

Unreadable TUN# label

TIP: When cleaning the unit, do not use any chemicals to wipe away dirt or debris on the TUN# label that may smear or remove the ink on the label. Brake cleaner or other solvents should not be sprayed or wiped directly on the TUN# label.
