# Programming Key Fob Transmitters

*When performing the IMMO Immobilizer Learn procedure to program or add key fob transmitters on some 2021-2023 Tahoe, Suburban, Yukon, Escalade; 2022-2023 Silverado, Sierra; and 2024 Silverado 2500HD/3500HD and Sierra 2500HD/3500HD models, there may be some difficulty completing programming or an error message such as “0004 Device Control Not Available” or “Communication Error” may be displayed.*

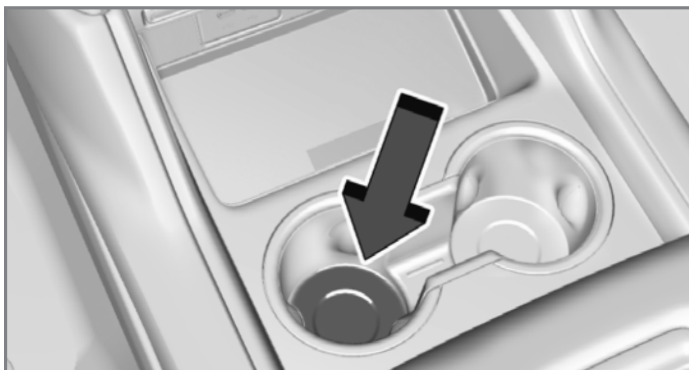
Before programming, check the Owner's Manual to confirm the location of the fob pocket in the vehicle. The programming location can vary from vehicle to vehicle.

Key fob pocket location on Yukon XL with bucket seats

If there is still a fob transmitter programmed to the vehicle, perform the following procedure to determine that the IMMO coil is working properly and the correct programming fob pocket location:

1. Remove the battery from the fob that is still programmed to the vehicle.
2. Move all fobs away from the vehicle.
3. Try to start the vehicle. The result should be a Driver Information Center (DIC) message stating no fob detected.
4. Place the learned fob, with the battery removed, in the programming fob pocket and try to restart or power up the vehicle. If the vehicle powers up, the IMMO coil is working properly and the correct programming fob pocket is being used.

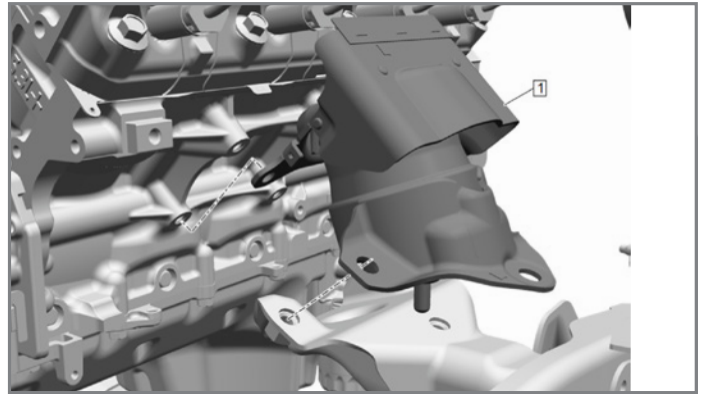
Left side engine mount

An engine vibration may be felt after the engine mounts were replaced on some 2019-2021 Silverado 1500, Sierra 1500; 2022 Silverado 1500 LTD and Sierra 1500 Limited models. The vibration may be more noticeable at idle.

The vibration condition may be due to not all necessary parts being replaced when the new engine mounts were installed.

A change was made to some engine mounts and additional parts need to be replaced with the new mounts. If these additional parts are not installed with the new engine mount, the mount will ground out and result in a vibration.

For new engine mounts that require additional parts, the electronic parts catalog will have a note that states "ORDER T/W" along with a list of the additional part numbers that must be replaced with the engine mount.

Be sure to review the electronic parts catalog to determine if additional parts are needed before replacing the engine mounts.
