Corvette Transmission Canister Filter

Corvette Transmission
Canister Filter and Maintenance
Information..... 2

TECH LINK

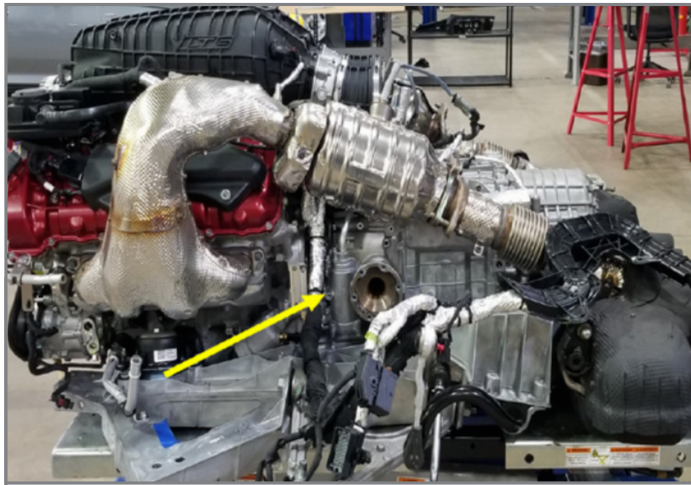
Transmission canister filter

The canister filter change in the first 7,500 miles (12,000 km) is critical due to the initial break-in of the internal transmission components.

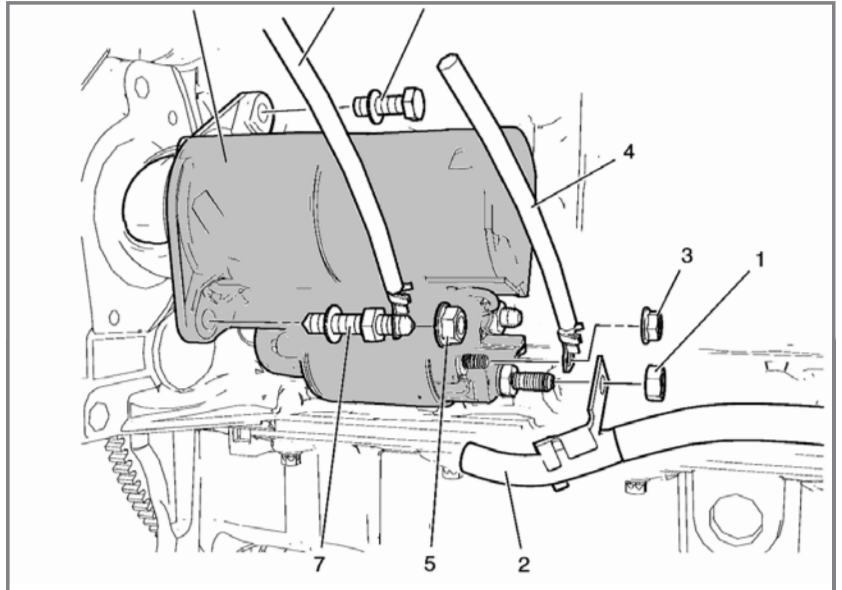
Some 2012-2014 Cruze models equipped with the 1.8L engine (RPO LUW, LWE) and a manual transmission may have a knock sound at the front of the vehicle when starting the engine. The sound may be due to the starter not having a high enough cranking speed.

Starter on the 1.8L engine

If the source of the low-cranking speed of the starter is not identified, replace the starter and the fuse block. Refer to Starter Replacement (1.8L LUW and LWE) and Fuse Block Replacement in the appropriate Service Information.

The fuse block and starter must be matched in service. If either part is being serviced, verify proper matched usage.

- Part numbers 55572439 (Starter) and 95937484 (Fuse Block) must be matched.
- Part numbers 55576980 (Starter) and 95476466, 96982033 or 95942232 (Fuse Block) must be matched.

If the knock sound is still present once the starter and block fuse have been replaced, the flywheel should be replaced. Choose the correct size flywheel based on the Electronic Parts Catalog (EPC) notes in accordance with the VIN.

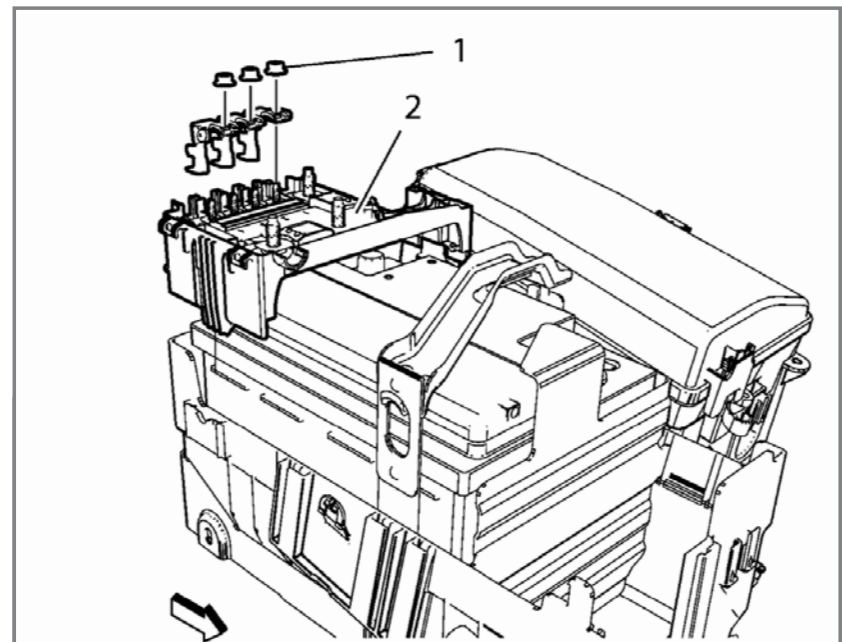
Fuse block (#2) is under the battery fuse box cover.

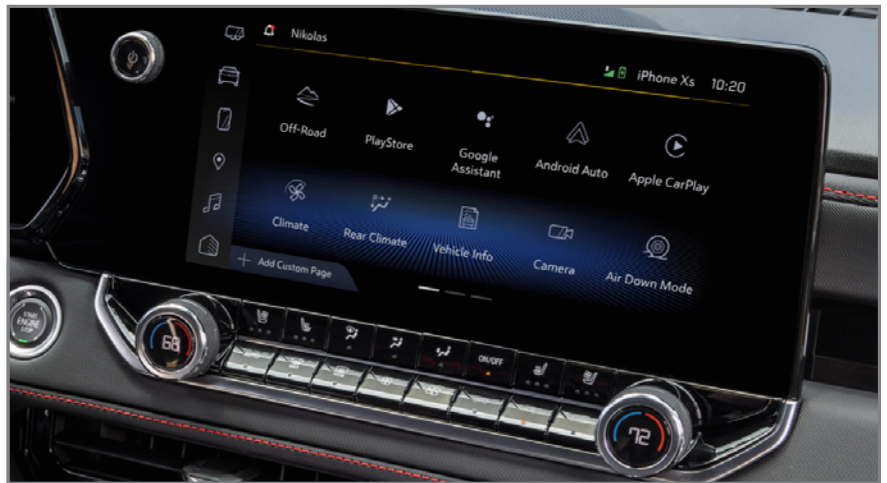
When USB programming the radio (RPO IVD) on some 2023 Colorado, Canyon; 2023-2024 LYRIQ; and 2024 XT4, Blazer EV and Silverado EV models, a message may display that programming is currently unavailable. The message may appear due to a routine check of the 12-volt battery state of charge before USB programming begins.

A11 radio in the 2023 Colorado

To allow USB programming, a file can be created that will prevent the check of the battery state of charge. After downloading the available USB file transfer for the radio from SPS 2 to a USB drive (16 GB or 32 GB Type-C USB drive formatted to FAT32), a new text document should be created on the USB drive to ignore the battery check.

Refer to the latest version of #PIT6047 for the complete procedure to create the file on the USB drive.

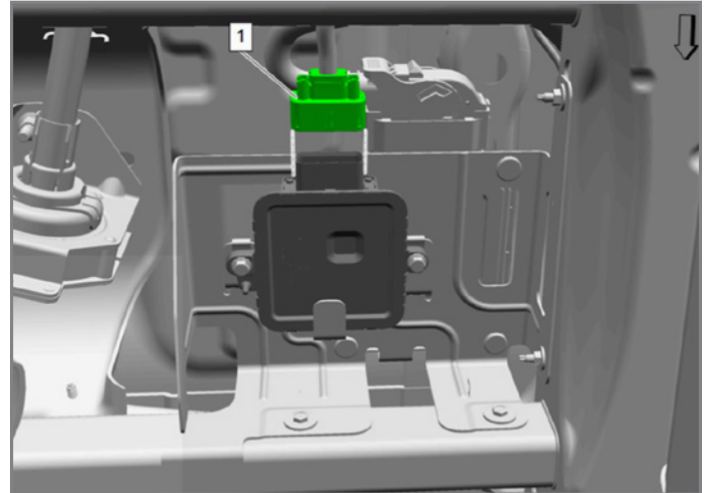
The trailer brakes may become disabled while pulling a trailer on some 2023 Colorado, Tahoe, Suburban, Silverado 4500/5500, Canyon, Yukon, Escalade; 2024 Silverado 2500HD/3500HD, Silverado EV, Sierra 2500HD/3500HD and HUMMER EV models due to a trailer battery condition. DTC C1114 (Trailer Brake Control Solenoid Valves Control Circuit) may be set and a Service Trailer Brake System message may appear on the Driver Information Center.

The trailer brakes may be disabled if the customer's trailer has a solar panel battery charger or generator. If the trailer's battery becomes fully charged and has a higher charge than the vehicle's battery, it can feed back into the trailer brake control module, causing it to shut down.

Trailer brake control module (Tahoe shown)

If diagnosis shows the trailer brake is disabled, replace the trailer brake control module. An updated part is available. Refer to Trailer Brake Control Module Replacement in the appropriate Service Information.
