M1L Dual Clutch Transmission Case

Design Update

TECH LINK

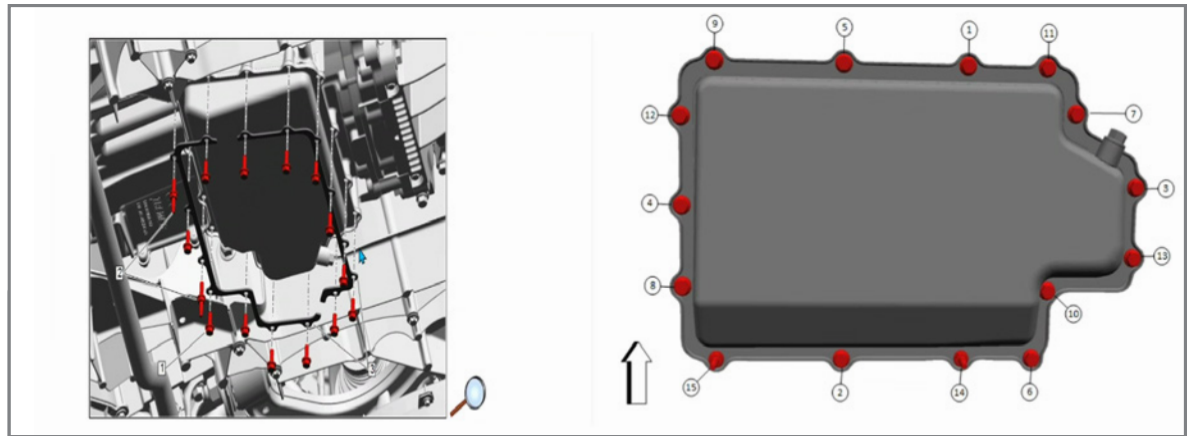
If any repairs were needed on a Die 1 transmission, it is possible to find a Die 1 transmission with a Die 2 pan installed, which can be identified by comparing the Die 1 and Die 2 bolt patterns. The Die 1 transmission sump pan has 15 bolts and the Die 2 cast sump pan has 19 bolts. If the Die 2 pan is installed on the Die 1 transmission, there will be holes in the pan without bolts.

Die 1 transmission sump pan has 15 bolts.

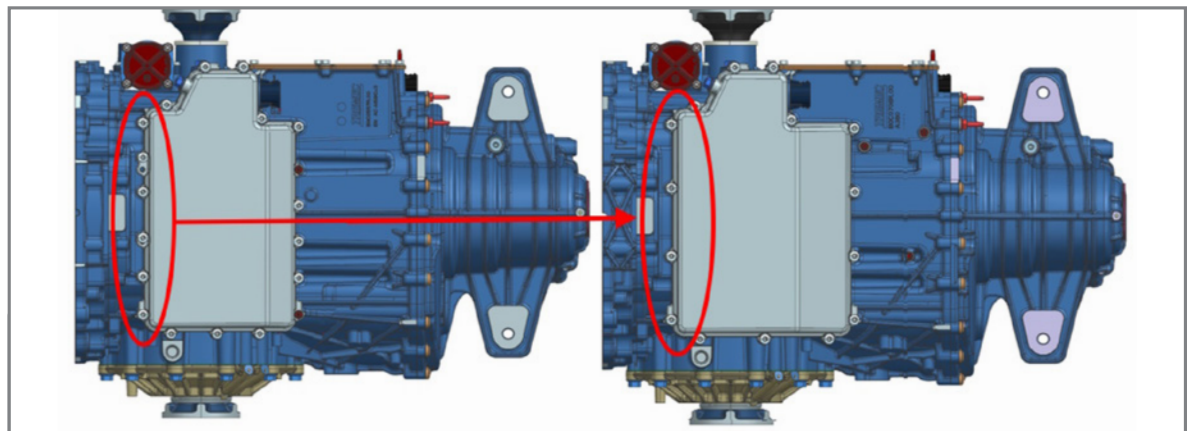
A new Die 3 transmission can be easily identified by the 4 fasteners along the front edge of the sump pan. The previous Die 2 transmission has 6 fasteners along the front edge of the sump pan.

Previous Die2 transmission (left) with 6 fasteners along the front edge of the sump pan and the new Die3 transmission (right) with 4 fasteners.

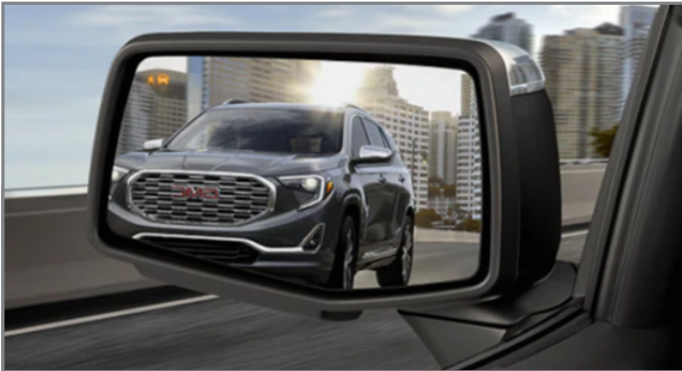
The Rear Cross Traffic Alert and/or Side Blind Zone Alert system on some 2021-2023 Tahoe, Suburban, Yukon and Escalade models may not detect certain vehicles. A "system unavailable" message also may be displayed on the Driver Information Center.

Side Blind Zone Alert warning

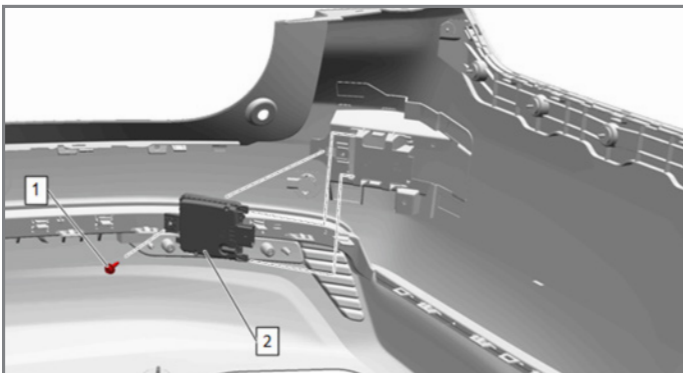
If vehicles are not detected properly, it may be due to the incorrect installation of one or both of the left/right Side Object Detection Control Modules in the rear bumper fascia bracket.

Side Object Detection Control Module in the rear bumper fascia bracket.

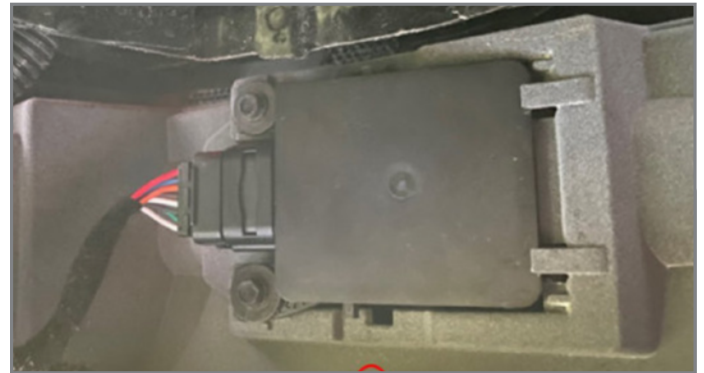
For example, if the Side Object Detection Module is flipped over (as shown below), the module's internal antenna that emits the radar wave will be pointed inward toward the passenger compartment. Despite the module being mounted incorrectly and pointing in the wrong direction, the system may still have some partial functionality.

Incorrectly installed Side Object Detection Module

When diagnosing a performance-related issue with the Rear Cross Traffic Alert and / or Side Blind Zone systems, first verify the proper installation of the left and right Side Obstacle Detection Control Modules. Review the appropriate Service Information for additional information.

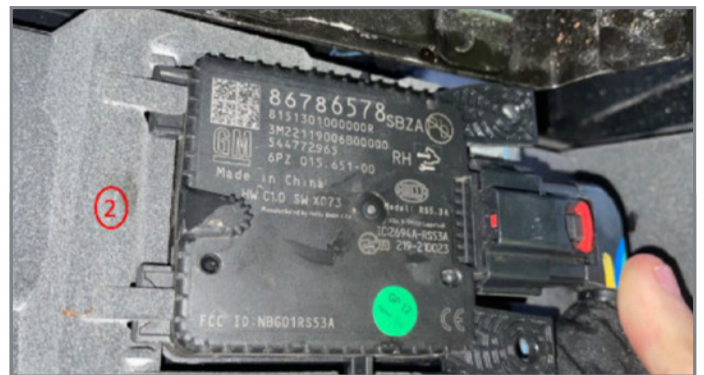
When installed correctly, the Side Object Detection Module label will point toward the front of the vehicle.

Correctly installed Side Object Detection Module

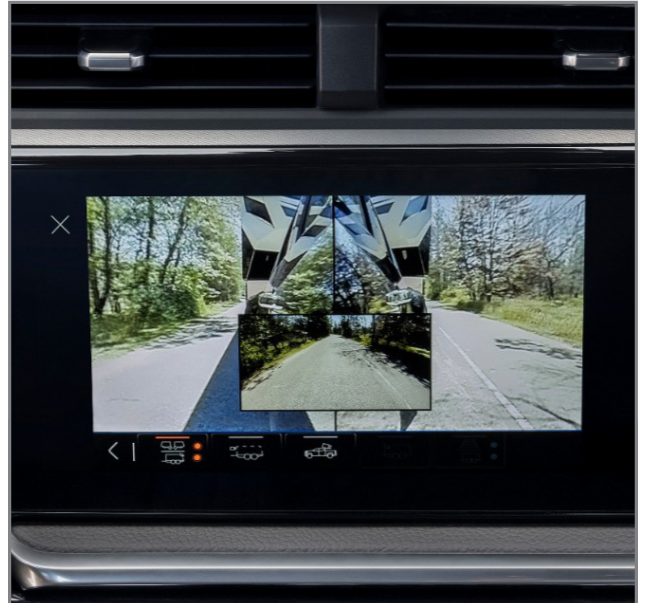
There may be some difficulty in setting up several trailering features on some 2024 Silverado 1500, Silverado 2500/3500, Sierra 1500 and Sierra 2500/3500 models equipped with the Surround Vision Cameras (RPO UV2) and Trailer Camera Provisions (RPO TRG). When setting up the transparent trailer, jack knife alert, trailer length indicator, biasing view, rear trailer guidelines or articulation angle indicator, the system will not calibrate. These conditions may be caused by a software issue with the Video Processing Module.

Normal valid trailer height inputs can range between 0.39 inches (1 cm) up to 177.1 inches (450 cm), but with the current software, any trailer height input that is 119 inches (303 cm) or greater will cause the system not to calibrate.

Several trailering features may not calibrate correctly.

To enable the system to calibrate if the trailer height is 119 inches (303 cm) or greater, change the height input to 118 inches (299 cm) when setting up the system. With the lower trailer height input, the trailer calibration will complete. There are not any adverse effects by changing the trailer height input to 118 inches (299 cm) and all trailering features will operate properly.
