# Front Fascia and Headlamp Adjustment

# High Resistance in Ground Straps

# Unable to Complete Transmission Park Lock Position Sensor Measurement

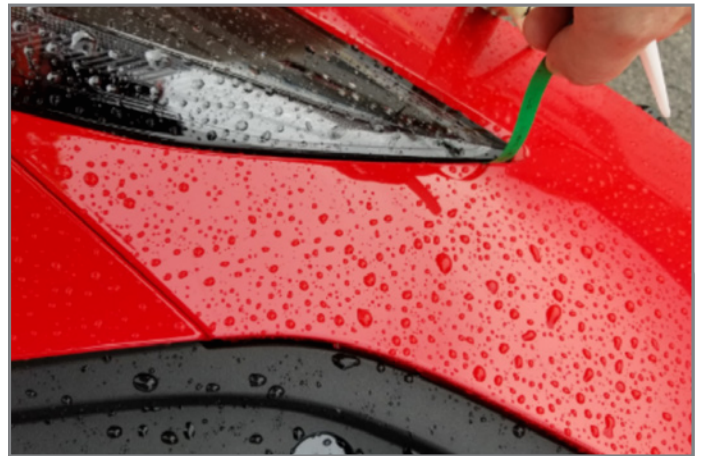
Measure the headlamp position.

Check for the correct headlamp position before and after any repairs. The headlamp lens should have a minimum 0.5 mm (0.02 in.) gap between the lens and the body panel.

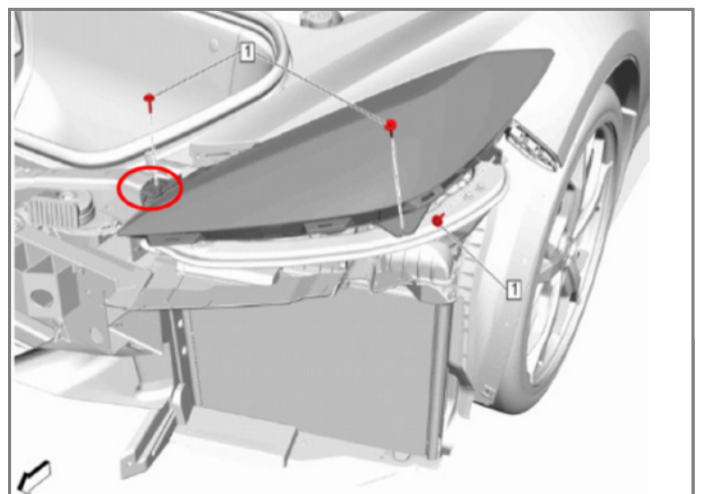
The paint may have chipped or peeled on the front fascia or fender-to-fascia body seam on some 2020-2024 Corvettes. The paint chip may be due to the headlamp being positioned too tightly to the body panel. The fit between the front fascia and fender also may be too tight on the same vehicle.

Complete a partial paint repair to the affected locations of the front fascia and reinstall the fascia.

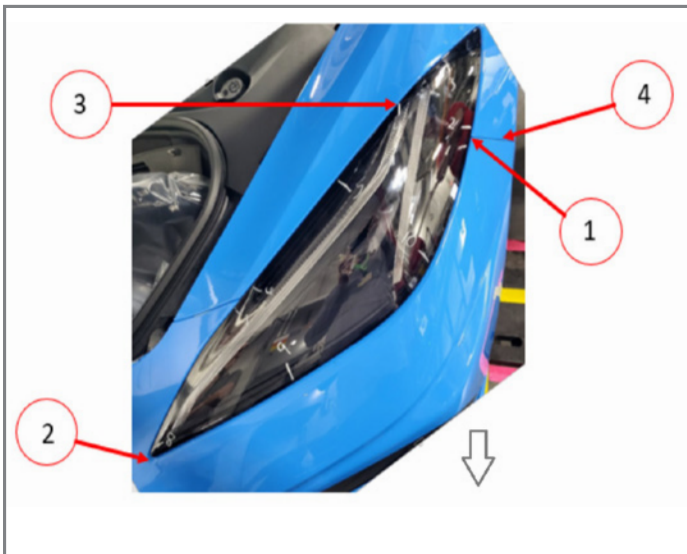
If these conditions are found, there are four potential high-contact areas where the paint may chip or peel:

1. Fender/fascia under the headlamp
2. Front corner of the headlamp to the fascia
3. Headlamp tight to fender
4. Front fascia to fender

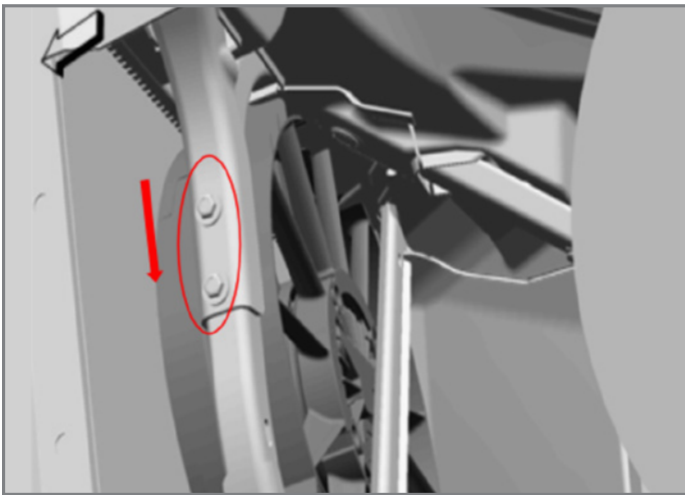
Two cobra bracket bolts

If there is a tight gap at the headlamp-to-fender area, mark the location of the two cobra bracket bolts on each side of the vehicle and adjust the brackets. Lowering the bracket will create a larger gap between the headlamp lens and the fender.

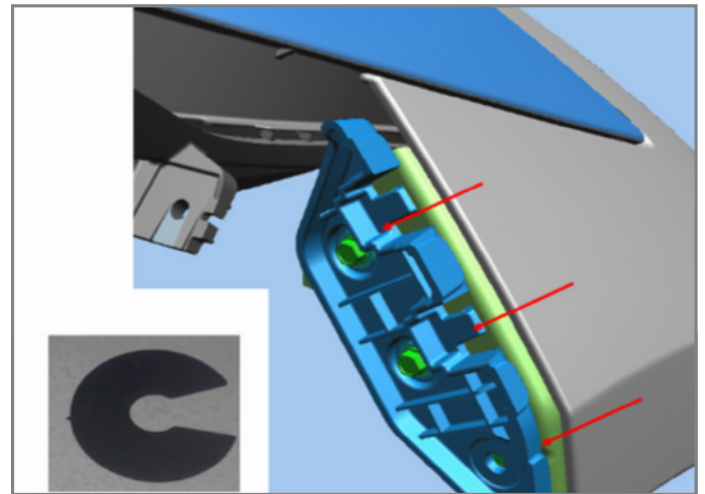
If there is a tight gap at the front fascia-to fender area, install shims at three locations (as indicated) between the bracket and fender.

Install shims at three locations between the bracket and fender.

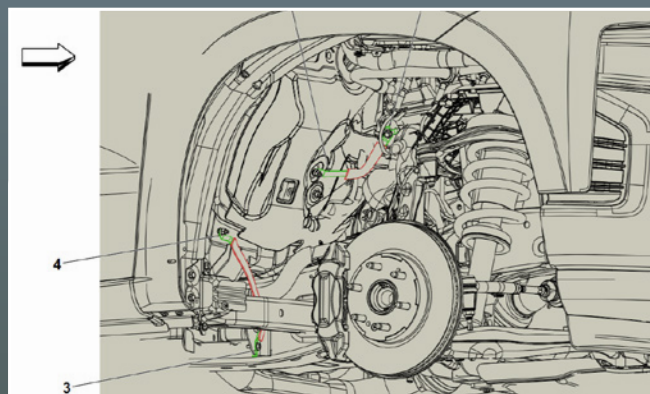
There may be high resistance in the G132 and G133 grounds, located behind the right-hand wheelhouse liner on some 2019-2022 Silverado 1500 and Sierra 1500 models. As a result, a loss of power steering assist or power braking assist may occur.

Inspect G132 (#1) and G133 (#4) for high resistance.

If these conditions are found, inspect the G132 engine ground strap and G133 frame ground strap for high resistance and repair as necessary. Check for any loose, stripped or corroded straps or connections. Refer to Ground Repair in the appropriate Service Information.

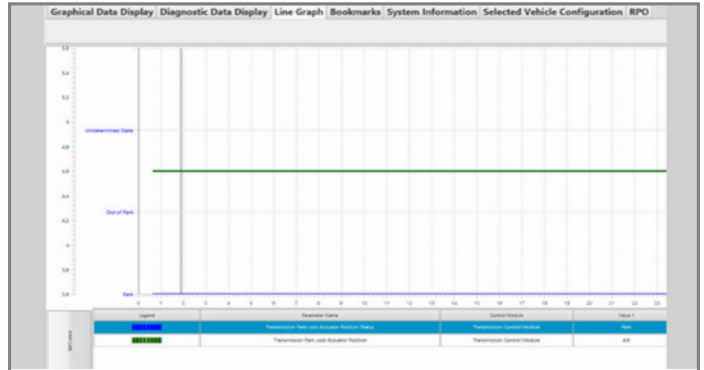
Park sensor measurement

These conditions may be due to park sensor drift in the transmission or a communication error caused by a module or circuitry.

found in the GDS transmission data; ETRS data lists. It's not necessary to submit the session log for this condition.

TAC will contact GM Engineering with this data to verify the park position at birth. The data comparison will confirm whether the transmission has park sensor drift that will require transmission replacement or if there is another direction for vehicle repair.

To help with diagnosis, start a Technical Assistance Center (TAC) case and forward the park sensor measurement in millimeters
