Wheel Drive Shaft Damage

Shift Concerns on 8-Speed Transmissions

TECH LINK

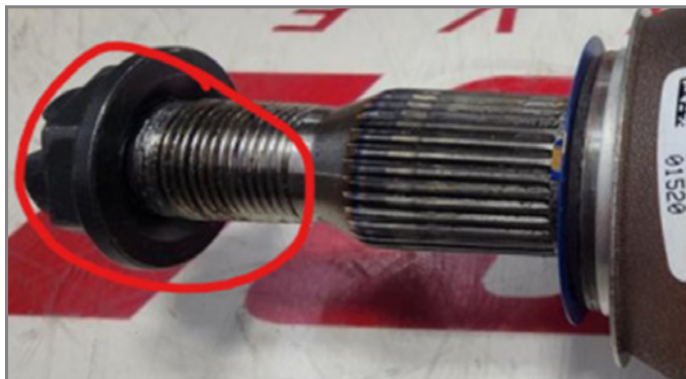
Damage to the wheel drive shaft threads may occur if power tools are used to remove the wheel drive shaft nut on some 2021-2023 XT5, XT6, Blazer, Traverse, Acadia; and 2021-2024 Enclave models equipped with all-wheel drive.

Damage to the wheel drive shaft threads

Power tools should not be used to remove the wheel drive shaft nuts. Use hand tools only. Any warranty claims submitted due to these conditions may be debited.

Refer to the proper replacement procedures in the appropriate Service Information. Removing the wheel drive shaft nut requires using a breaker bar and the proper sized socket to loosen the nut.

The wheel drive shaft nut is a single-use fastener and should be discarded once removed from the wheel drive shaft.

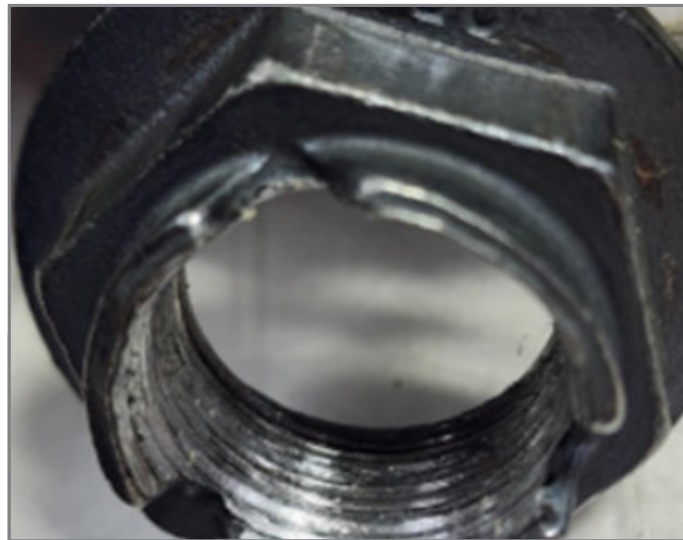
Wheel drive shaft nut

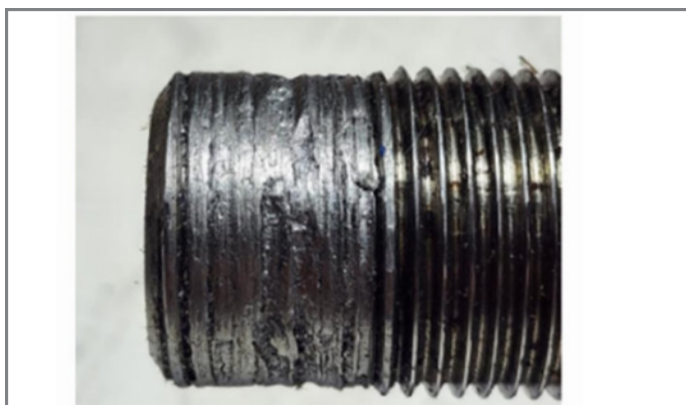
Damage to the wheel drive shaft threads

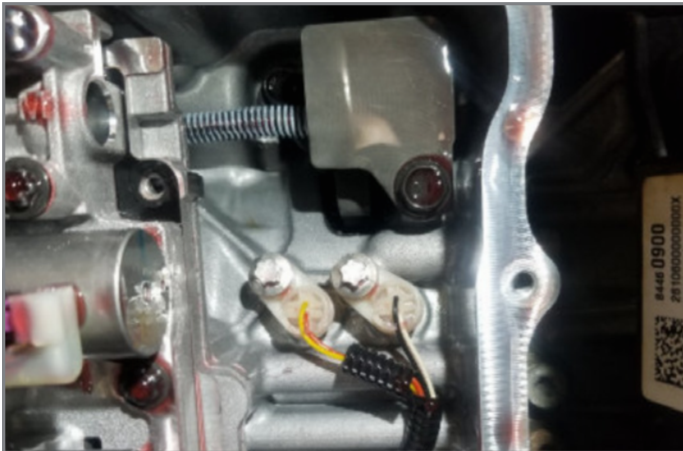
In addition, if the speed sensors were recently replaced and the Transmission Service Fast Learn fails for excessive vehicle speed,

or if DTCs P0717, P0722, P0746 and/or P0796 also set, inspect the speed sensors for the proper orientation. When correctly installed, the smaller portion of the sensor conduit should be facing the rear of the unit.

Incorrect speed sensor orientation

Refer to #PIP5943 for additional information.

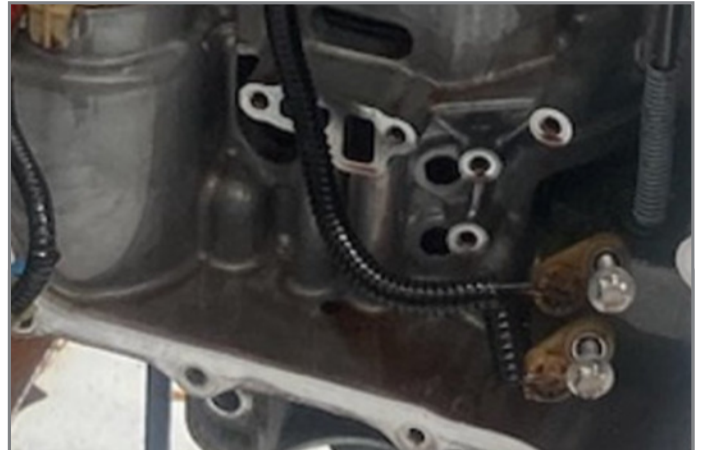
Correct speed sensor orientation
