Hands-Free Start Power Modes .....	2
Lunch with Your FSEs Meetings Now Offer Three Convenient Call Times .....	5
Headlamps Flashing Due to Low Battery Charge .....	6
Rear Axle Differential Lock Control Actuator Condition .....	7

## TECH LINK

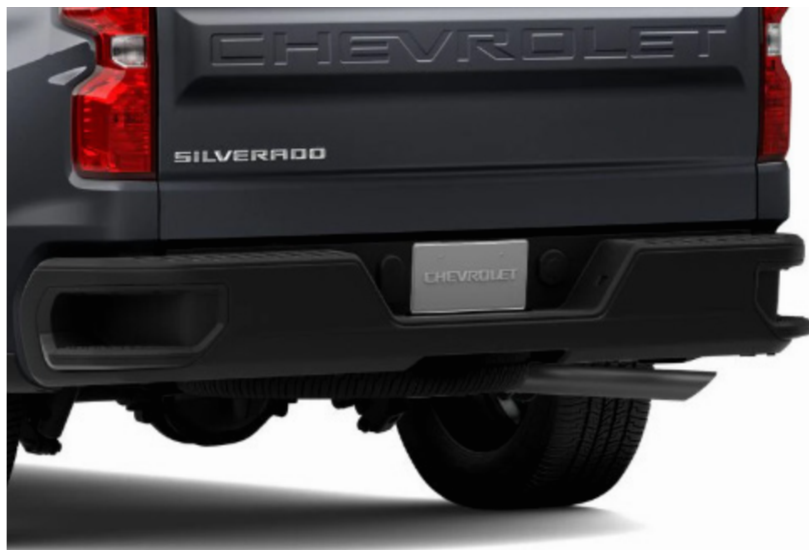
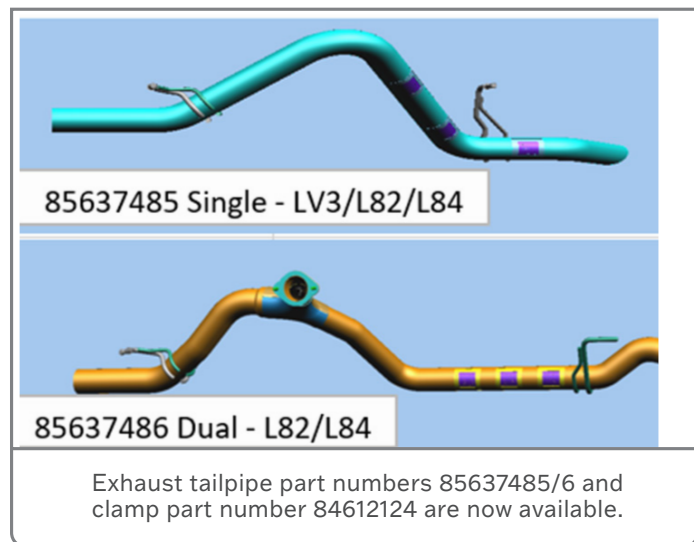
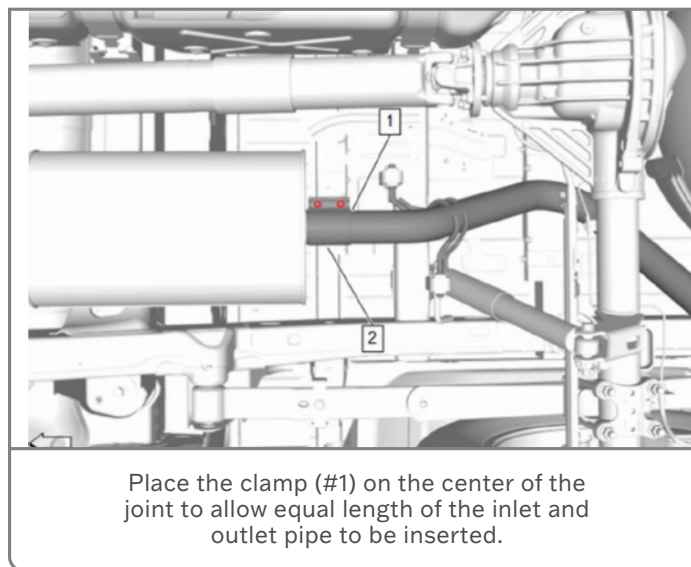
The replacement tailpipe is a cost-effective alternative to replacing the complete assembly when damage is isolated to only the tailpipe. Since rear collision damage may cause the complete exhaust system to move forward, resulting in damage upstream of the tailpipe, it's important to perform a thorough inspection of the complete exhaust system prior to any repairs.

When installing the service tailpipe, position the clamp on the center of the joint to allow equal length of the inlet and outlet pipe to be inserted. Be sure to trim the tailpipe length as needed to adequately clear surrounding components before tightening the clamp to specification.

Exhaust tailpipe part numbers 85637485/6 and clamp part number 84612124 have been released to cover single- and dual-exhaust applications for the V6 and V8 engine applications (RPO LV3, L82, L84).

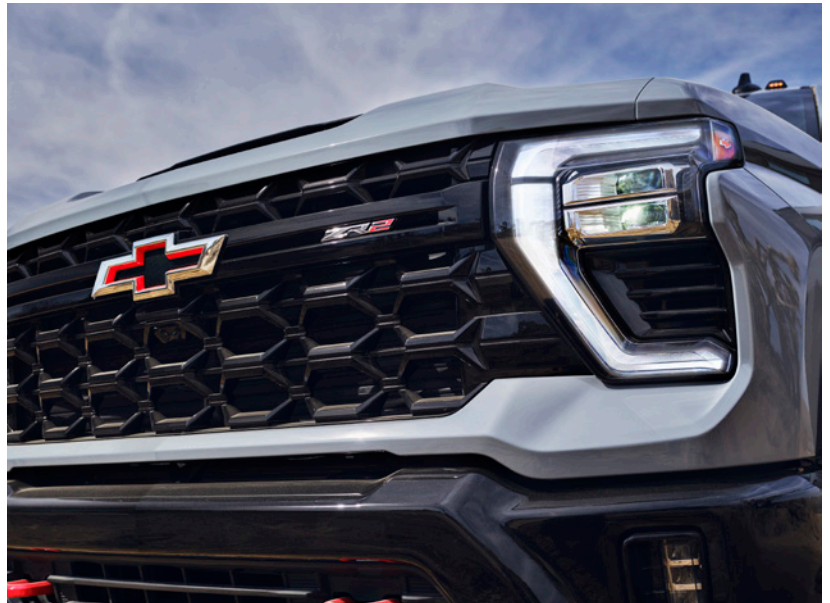
Some 2024 Silverado 2500HD/3500HD and Sierra 2500HD/3500HD trucks may have an electrical condition where the headlamps flash and/or the windshield wipers pause while wiping. DTC P0606 (Control Module Processor Performance) may be set in the Lighting Control Module. The headlamp and/or wipers condition may be caused by a low battery state of charge, which can cause voltage diagnostics to fail in the Lighting Control Module.

If the vehicle's battery goes below the threshold in the Lighting Control Module during a cranking event or the battery is discharged and needs a jump start, the Lighting Control Module may go into a reset every 8-10 seconds, causing the headlamps to flash.

If the headlamps are flashing, do not replace the Lighting Control Module. Test the battery following the recommended testing procedures in the appropriate Service Information and replace the battery if necessary.

To correct the flashing headlamps and clear DTC P0606, disconnect the battery, which will reset the Lighting Control Module.

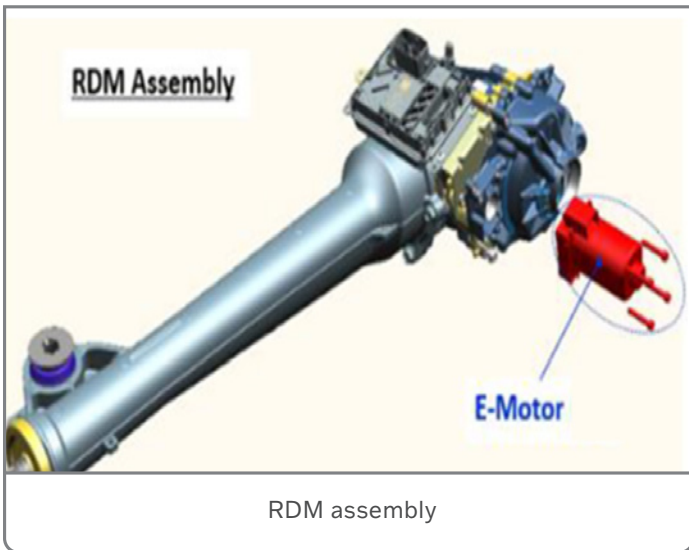
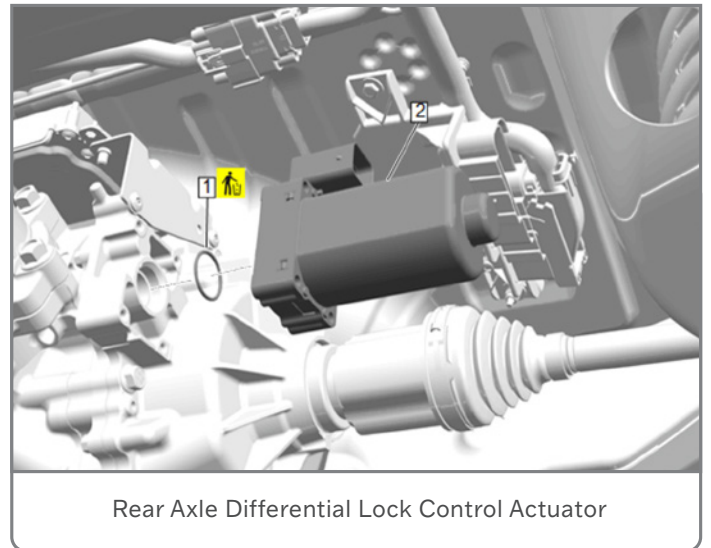
A Service All Wheel Drive message may be displayed on the Driver Information Center in some 2020-2023 Encore GX and 2021-2023 Trailblazer models equipped with the 1.3L engine (RPO L3T) and 9T45 automatic transmission (RPO M3F). The message may be caused by the Rear Axle Differential Lock Control Actuator.

Verify the Rear Differential Clutch Control Module (RDCM) has the latest calibrations. In addition, check that the wiring harness connection between the RDCM and e-motor is properly installed.

If the latest calibrations are installed and the wiring harness connection is in good condition, the Rear Axle Differential Lock Control Actuator should be replaced. Refer to Rear Axle

Differential Lock Control Actuator Replacement in the appropriate Service Information.
