Diesel Exhaust Fluid Supply Pipe Contamination

Diesel Exhaust Fluid Supply Pipe Contamination.....	2
Transmission Whine Sound	4
Power Tonneau Cover Tips.....	6

TECH LINK

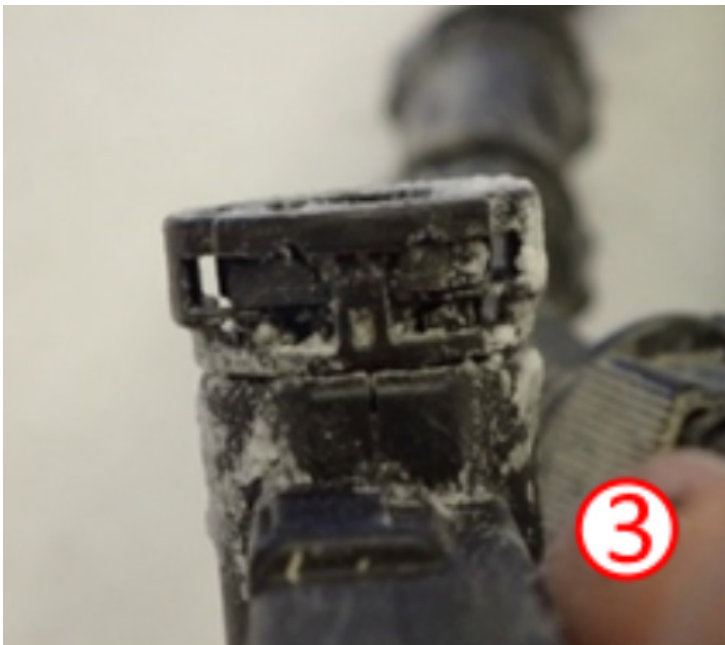
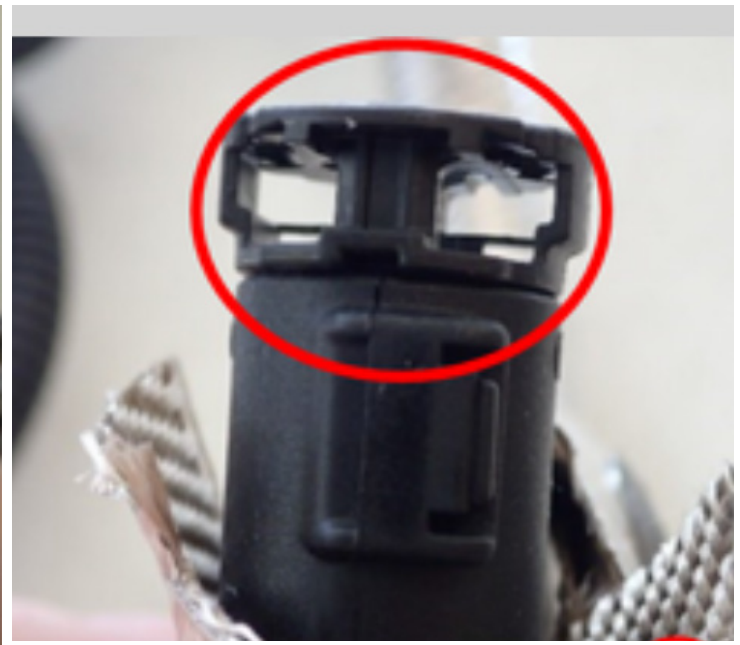
Check for crystallized Diesel Exhaust Fluid (DEF) at the supply pipe connector.

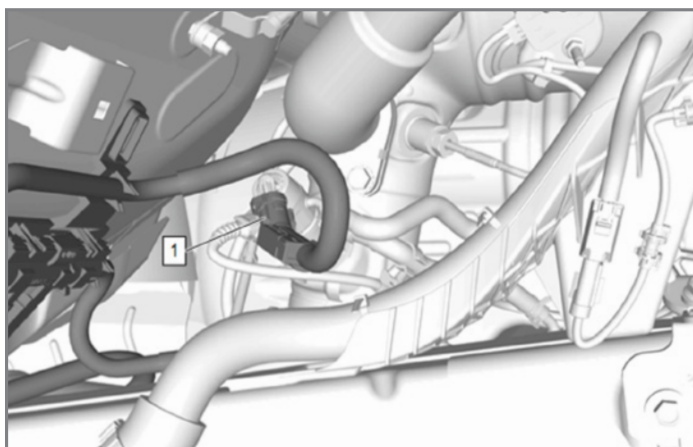
Emission Reduction Fluid Exhaust Front Pipe Injector Supply Pipe connector (#1)

If DTCs P249C and/or P20E8 are set, it may be necessary to perform a cleaning procedure and check for crystallized Diesel Exhaust Fluid (DEF) at the supply pipe connector.

If there is not any damage, a connector cleaning procedure should be performed. Crystallized DEF may have formed, which may not allow the pipe to properly seat on the injector and lead to a possible leak.

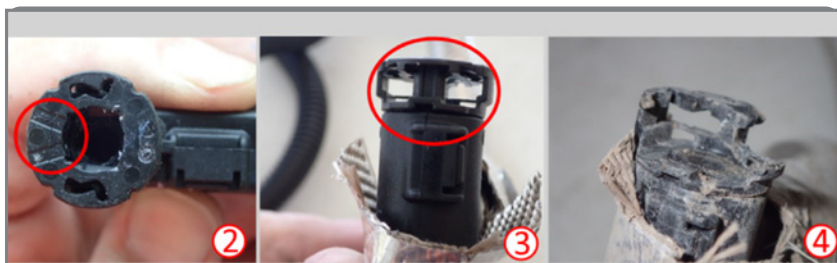
A damaged DEF pipe that cannot be reused.

If the supply pipe or connector is damaged, replace the Emission Reduction Fluid Exhaust Front Pipe Injector Supply Pipe and perform a Reductant System Tamper Service Bay Test.

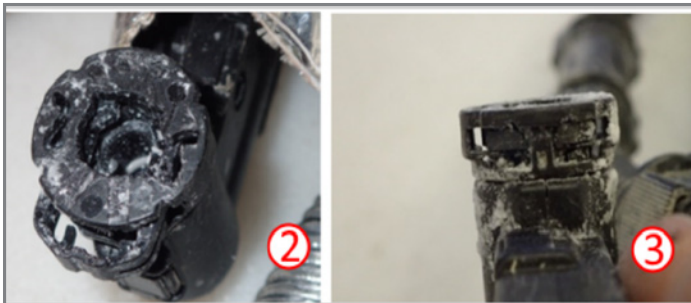
DEF pipe with crystallized DEF.

If the Emission Reduction Fluid Exhaust Front Pipe Injector Supply Pipe is contaminated with crystallized DEF in or around the connector, perform the cleaning procedure before attempting to reconnect the supply pipe to the Reductant Fluid Injector or the Emission Reduction Fluid Pump Outlet Port.

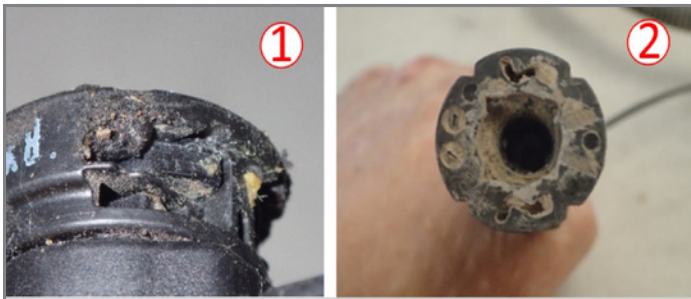
TIP: The cleaning procedure cannot be performed if the Emission Reduction Fluid Exhaust Front Pipe Injector Supply Pipe connector is contaminated with other forms of contaminants, such as frame wax or dirt inside the connector. If these types of contaminants are present, the Emission Reduction Fluid Exhaust Front Pipe Injector Supply Pipe will need to be replaced.

Replace the DEF pipe if frame wax, dirt or other contaminants are present.

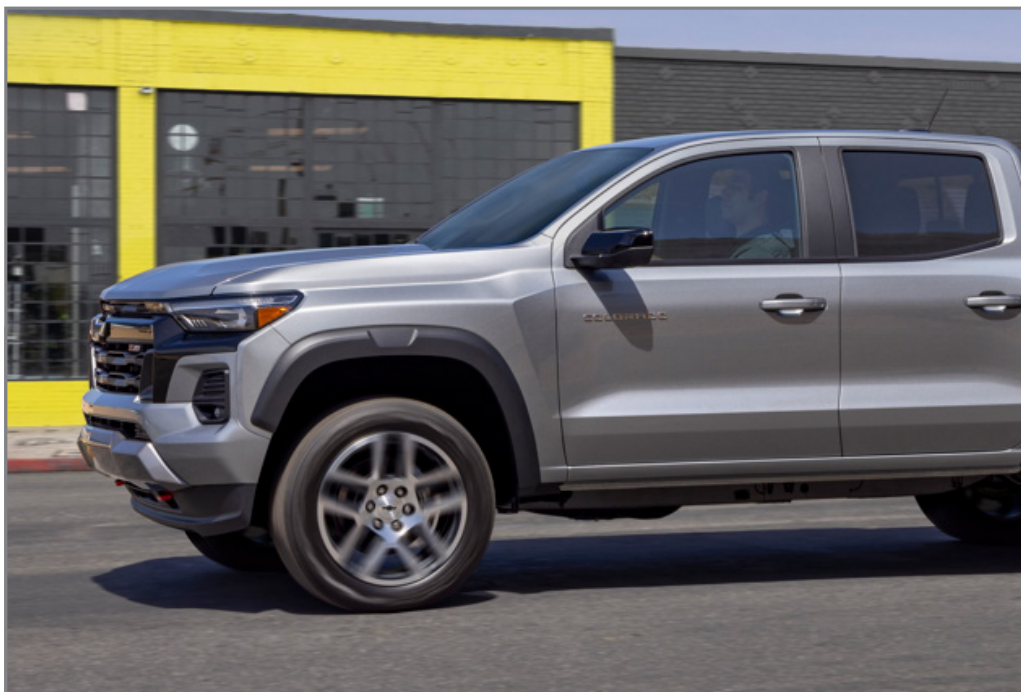
There may be a whine sound heard under light acceleration or when coasting on some 2023-2024 Colorado and Canyon models equipped with the 8L45 or 8L80 8-speed automatic transmission (RPO N8R, MFC). The sound, usually heard around 25-50 mph (40-80 km/h), may be caused by cable isolation in 4th and 5th gear at approximately 42 mph (68 km/h) under moderate acceleration.

Test drive the vehicle in 4th gear, at approximately 2000-2800 rpm, and observe if there is a gear whine sound under light throttle or coasting.

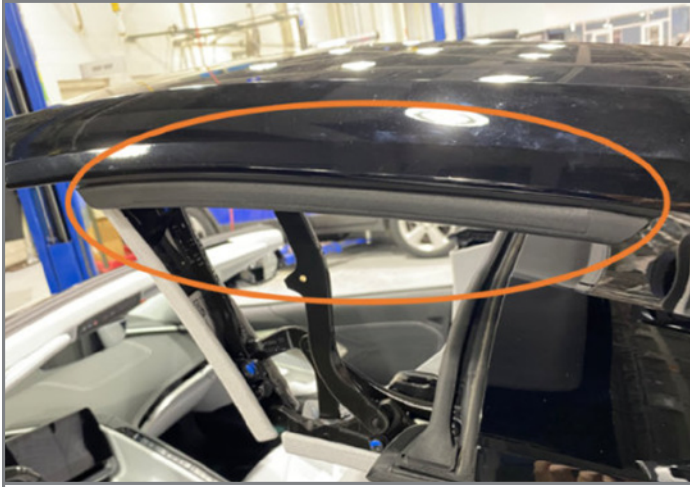
Some 2020-2024 Corvette convertible models may have a water leak around the side glass. The leak, which is found at approximately the middle rear of the side glass area, may be noticed when the vehicle is exposed to a high-pressure car wash.

A water leak may be found around the side glass.

The side glass leak may be due to slight variations in sealing between the roof panel seals. To correct this condition, a piece of semi-closed EPDM foam should be installed at the edge of the top panel.
