Inoperative 110/120-Volt Power Outlet

Forward Collision Alert Indicator On at All Times

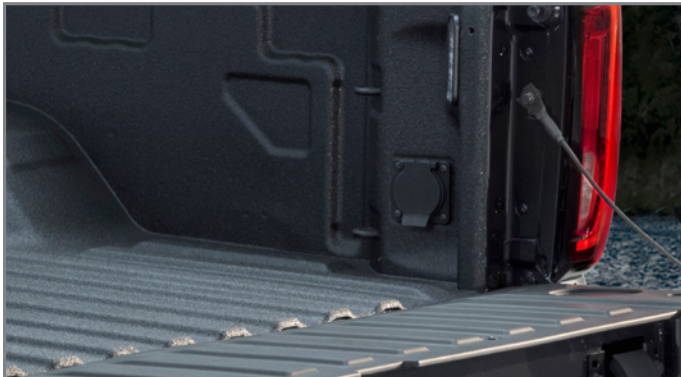
The 110/120-volt power outlet may be inoperative on some 2020-2023 Silverado 2500HD/3500HD and Sierra 2500HD/3500HD models. Vehicles may have two alternating current power outlets, located in the cab on the center stack or in the truck bed. An inoperative power outlet may be due to a low voltage condition.

If the accessory power outlet was correctly turned on, turn it off. Next, disconnect the battery or batteries for several minutes and then reconnect. Start the vehicle and turn on the in-cab power outlet switch. Connect a suitable device to the power outlet and check to see if there is power to it.

If the power outlet now operates, it is possible that the Body Control Module (BCM) determined there was a low battery condition and locked out the 110/120-volt power outlet(s). Inspect the vehicle for any type of condition that may cause a low voltage concern.

Repair any conditions found that would affect the 12V battery.

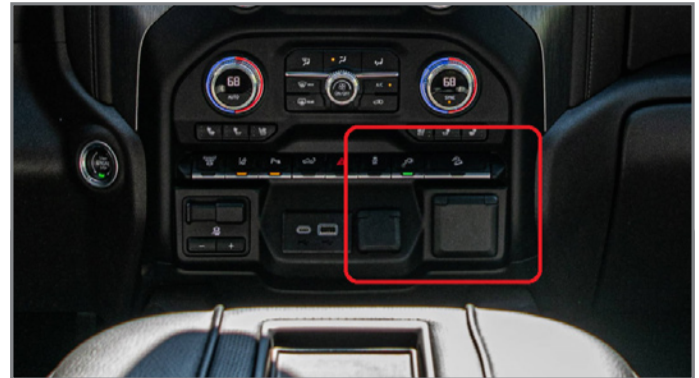
When the ignition is on, power is supplied to the outlets after the DC/AC switch is pressed. A green indicator light on the switch indicates that DC/AC operation is active. All connected devices should not exceed a maximum of 400 watts. If equipment is connected using more than 400 watts or a system fault is detected, a protection circuit shuts off the power supply and the indicator light turns off.

Power is supplied to the power outlets after the DC/AC switch is pressed, indicated by a green light on the switch.

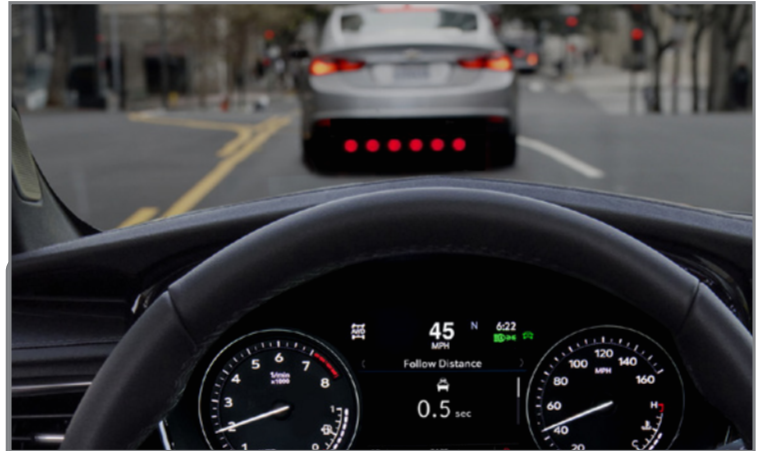
Some 2020-2024 XT5 and XT6 models may have the Forward Collision Alert indicator shown on the windshield at all times. The indicator may be on any time the ignition is on or when the headlights are turned on.

If the Forward Collision Alert indicator is illuminated when it should not be, check the harness to the P43 Forward Collision Alert display. The harness may be pinched between the cowl and the instrument panel tie bar, which may cause the circuits to short together or to ground.

If the harness is pinched or damaged, remove components as needed to gain access to the area and make repairs as needed following the wire repair procedures in Service Information.

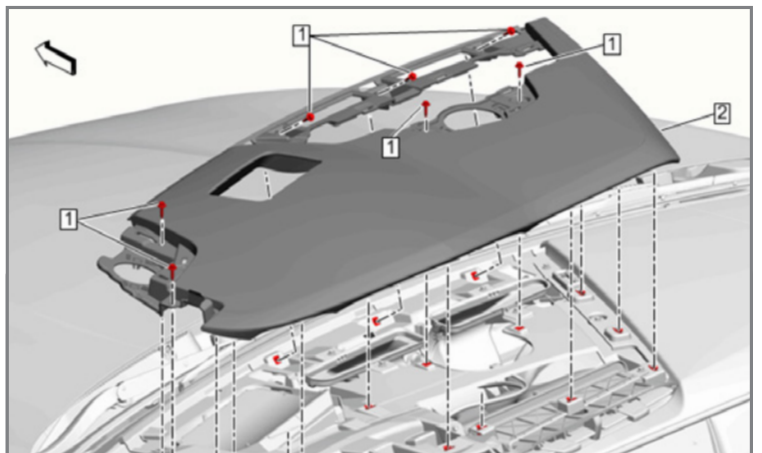
Remove the instrument cluster hood.

To inspect the harness, refer to the appropriate Service Information for the procedure to remove the instrument cluster hood.

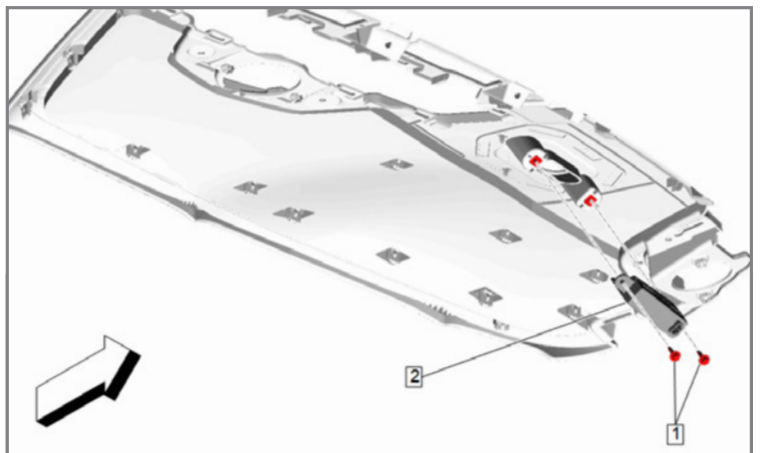
Forward Collision Alert display (#2)

Next, remove the P43 Forward Collision Alert display and check the harness between the cowl and the instrument panel. It may be pinched between the cowl and the large tie bar that goes across the instrument panel carrier. It may be necessary to move the sound deadening material on the cowl to see the harness clearly.

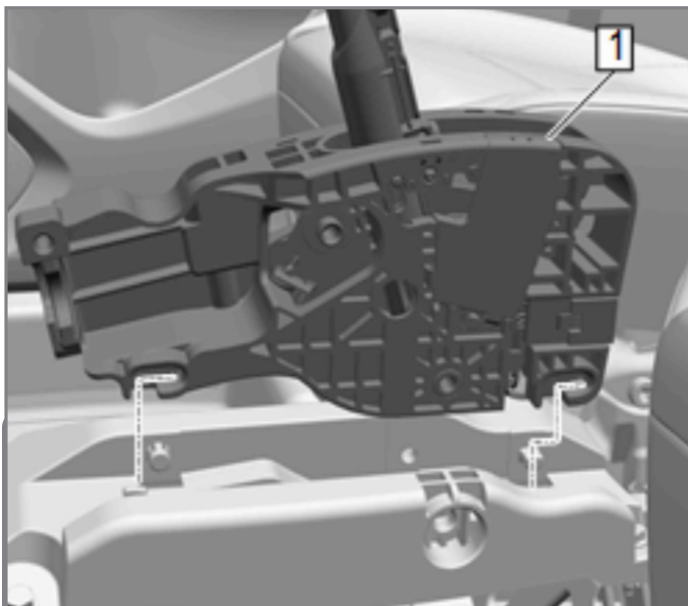
Transmission shifter control

A Shift to Park message may be displayed on the Driver Information Center while the vehicle is in Park on some 2020-2023 Encore GX, Malibu; and 2021-2023 Trailblazer models. A no start condition also may be present along with DTC B000A (Park Switch - Shift Lever Position Not Plausible).

These conditions may be caused by a park switch malfunction inside the shifter assembly. Inspect the female terminals of the body harness connector that plugs into the shifter harness for any damaged or spread terminals. If the terminals are not spread or damaged, replace the shifter control. Be sure to use the specific General Motors pin drag tools for inspection.

Refer to Transmission Control Replacement (without Base) in the appropriate Service Information.

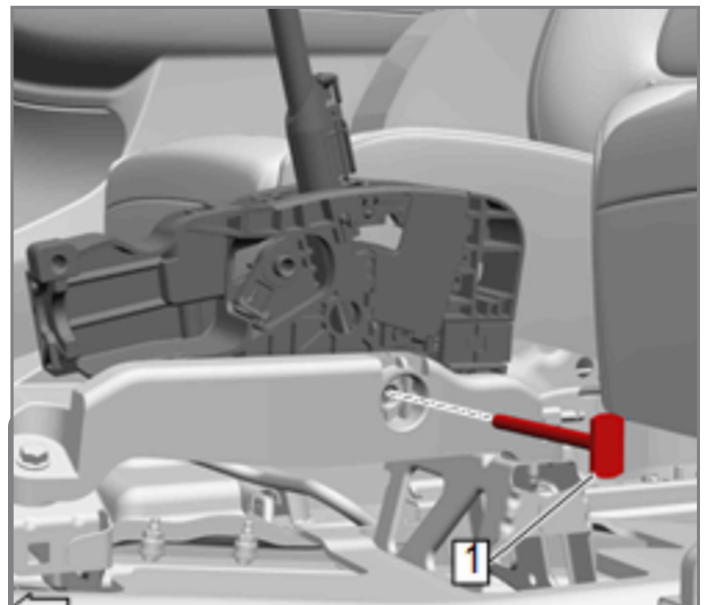
Main shaft bolt

During installation, hold the face of the transmission control main shaft bolt in the slot of the mounting bracket as the nut is torqued to ensure it remains seated and does not rotate out of the slot. If not seated properly, it may result in a loose shifter feel or rattle sound.

After installation, be sure to adjust the range selector lever cable. For additional details, including parts information, refer to Bulletin #23-NA-119.

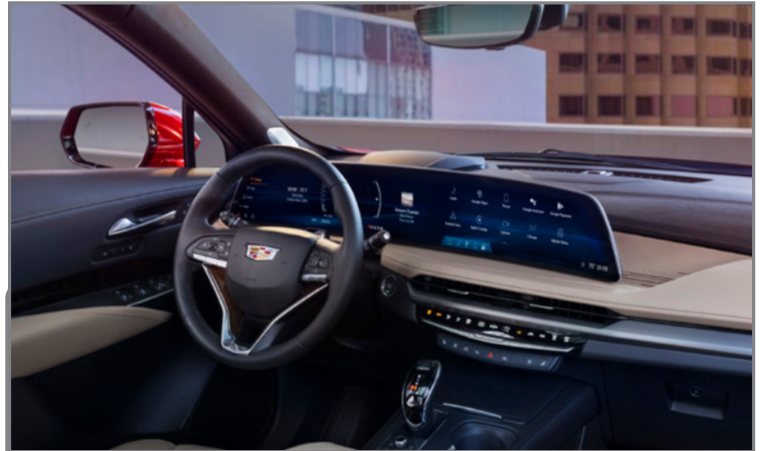
The loud sound may be caused by the Active Noise Cancellation (ANC) microphone projecting engine noise inside the cabin. Verify that the sound in the cabin is coming from the ANC microphone by rolling down the window while driving when the sound is occurring. The sound should stop immediately.

The ANC microphone may be projecting engine noise inside the cabin.

If the source of the sound is determined to be the ANC microphone, update the Vehicle Communication Unit (VCU) software.

TIP: A VCU software updated was recently released in December 2023 that fully resolves this issue. Vehicles that received a prior VCU software update may require an additional update.
