Window Indexing After Loss of Vehicle Power

Window Indexing After Loss of Vehicle Power.....	2
Inoperative Trunk Latch.....	3
PicoScope Recording for CVTs with Noise Concerns.....	6
Newly Arrived EVs May Not Charge.....	7

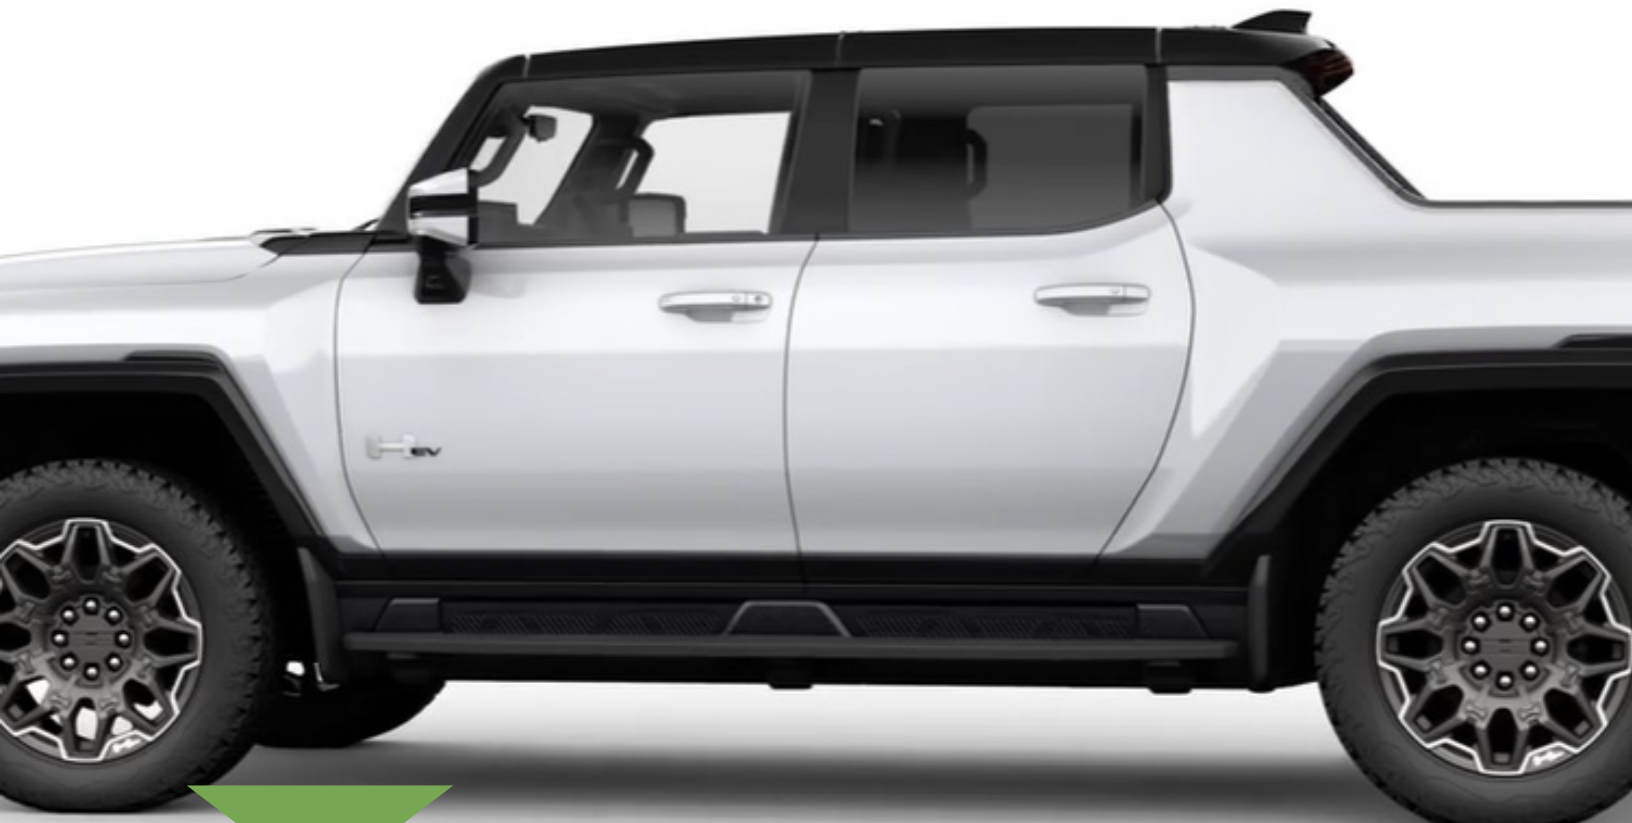
If the vehicle loses 12V battery power, the automatic indexing feature will not operate.

The doors can be opened if there is a loss of 12V battery power. However, with the indexing feature inoperative, care should be taken to not forcefully slam the door because the top of the side window will contact the sky panel and/or the front A-pillar applique. Damage will likely occur if the door is forcefully closed with the side window in the full up position. Any damage that occurs to the sky panels or A-pillar appliques would not be covered under the New Vehicle Limited Warranty.

To close a door with the side window fully raised without 12V battery power, push the top edge of the side window inward while simultaneously slowing closing the door in order to “tuck” the top of the side window underneath the A-pillar applique and sky panel. Once the side window is in place, push the door to latch it. Following this procedure will help prevent potential damage to the sky panel or A-pillar applique when closing the door.

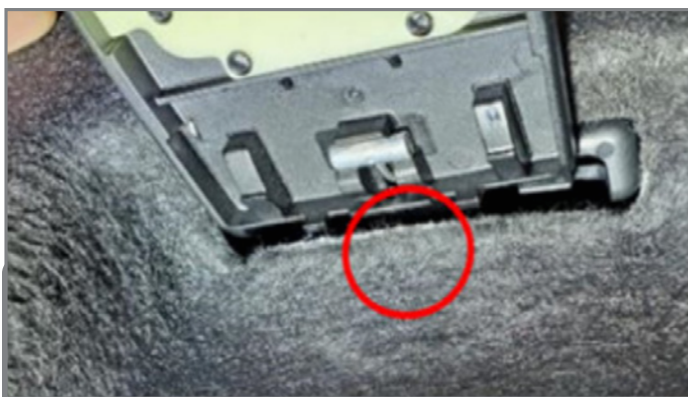
The inoperative trunk latch may be due to an improperly seated Emergency Trunk Release (ETR) handle, which may prevent the trunk lid from opening.

Improper ETR bezel installation

If the trunk latch is not operating, first check that the carpet around the ETR bezel is positioned properly (improper installation shown).

The carpet should be tucked between the ETR bezel and the sheet metal so that the bezel tab can be seen.

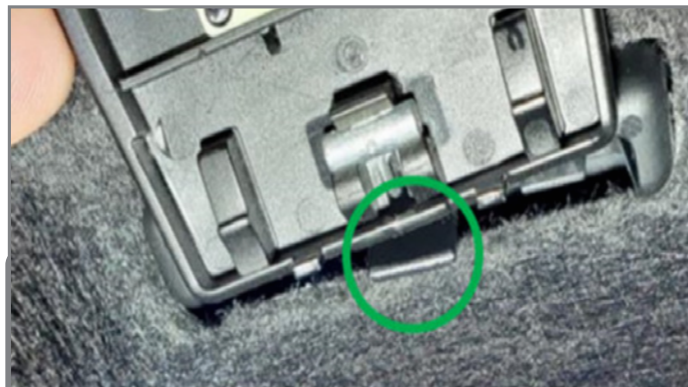
Correct ETR bezel installation with visible bezel tab.

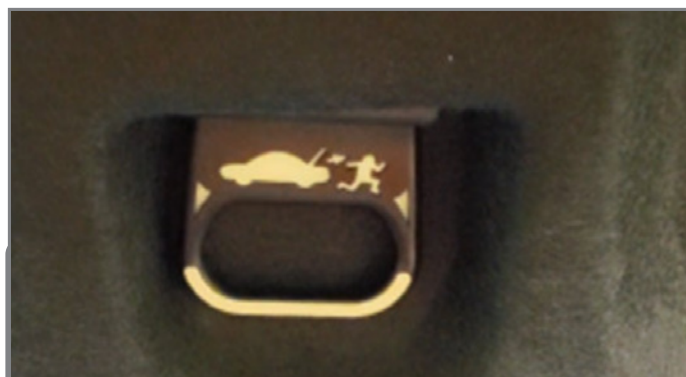
ETR handle snapped in properly.

Next, verify that the ETR handle is snapped upward into the bezel. When the ETR handle is snapped in properly, there will be very little distance between the car/person graphic and the bezel.

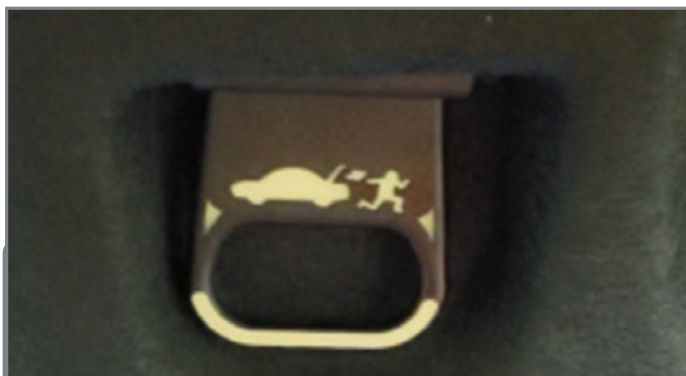
If there is a large amount of space above the graphic, the ETR handle is not snapped in properly.

ETR handle not snapped in properly.

With the ETR handle in place, verify that the trunk latch functions correctly using the key fob as well as the vehicle's exterior and interior trunk release buttons.

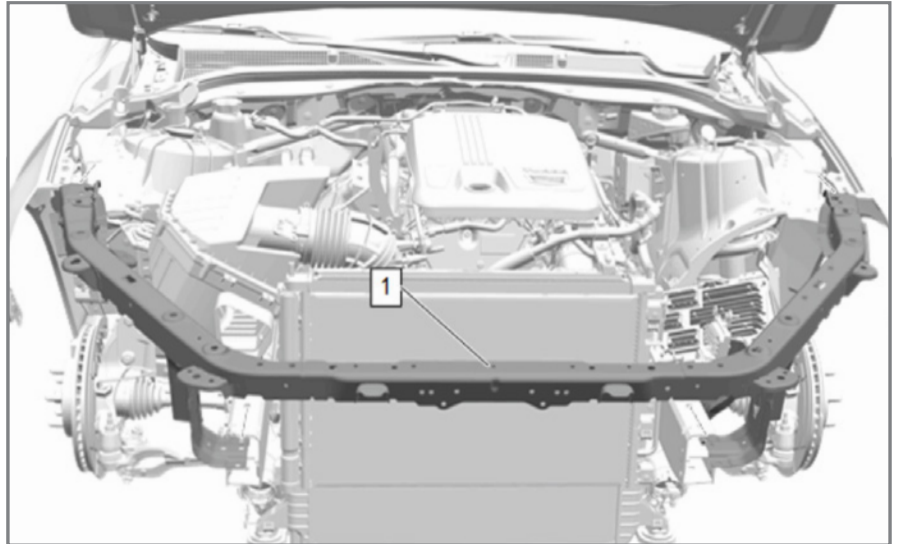
Front compartment front panel

These conditions may be caused by a poor ground path through the front compartment front panel-to-vehicle body connection.

If there is excessive voltage loss to a module or device on the ground path, perform a loaded voltage drop test between any of the ground connections G103, G107, G108 and G110 at the front compartment front panel to the negative post of the battery.

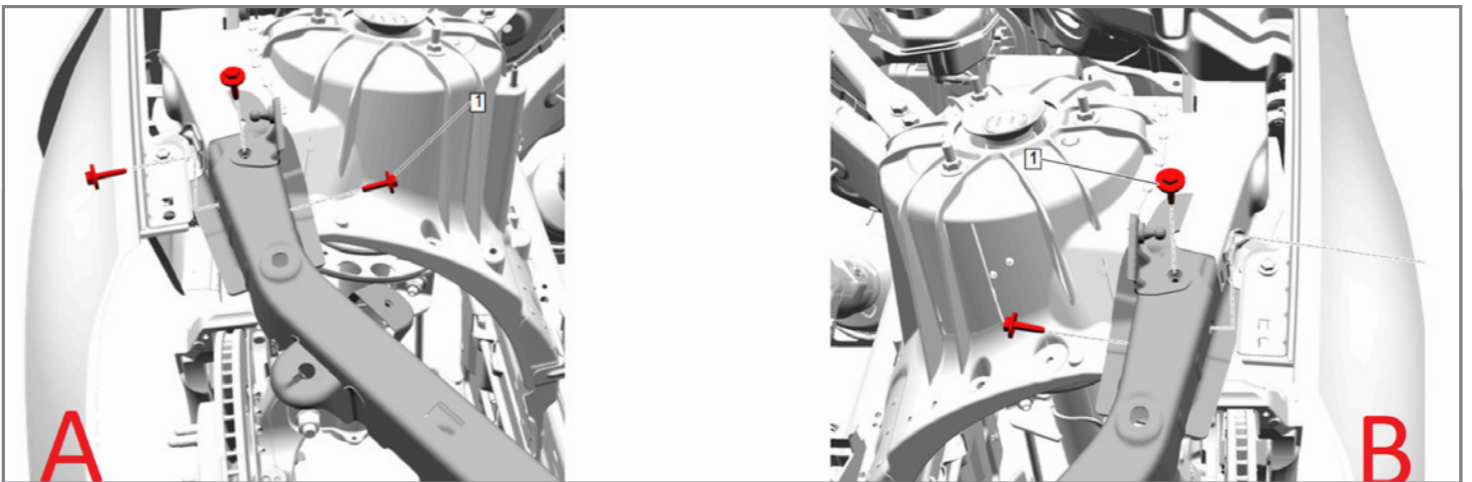
Right-side (A) and left-side (B) front compartment front panel attaching points.

If the voltage drop is significant, remove and clean the front compartment front panel attaching points and fasteners.

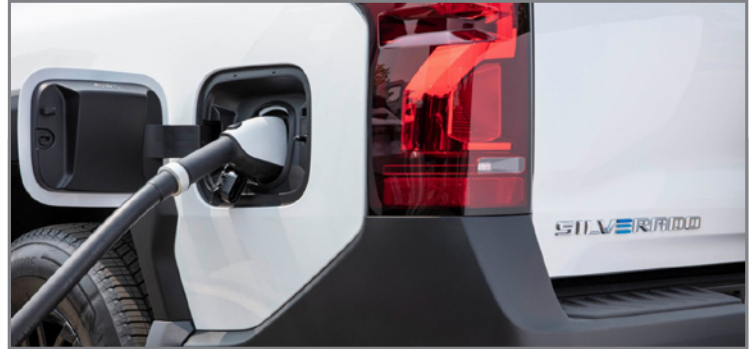
These EVs have a Charging Inhibit Latch built into the software as part of the manufacturing process.

Newly arrived EVs may not charge initially.

In order to charge the vehicles once they arrive at the dealership, ensure that Transport Mode is disabled and then drive the vehicle for 5 miles.

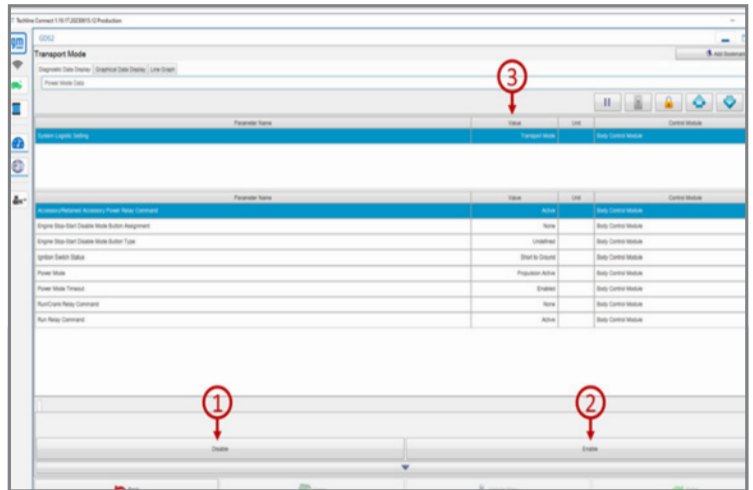
Use GDS 2 to disable Transport Mode.

Use GDS 2 to disable Transport Mode on the Silverado EV, which features a Passive Power Mode. Go to Module Diagnostics/Body Control Module/Power Mode/Transport Mode and select the Disable button at the bottom of the screen.
