Dual Clutch Transmission MCVM PUN Characterization

DCBS Warranty Requirement
Deadline Extended 2

6-Speed Automatic Transmission
Oil Filter and Seal Now
Available Individually 4

Crankshaft Bearing Diagnosis..... 5

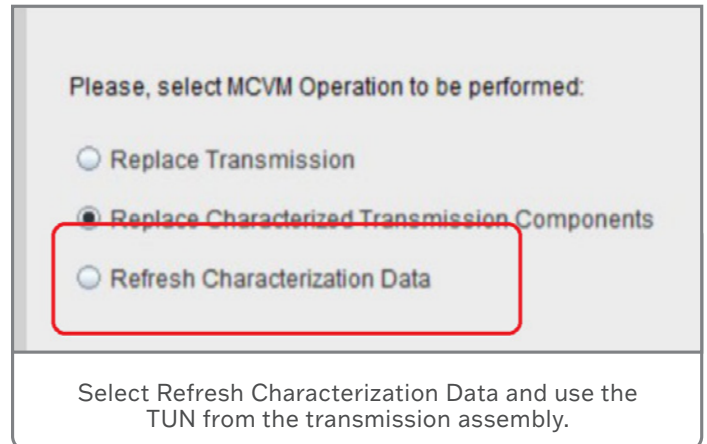
Select Refresh Characterization Data and use the TUN from the transmission assembly.

TIP: If direct clutch or MCV PUN characterization has been attempted and fails, select Refresh Characterization Data and use the Transmission Unique Number (TUN) from the transmission assembly.

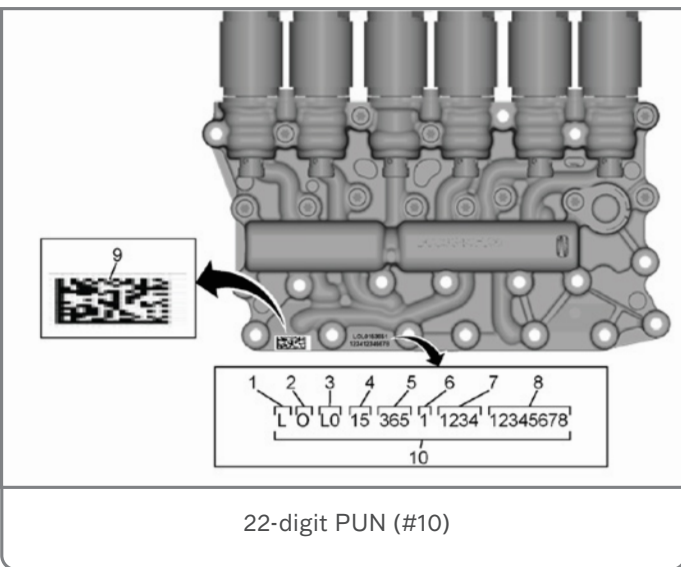
22-digit PUN (#10)

The supplier uses the 21-digit PUN for production parts and the 22-digit PUN is used in service. Only the 22-digit PUN should be entered when TCM programming.

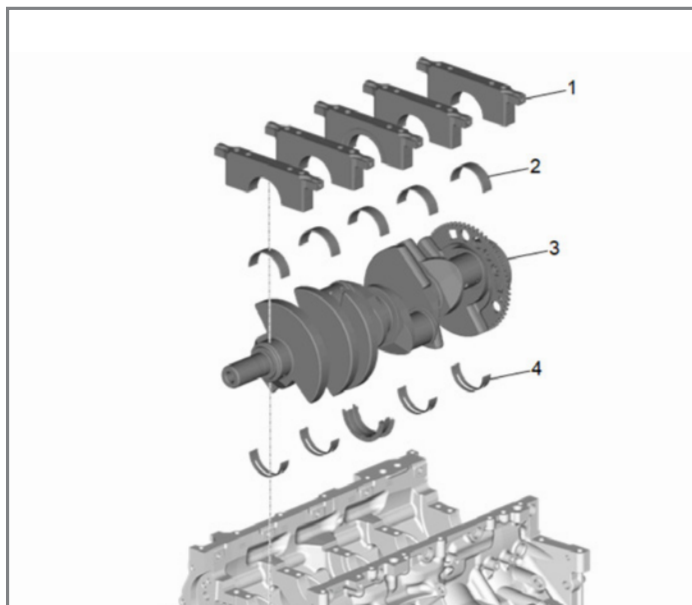
A growling, knocking or rhythmic thumping sound may be heard on some 4.3L engines (RPO LV3), 5.3L engines (RPO L82, L84) and 6.2L engines (RPO L87, LT1, LT2, LT4, L8T) on some 2019-2024 Camaro, Corvette, Silverado 1500, Sierra 1500; 2020-2024 Silverado 2500/3500, Sierra 2500/3500; 2021-2024 Tahoe, Suburban, Yukon, Escalade; 2021-2024 Express, Savana; and 2022-2024 CT5 models. The engine may be hard to rotate once at operating temperature, which may lead to it locking up and unable to restart. Once the engine cools down to ambient temperature, it may re-fire and run normally. In addition, the starter fuse may be open. All of these conditions may be a sign of an early bearing failure.

Check for crankshaft bearing or thrust bearing failure.

If these engine conditions are present, check for crankshaft bearing failure or a damaged thrust bearing. There are several items to inspect to determine if bearing failure has occurred.

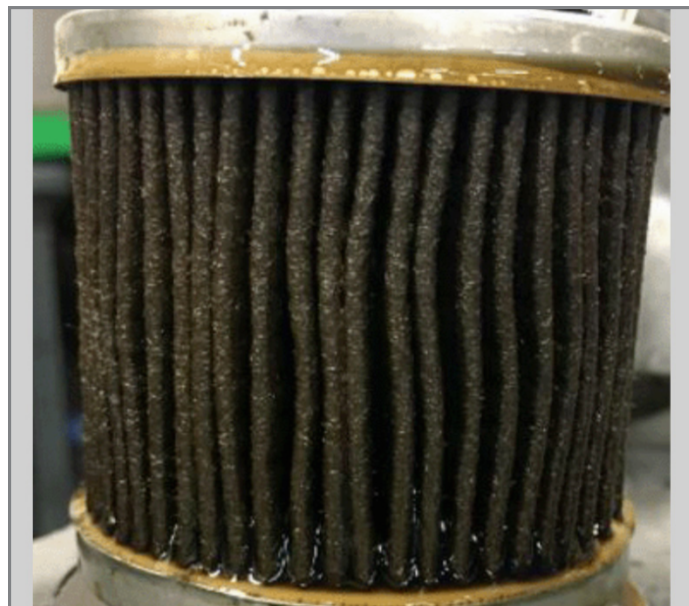
Inspect the engine oil and filter for bearing material.

Begin diagnosis by inspecting the engine oil and filter for bearing material or excessive metal debris. Pouring the oil through a white shop towel may be helpful.

TIP: There may be light glitter in the oil from the manufacturing process if the engine has not had its first oil change. In this case, further engine inspection is necessary.

Remove the engine oil pan for further inspection of the crankshaft rod and main bearings if bearing debris has been identified.

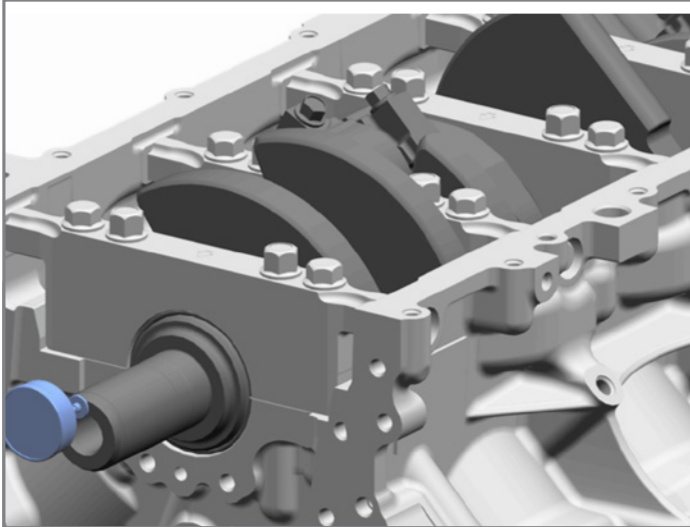
In addition, if material is found in the engine oil, measure crankshaft end play following the appropriate Service Information. If there is not excessive crankshaft end play, remove the engine accessory drive belt and run the engine again. If the noise is eliminated, check the accessory drive belt-driven components for possible issues.

Measure crankshaft end play.

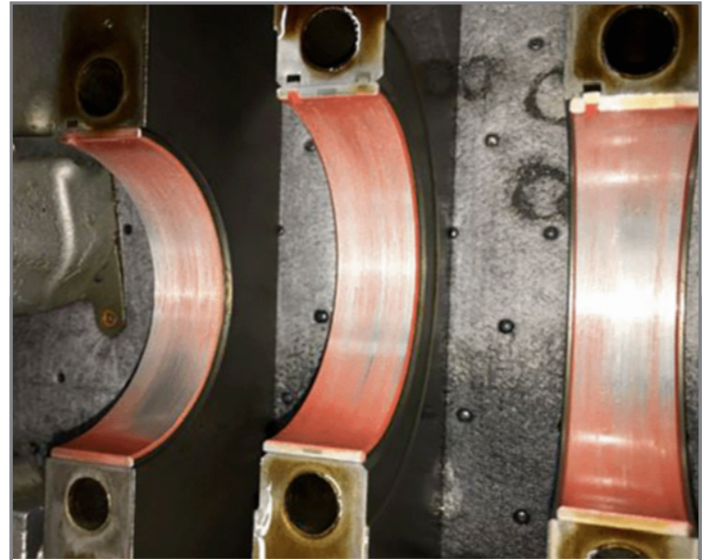
Refer to Bulletin #18-NA-073 for additional repair directions if crankshaft bearing damage is found.

TIP: If crankshaft bearing damage is found once all diagnostic procedures are completed, refer to Bulletins #22-NA-074 and #18-NA-073 for additional repair directions.
