MDI 2 Advanced Setup Technical Tips Update

TECH LINK

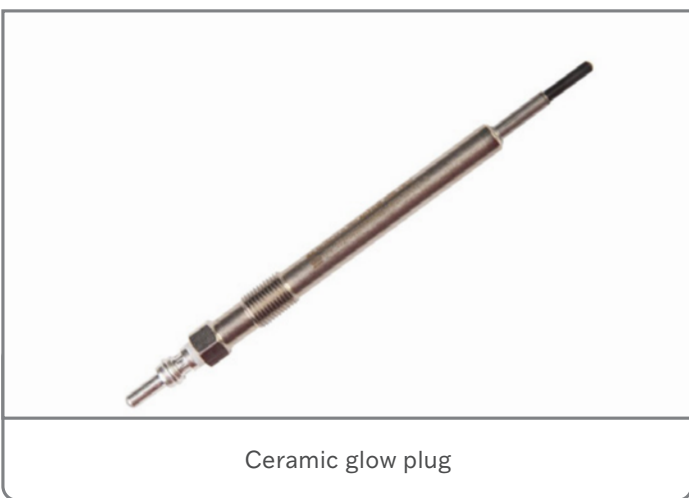
Ceramic glow plug

- Measure the resistance of a new glow plug. An open circuit in a glow plug indicates that the glow-plug tip is broken and should not be installed in an engine.
- Do not install a glow plug into an engine if the glow plug has been dropped.
- Pull on the tip of a new glow plug before installation. Be sure your hands are clean before handling the glow plug.
- Always use the EN-52074 Glow Plug Bore Reamer when replacing a ceramic glow plug on the 1.6L, 3.0L and 6.6L

- Never use any type of grease or anti-seize compound on a new glow plug. Using any lubricant could lead to over-tightening of the glow plug.
- When installing a glow plug, make sure that it is in line with the glow-plug hole. Any side load placed on the glow plug could cause a crack in the ceramic, which would lead to premature failure.
- Do not use power tools to install a glow plug.
- Do not overtighten a glow plug. An overtightened glow plug could initiate a crack in the ceramic, leading to premature failure.

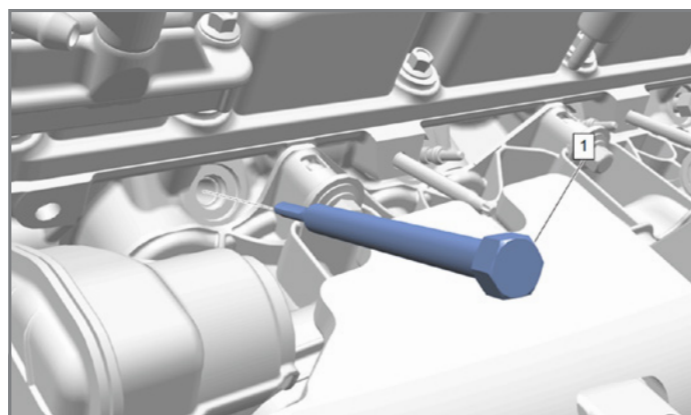
EN-52074 Glow Plug Bore Reamer

diesel engines. A glow plug hole bore cleaning tool will remove the soot built up on the inside of the glow plug hole. Once a glow plug is removed, the soot collected in the bore must be removed. Otherwise, the soot could "side load" the new glow plug and induce a premature failure. The only exception to this is when servicing a glow plug on a 2.0L or 2.8L diesel engine.

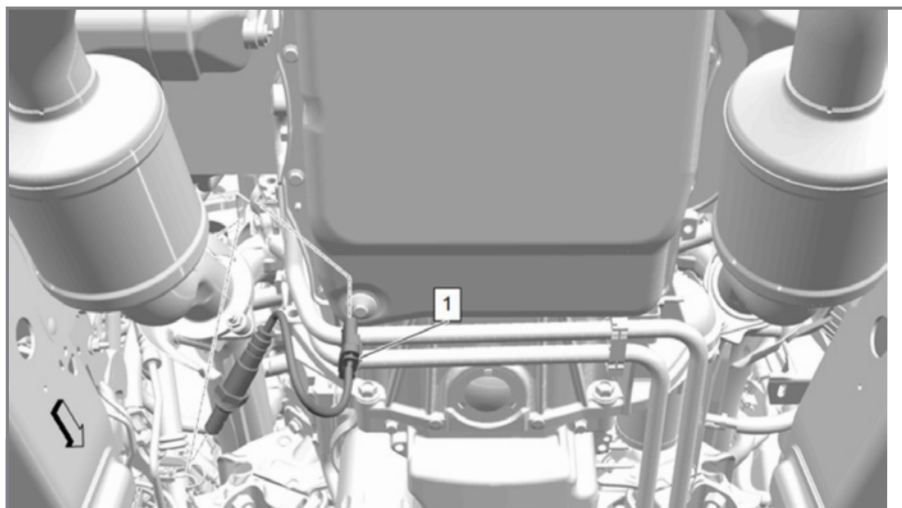
An engine misfire condition and an illuminated Check Engine MIL may be found on some 2024 Silverado 2500HD/3500HD and Sierra 2500HD/3500HD models equipped with the 6.6L V8 engine (RPO L8T).

The misfire condition may be caused by a misrouted Bank 1 Sensor 1 oxygen sensor wiring harness that is contacting the exhaust pipe. Inspect the oxygen sensor wiring for any contact with the exhaust pipe or heat shield. The fuse related to the circuit also may be open and should be replaced.

Check the oxygen sensor wire for contact with the exhaust pipe or heat shield.

If there is damage to the oxygen sensor wiring, replace the Bank 1 Sensor 1 oxygen sensor and ensure that the sensor wiring is routed away from the exhaust pipe. Refer to Heated Oxygen Sensor Replacement – Bank 1 Sensor 1 in the appropriate Service Information.

Refer to Bulletin #24-NA-042 for additional information, including part numbers.
