Transmission Not Shifting, Defaults to 5th Gear 4

Preventing Rear Glass Damage During Folding Top Service 5

Loss of Forward Gear on CVT Transmission 6

TECH LINK

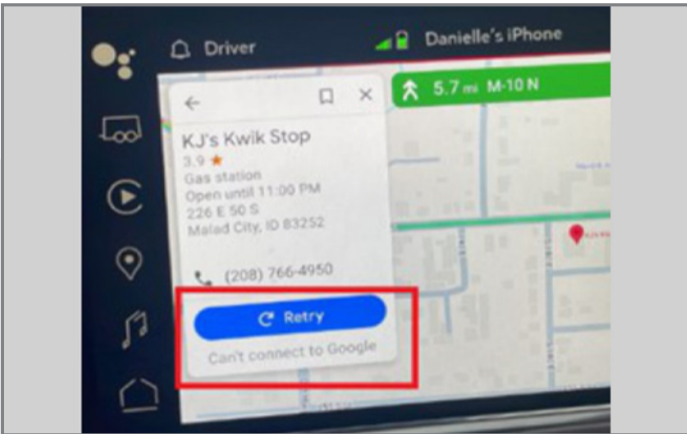
Due to a recent update of the Google Maps application, an issue may arise in which the infotainment system (RPO IOK, IVD, IVE) has a persistent "Offline" icon in maps and a "Can't connect to Google" message present on some 2022-2024 Silverado, Tahoe, Suburban, Sierra, Yukon, HUMMER EV, BrightDrop EVs; 2023-2024 LYRIQ, Colorado, Canyon; 2024 Envision, XT4, Corvette, Traverse, Blazer EV, Equinox EV, Silverado EV and Acadia models.

"Can't connect to Google" message

Update the Google Maps application to clear the messages and restore Maps operation.

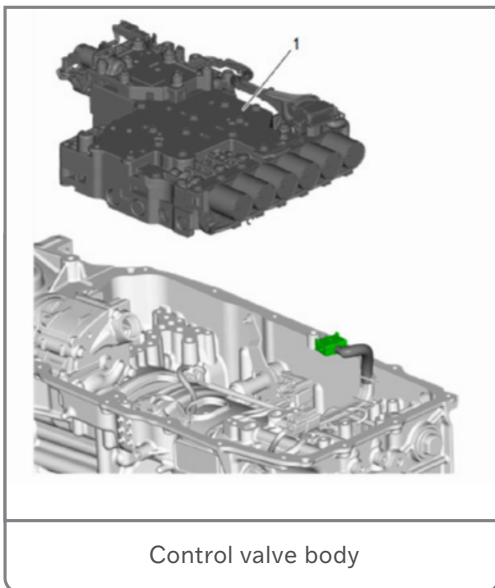
Control valve body

The shift condition may be due to the Transmission Control Valve Body failing, which likely caused DTC P0747 to set and for the transmission to default to 5th gear. In most cases, only the control valve body requires replacement.

If the fluid shows good color with no evidence of clutch material, only replace the

control valve body.

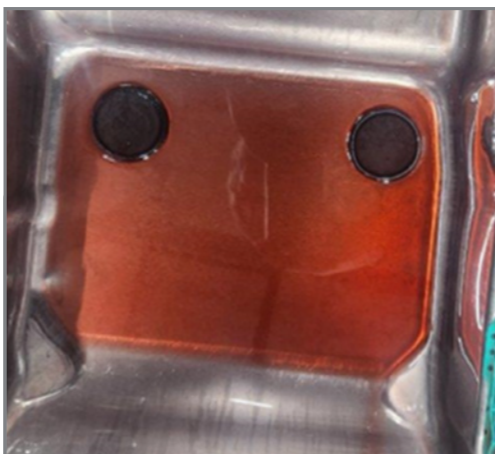
Example that shows good fluid color with no evidence of clutch material.

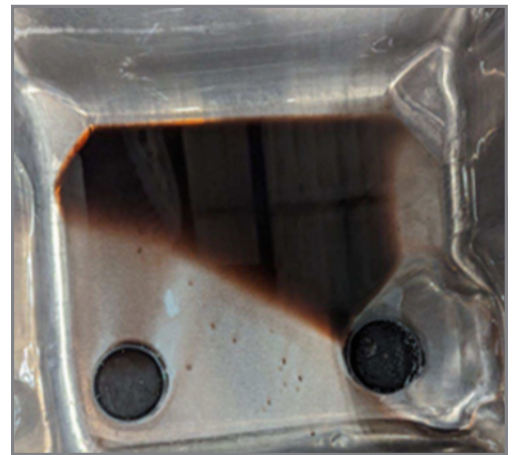
Example that shows darker fluid with minimal evidence of clutch material.

A transmission with fluid that may be darker in color with minimal evidence of clutch material, and without any burnt odor, also should be serviced only with a control valve body.

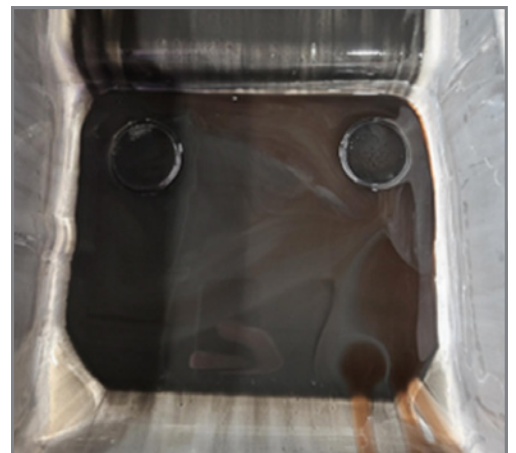
Example that shows fluid with extreme distress along with clutch material in the pan.

Fluid that shows extreme distress along with clutch material in the pan will require that the transmission be removed from the vehicle for further inspection to determine the clutches that have been damaged. Any suspect clutch should be repaired following the appropriate Service Information. The control valve body should be replaced as well.

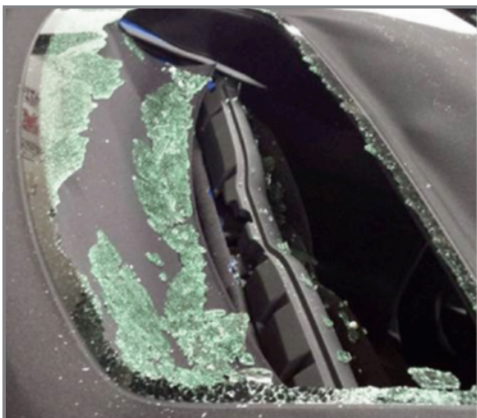
The rear glass is an integral part of the folding top canvas. The folding top linkage that connects the frame to the rear glass must be assembled properly to avoid any potential damage. If the folding top linkage is installed incorrectly, it can create stress on the rear glass, resulting in the glass cracking or shattering while cycling the folding top assembly.

If incorrectly installed, the folding top linkage can create stress on the rear glass.

When assembling the folding top, the folding top linkage that attaches to the rear glass must be located on the outboard side of the back glass bracket. The pin that holds it together should be inserted from the inboard side of the linkage.

The pin first goes through the back glass bracket, and then through the top frame linkage.

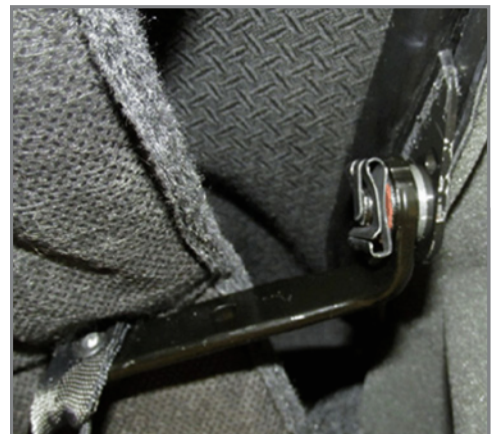
Correctly assembled folding top linkage at the rear glass attachment point

A gray, plastic washer may be found in this assembly during disassembly of the folding top. If present, it should be reinstalled. Finally, the spring clip should be installed on the outboard side of the top frame linkage. Before continuing with repairs, verify that the linkage has been correctly reassembled.

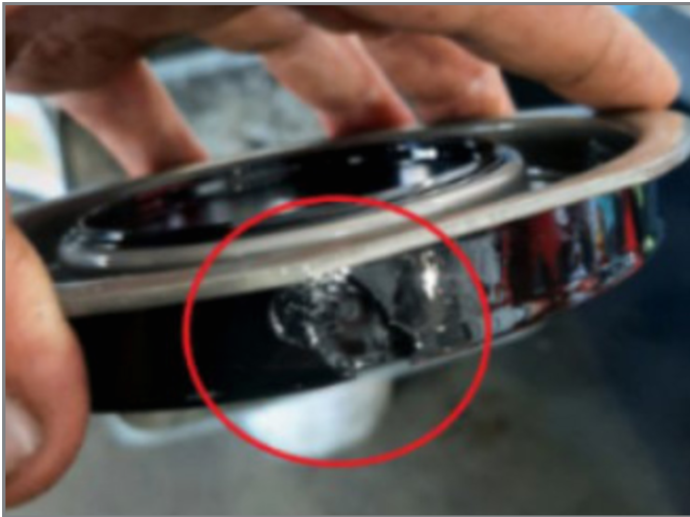
Damage to the forward clutch piston

The intermittent transmission gear condition may be due to the clutch regulator valve sticking in the valve body, damage to the forward clutch piston and/or wear in the primary pulley bearing bore.

If the forward clutches are worn and the forward clutch piston is damaged, replace the forward clutch piston, the housing and the applicable apply components as needed.

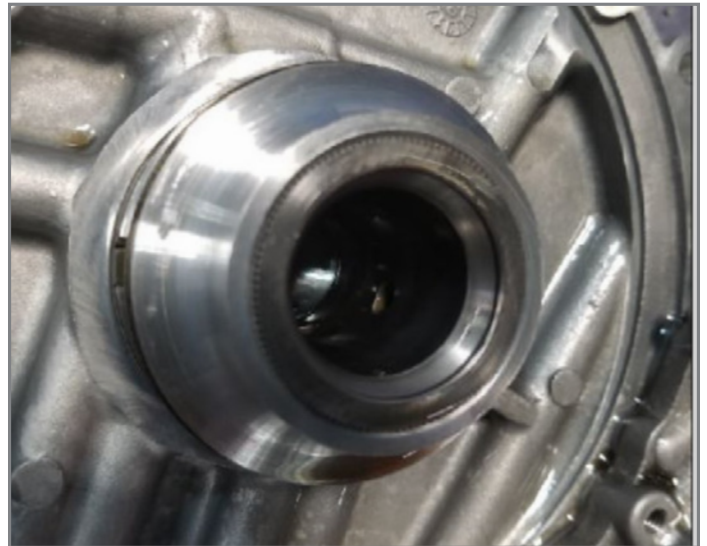
Inspect the pump for signs of wear.

If the forward clutch piston is not damaged, check the pump for signs of wear.

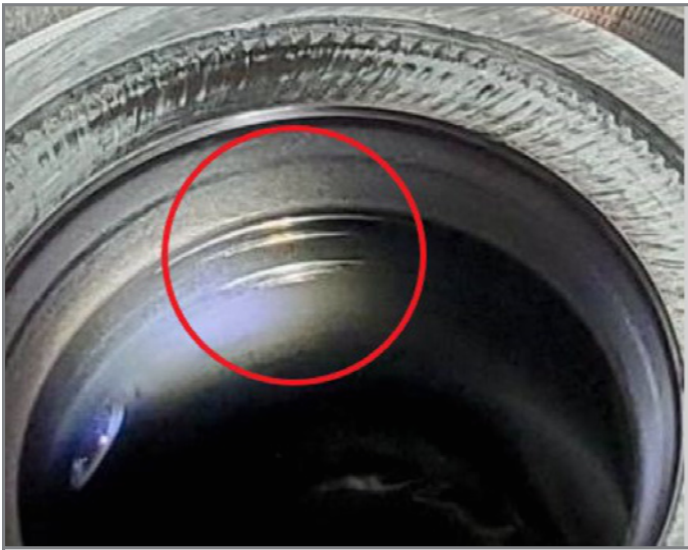
Damage indicates the primary pulley bearing has spun in the bore.

Signs of wear indicate the primary pulley bearing has spun in the bore, allowing the turbine shaft to become off-center. When this happens, it causes a pressure leak. If this condition is found, the transmission will need to be replaced.
