# Corvette E-Ray

Corvette E-Ray Delivers  
Electrified AWD Performance ..... 1

Use Correct Labor Code  
for Tire Valve Stem Repairs..... 4

Insufficient Dual Tank Fuel Transfer..... 5

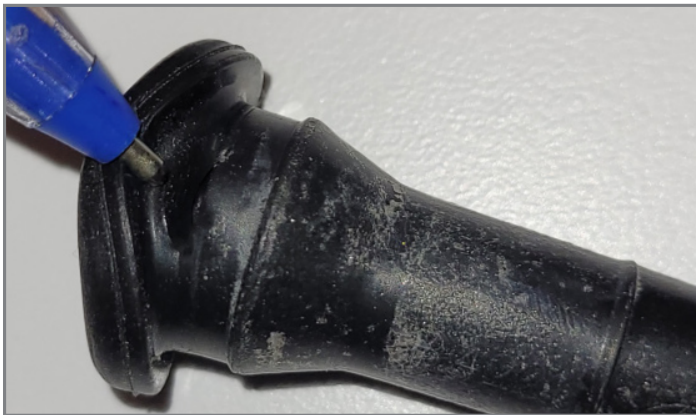
A damaged valve stem is a common cause of a tire leak. The valve stem may have been damaged by normal wear and tear from road conditions or impacts or from improper valve stem installation where the stem isn't full seated into the wheel.

Tire valve stem damage

If there is damage to a tire valve stem that requires valve stem replacement, also inspect the Tire Pressure Monitor (TPM) sensor for damage if the vehicle was driven on an underinflated or deflated tire and check the sensor porthole for any debris.

When the tire valve stem is replaced, be sure to use the correct labor code — 8060680 Tire Valve Stem Replacement.

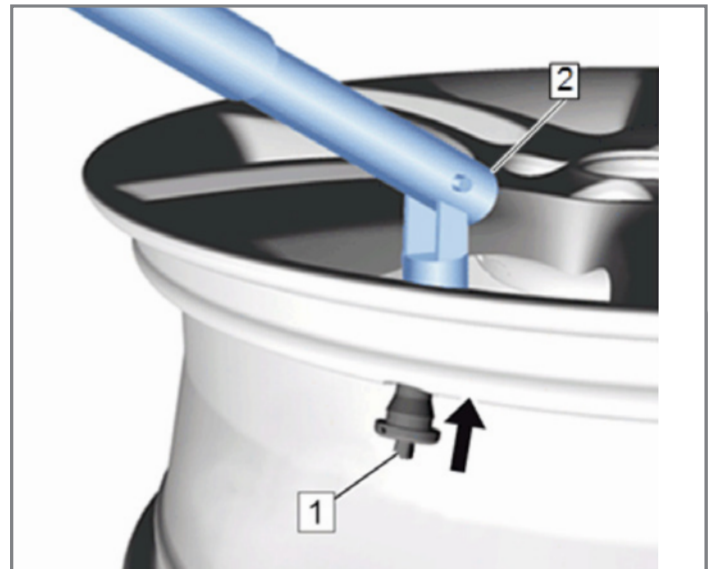
Pull the valve stem (#1) through the valve hole using a tire valve stem installation tool (#2).

- When installing the tire valve stem, ensure the tire valve stem installation tool is fully engaged with the stem threads. Pull the valve stem through in a parallel direction to the valve hole on the wheel to help ensure proper seating.
- The valve stem should be fully seated on the rim. The rim hole edge has to be completely in the notch of the valve stem. The valve stem and the rim holes must be concentric.
- If a GM-approved tire sealant was used in the tire, remove the sealant residue from the TPM sensor using mild dish soap, clean water and shop cloths. If it cannot be confirmed that the tire sealant was a GM approved product, replace the TPM sensor.
- Use care not to scratch or damage the clear coating on aluminum wheels with any tire changing equipment. Scratching the clear coating may cause the aluminum wheel to corrode or the clear coating to peel from the wheel.

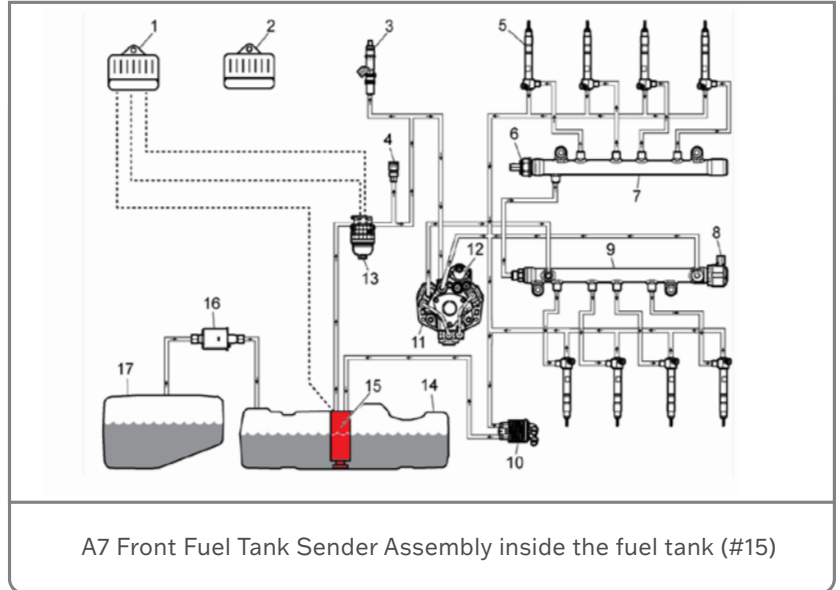
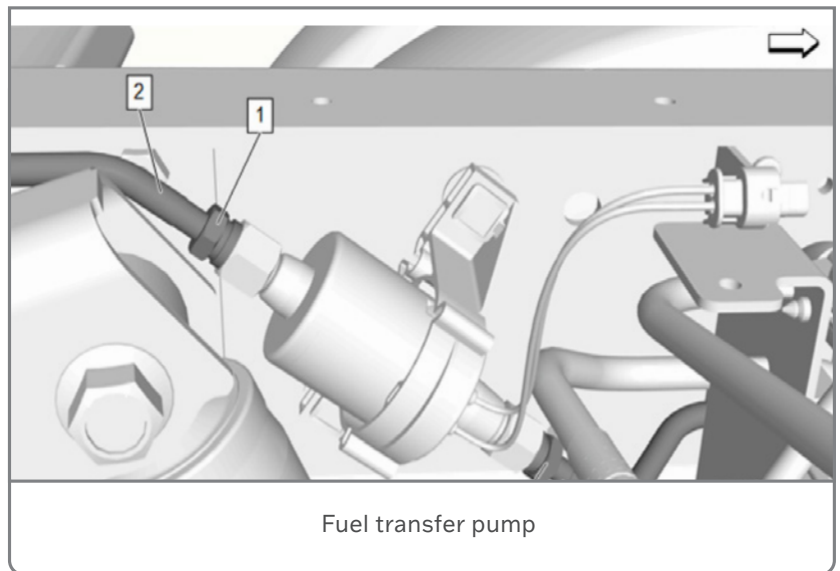
The poor fuel transfer from the rear tank to the front tank may be due to a blockage in the fuel transfer inlet port at the A7 Front Fuel Tank Sender Assembly inside the fuel tank. The assembly may have an internal check valve within the inlet port blocking the fuel from entering the front tank. If it is found that the A7 Front Fuel Tank Sender Assembly fuel transfer inlet port is blocked, it should be replaced.

Before installing the new A7 Front Fuel Tank Sender Assembly, inspect it to make sure there isn't any blockage. Use very low air pressure (below 5 PSI) to determine if the fuel inlet port is blocked or flowing freely.

- Verify that the fuel transfer pump will run electrically by using the scan tool to command the pump on. This test does not confirm that the transfer pump is pumping fuel.
- Use the scan tool to monitor the front tank and rear tank fuel level voltages. Proper fuel level sensor voltages for either tank level sensor are 0.7 volts = full tank and 2.5 volts = empty.
- To determine if fuel is being transferred from the rear tank to the front tank, monitor the fuel level sensor voltages while commanding on, or jumper power and ground to the

fuel transfer pump. The fuel level should decrease (voltage increases) in the rear tank and the fuel level should increase (voltage decreases) in the front tank.

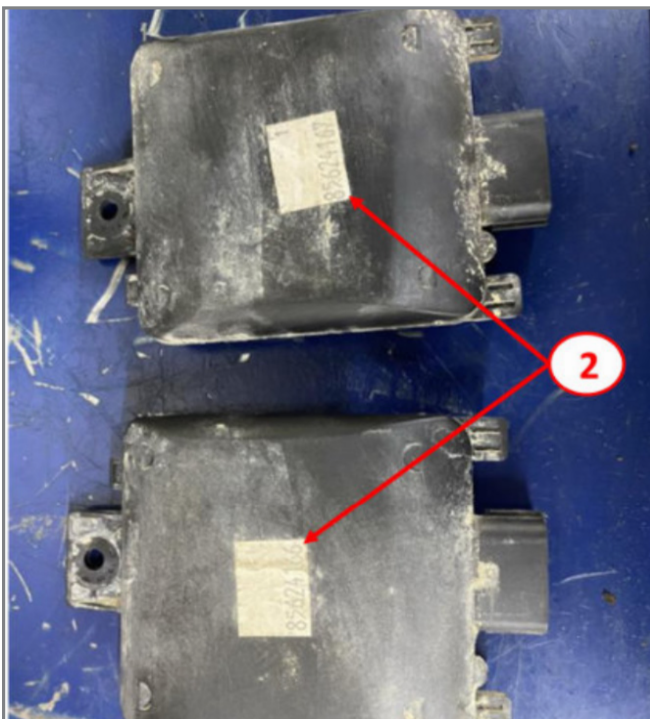
A Side Detection System Temporarily Unavailable message may be displayed on the instrument cluster of some 2024 Silverado 2500 HD/3500 HD and Sierra 2500HD/3500 HD trucks. There also may be false alerts or the system may operate erratically or not at all. These conditions may be caused by a decal attached to the radar-emitting side of one or both of the Side Obstacle Detection Modules

Improper decal attached to the radar-emitting side of the Side Obstacle Detection Modules..

Any decals or stickers that are attached to the radar-emitting side of the Side Obstacle Detection Module can cause interference or blockage of the radar and must be removed. The Side Obstacle Detection Modules are attached to the rear bumper impact bar brackets. Once the decal is removed from the module and the vehicle is driven, the Side Obstacle Detection Modules will automatically learn the blockage has been removed and return to normal operation.

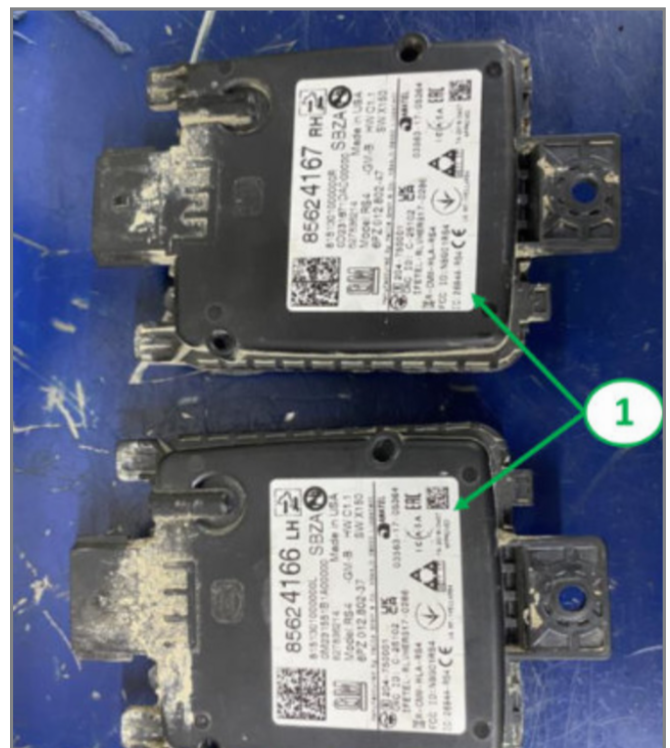
The supplier-installed part label that is attached to the non-radar emitting side of the module is not an issue and does not cause any interference or blockage of the radar.

Supplier-installed part labels
