Techline Update Manager 2

Front Stabilizer Bar Links
Installation Update 3

Corvette Transmission External
Canister Filter and Maintenance
Update, Labor Code Added. 6

TECH LINK

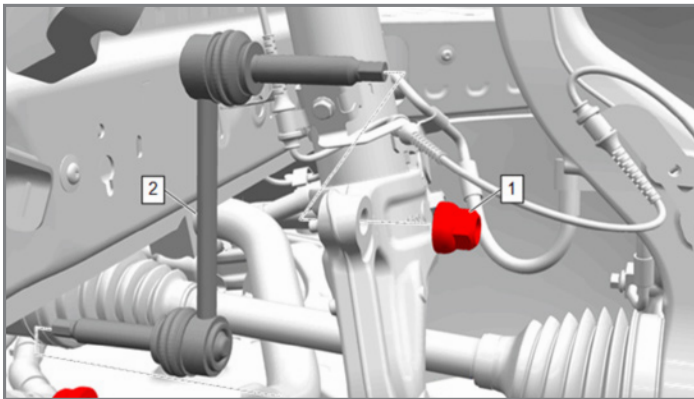
Front stabilizer bar links

With the vehicle on a hoist, the suspension is in full rebound. The stabilizer bar has mold-bonded bushings, which positions an unconnected stabilizer bar at the designed ride height, not the rebound position.

Taking the state of the suspension into consideration, it will be helpful to push down on the stabilizer bar to install the lower and upper link studs.

TIP: Do not over-articulate the ball stud on the stabilizer bar link during installation or the link may be damaged.

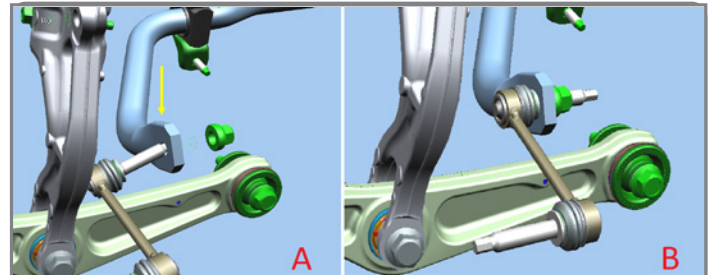
There is limited clearance to assemble the lower stud into the stabilizer bar on AWD models. Pushing down on the stabilizer bar will make assembly easier.

Push down on the stabilizer bar by hand to articulate the lower stud into position (A), and then assemble the lower stud into the stabilizer bar (B). Hand-tighten the nut to seat the joint.

Lower the stud into position (A), and then assemble the stud into the stabilizer bar (B).

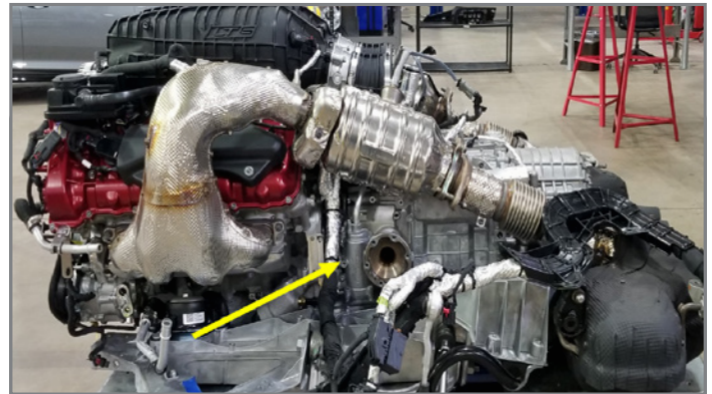
Transmission canister filter

The canister filter should be replaced in the first 7,500 miles (12,000 km) due to the initial break-in of the internal transmission components. The 7,500-mile (12,000 km) break-in period is when most contaminants may be created. Engineering recommends that the filter be changed as close to 7,500 miles (12,000 km) as possible – plus/minus 1,000 miles (1,600 km) should not be detrimental.

It is recommended to only replace the canister filter at the required maintenance interval due to the loading characteristics of the filter. The filter does not need to be changed earlier than 7,500 miles (12,000 km).

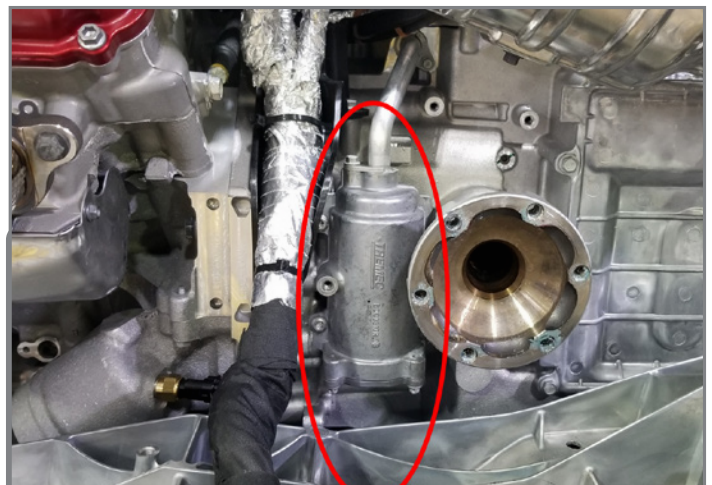
The initial filter change should be at 7,500 miles (12,000 km).

Additional filter changes can be performed, but the recommended mileage intervals should still be followed for regular maintenance. For example, if a customer elects to have the filter changed before 7,500 miles (12,000 km), it should be changed again at 7,500 miles (12,000 km). GM will only cover one filter change.

If a transmission is replaced, it should be treated the same as the new vehicle break-in period. The canister filter maintenance should restart as if it was a new vehicle, with the next filter change at 7,500 miles (12,000 km) after transmission replacement.

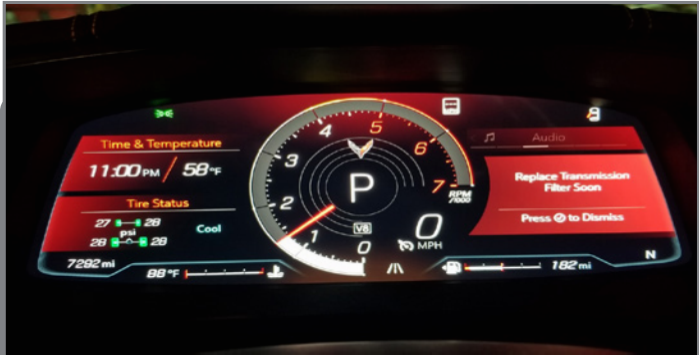
Beginning with the 2023 model year, the Corvette has a maintenance minder on the Driver Information Center that will display a maintenance message shortly before the 7,500-mile (12,000-km) maintenance interval. The message also will appear every 22,500 miles (36,000 km). The transmission filter minder cannot be reset like the engine oil life monitor.

2023 Corvettes feature a maintenance minder for the transmission filter.
