Mid-May 2024, Volume 26, No. 10

Noise from the Transmission Area

Wheel Drive Shaft Retention Snap Ring Design Change

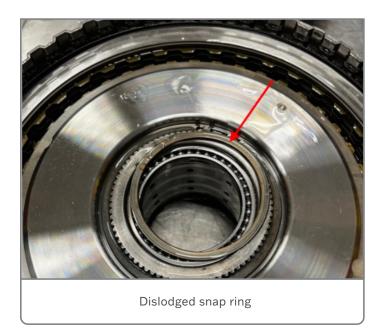
There may be a noise from the bell housing area of the DCT TR9080 transmission (RPO M1L, M1M) on some 2020-2024 Corvettes along with a number of DTCs set in the Transmission Control Module (TCM). The noise may be due to a dislodged snap ring in the direct clutch assembly. As a result, one or more pressure DTCs may set if there is debris caused by the valves sticking in the Main Control Valve (MCV) Body or the direct clutch may contact the fluid tubes, stator shaft or transmission housing.

- If there is direct clutch snap ring failure without any DTCs set as current, replace the direct clutch and stator. In addition, remove the transmission pan to clean any debris from the magnets and replace the sump and canister filter elements.
- If there is direct clutch gear noise, replace the direct clutch, stator and pump gear. Also remove the transmission pan to clean debris from the magnets and replace the sump and canister filter elements.
- If there is direct clutch snap ring failure with an illuminated MIL and pressure DTCs set, replace the direct clutch and stator. Also remove the transmission pan to clean debris from the magnets, replace the sump and canister filter elements, and replace the Main Control Valve (MCV).

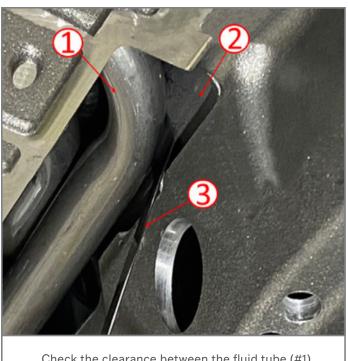
Inspect the direct clutch for failure by removing the MCV and check the clearance between the direct clutch and fluid tube using a feeler gauge. If the clearance is 0 mm with obvious contact, follow the repairs for Direct Clutch Replacement in the appropriate Service Information. If the clearance is 0.5 mm, follow the repairs for direct clutch pump gear noise.

Check the clearance between the fluid tube (#1) and direct clutch (#2) using a feeler gauge (#3).

While inspecting the pump gear for damage, if the direct clutch can be removed easily but there is contact with the pipe and stator, replace parts as needed. Light damage to the housing caused by direct clutch contact will not require replacement.

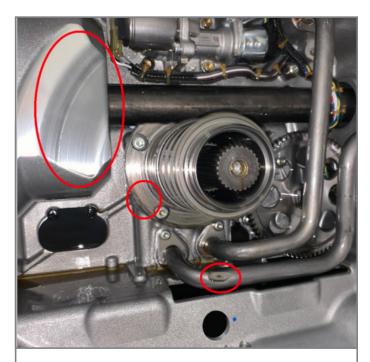
Possible areas of concern on the stator housing caused by direct clutch contact.

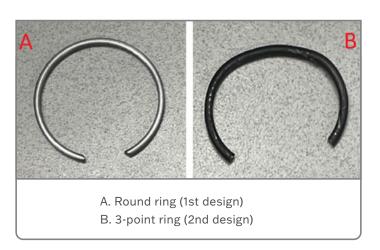
Service groove (new design)

On vehicles equipped with the ball-spline wheel drive shaft, the presence of a service groove (as shown) on the inboard housing means the drive unit is equipped with the 2nd-design 3-Point snap ring.

TIP: The snap ring must always be replaced when removing or replacing the wheel drive shaft.
