# Front Bumper Bracket May Affect Active Grille Shutter Operation

# 8-Speed Transmission Noise Concerns

# Adjusting the Hood Bumpers and Latch to Remove Low Spots on Hood

## TECH LINK

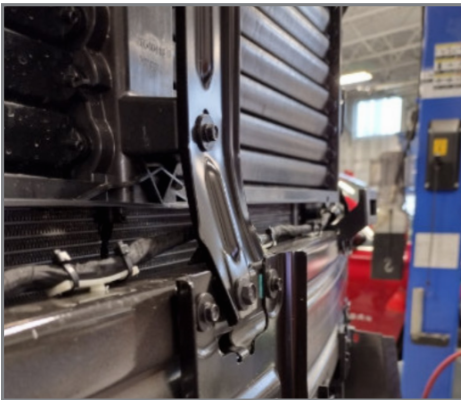
Some 2024 Acadia, Traverse; and 2025 Enclave models may have an active grille shutter malfunction along with DTC P059F (Active Grille Air Shutter 1 Performance) set in the Engine Control Module. These conditions may be caused by a bent hood-support front bumper bracket. The condition of the bracket should be inspected before replacing the active griller shutter.

Bent hood-support front bumper bracket

If the bracket is found to be bent, remove the bracket and command the active grille shutter using GDS2. If the shutter moves when commanded, replace the damaged bracket only. If the shutter does not move smoothly or does not operate properly, replace the bracket and the shutter. A good bracket is shown below. If there is not any damage found, follow the appropriate Service Information for the DTC.

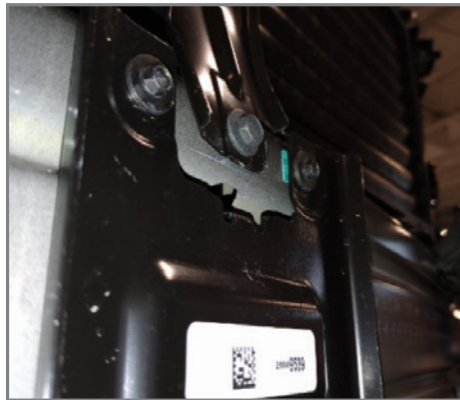
When checking the hood-support front bumper bracket, look for a bend in the lower part of the bracket.

Check for a bend in the lower part of the bracket.

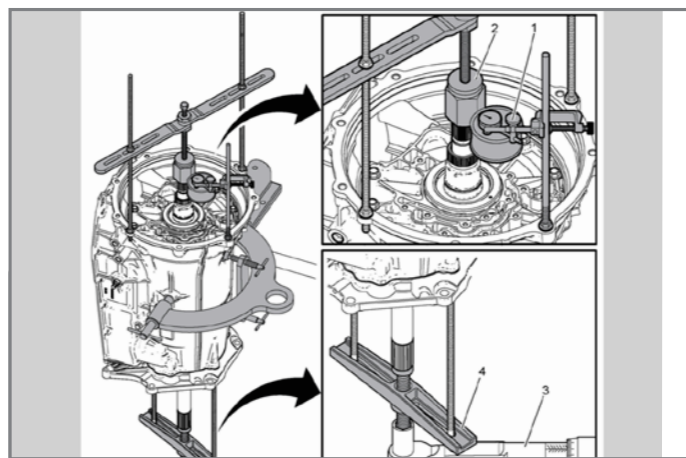
Make sure to verify the transmission endplay measurement using the required special tools and following the proper procedure in the appropriate Service Information prior to replacing the torque converter and prior to disassembly of the unit. The endplay measurement is critical to proper diagnosis. There have been instances of a worn, damaged or missing transmission thrust bearing and/or other components that may be easily overlooked.

Check transmission end play travel.

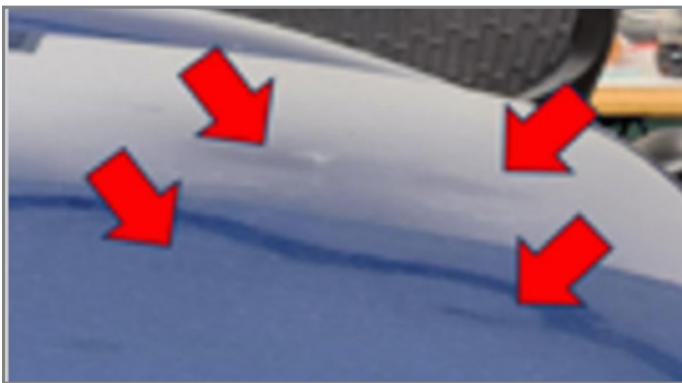
Some 2024 Traverse models may show low spots or dimples on the front and center portions of the hood. The low spots will only be noticeable when the hood is closed and latched.

Low spots or indents may be visible in the hood when closed and latched.

The low spots or indents in the hood may be due to the position of the latch and hood bumpers. The hood latch and bumpers should be adjusted to remove the visible low spots.

Adjust the hood latch up in 0.5 mm increments and adjust the 6 hood bumpers until the hood dimples are mitigated.

Ensure all of the adjustable bumpers are making contact with the hood after each adjustment. Also make sure the latch bolts are torqued to the correct specification.

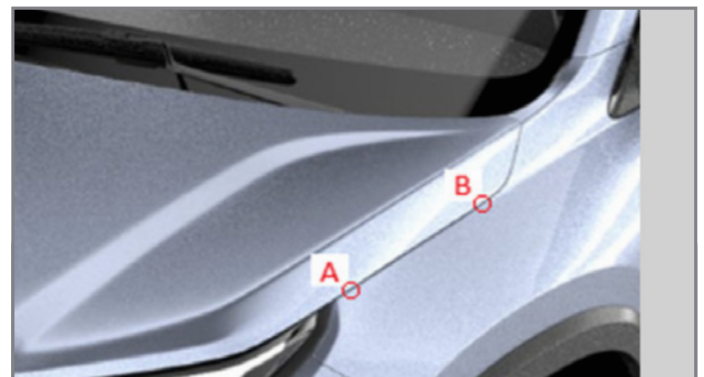
Measure the gap for proper alignment from fender to hood at locations A and B on the driver and passenger side.

Once the adjustments are complete, check the alignment on the driver and passenger side. The gap from fender to hood should

be 4.5 mm nominally with a  $\pm 0.75$  mm. If the gap is not correct, adjust the hood latch down in 0.5 mm increments and readjust the hood bumpers until the gap is within specification.

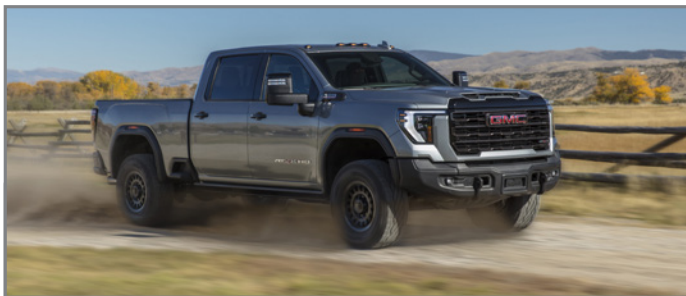
A slight knocking or thud sound may be heard coming from the steering column area when driving some 2014-2025 Silverado 2500HD/3500HD and Sierra 2500HD/3500HD trucks over rough roads or potholes. In some cases, the knocking condition also may be felt in the steering wheel. The condition may be more noticeable when turning and driving over a bump or uneven surface.

A slight knocking or thud sound may be heard driving over rough roads

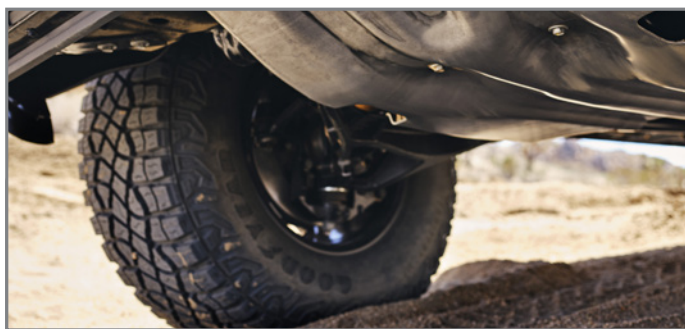
The knocking or thud sound may be a normal condition with the hydraulic steering system known as hydraulic hammer. It is caused by irregular road surfaces feeding back into the steering gear through the tires and steering linkage. The sound and steering wheel feedback can be more pronounced with larger wheels and tires.

Hydraulic hammer is caused by irregular road surfaces feeding back into the steering gear through the tires and steering linkage.

Be sure to compare the condition with another HD truck with a similar tire and wheel combination and steering system (RPO NV8 or non-NV8). If the condition is comparable to another truck, no parts should be replaced for this condition. Inform the customer of the operating characteristics of the steering system.
