## Wiper Blade Performance Diagnosis

# Wiper Blade Performance Diagnosis

GM TechLink is published for all GM retail technicians and service consultants to provide timely information to help increase knowledge about GM products and improve the performance of the service department.

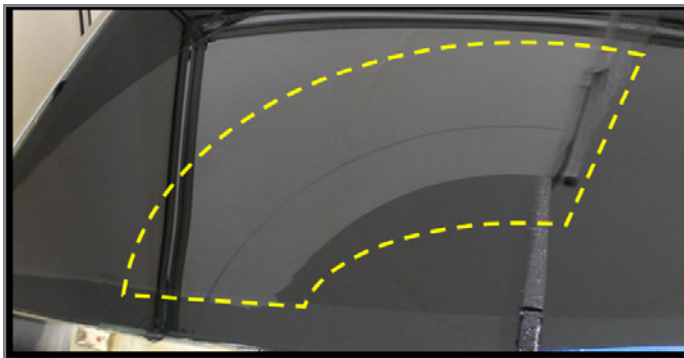
Streaking can be caused by a variety of issues, including:

- Small tears in the blade element.
- Blade wear over time.
- Nicks created from attempting to clear the windshield of ice; contamination buildup on the wiper blade or windshield, such as from bugs, road grime, sap or car wash/wax treatments.
- Non-uniform blade-element edges (as manufactured).

Example of a streaking condition.

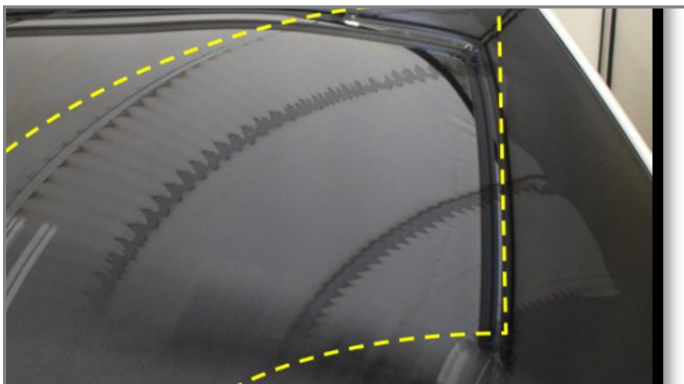
Chatter is a wiper defect where the blades move across the glass with a bouncing or uneven motion. The causes of chatter can be related to:

- The permanent set of the blade, causing resistance of the blade to flip after reversal.
- High tip force of the arm.
- Snow or ice buildup in the wiper blade hinge.
- The blade not sitting on the glass at the proper angle.

If a chatter condition still exists after a blade change, it's possible that the tip force of the wiper arm is contributing to the chatter.

Example of a chatter condition

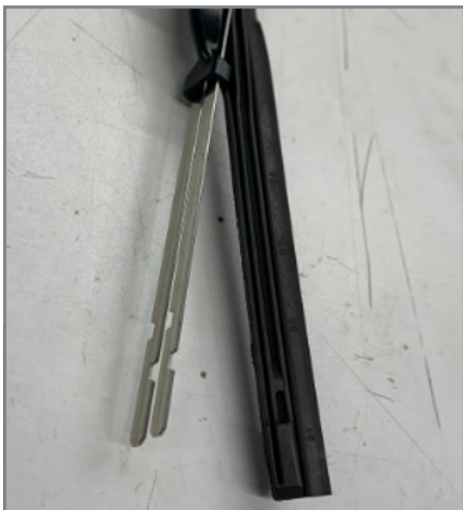
Improper use of ice scrapers also can lead to wiper blade damage. Rubber blades are easily cut or torn when using ice scrapers. Avoid excessive contact with the wiper blade by moving the ice scraper parallel to the blade, which minimizes the possibility of damage. Do not pull the blades off a frozen windshield, which can tear the rubber or damage the wiper.

Ice scraper damage

To avoid contacting the wiper blades with an ice scraper, place the wiper arms in the “service up” position, if applicable. With the wiper arms up, the wipers will not collect snow or stick to the glass, and it will prevent the ice scraper from contacting a wiper blade that is frozen to the windshield.

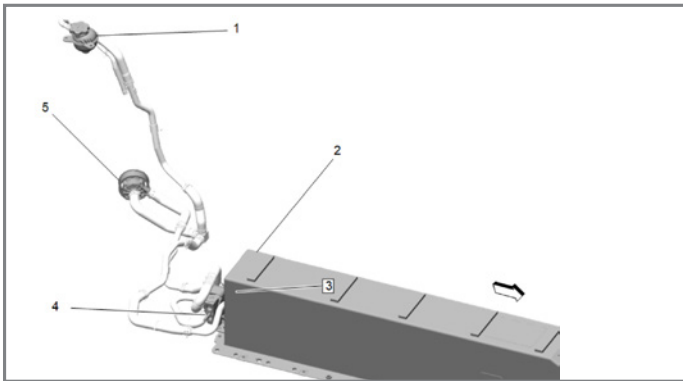
Hybrid/Electric Vehicle Battery Coolant Pump (#5)

The 2024-2025 Corvette E-Ray features an independent cooling system to cool the high-voltage battery. If air gathers and gets trapped in the hoses around the Hybrid/Electric Vehicle Battery Coolant Pump during repairs, it can cause the pump to stop for self-protection, which the Battery Energy Control Module (BECM) interprets as an under-speed condition. DTC P0E3C (Hybrid/Electric Vehicle Battery Pack Coolant Pump Underspeed) may set in the BECM and DTC POA7B (Battery Energy Control Module Requested Malfunction Indicator Lamp Illumination) may set in the Engine Control Module (ECM). The air trapped in the system must be purged.

To purge the pump, begin by removing the Front Compartment Rear Access Cover and the Underbody Rear Air Deflector. The G65 Hybrid/Electric Vehicle Battery Coolant Pump is on the lower-left side of the engine bay. The pump will need to be slid inboard out of its mount and lowered relative to the other plumbing without kinking the hoses.

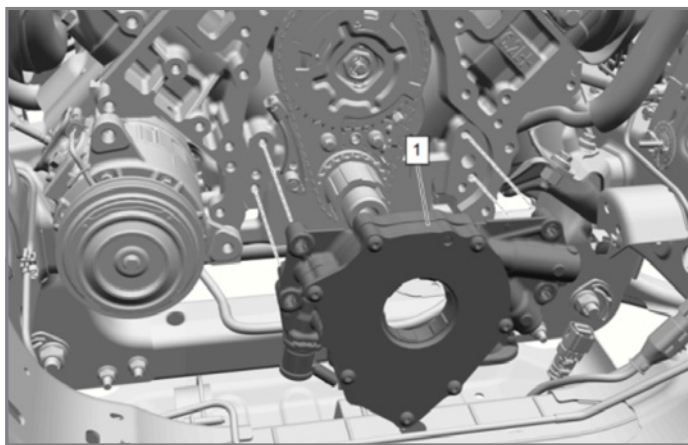
Oil pump assembly

There may be low oil pressure in the 5.3L V8 engine (RPO L84) or 6.2L V8 engine (RPO L87) on some 2019-2024 Silverado 1500, Tahoe, Suburban, Sierra 1500, Yukon; and 2021-2024 Escalade models. If the oil pressure relief valve inside the oil pump assembly is stuck, it may cause low oil pressure at idle and, as a result, the Check Engine MIL may be illuminated and DTC P0521 (Engine Oil Pressure Sensor Performance) may be set in the Engine Control Module (ECM).

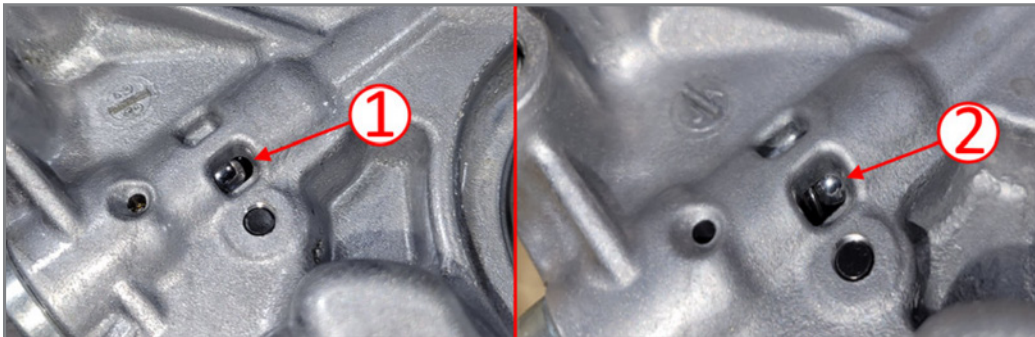
Stuck valve (#1) and a normal valve (#2).

If the oil pressure reading is below 20 psi when measured at the oil sensor port, it may be due to a stuck oil pressure relief valve inside the oil pump assembly.

At this point, it will be necessary to remove the oil pump for further inspection. If the valve is found to be stuck, replace the

oil pump. Refer to Oil Pump Replacement in the appropriate Service Information.
