## Using the NACS DC Adapter to Access the Tesla Supercharger Network

*Unable to Fill the DEF Tank..... 4*

*Gross Combined Weight Message on the Driver Information Center ..... 6*

*MDI 2 Manager Software Update ..... 7*

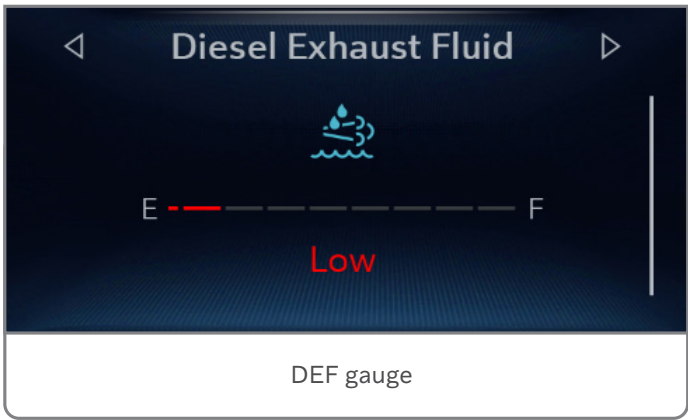
The Diesel Exhaust Fluid (DEF) tank may appear to be empty shortly after beginning a towing trip or it may be difficult to properly fill the DEF tank on some 2020-2025 Silverado 1500, Silverado 2500HD/3500HD, Tahoe, Suburban, Sierra 1500, Sierra 2500HD/3500HD, Yukon; and 2021-2025 Escalade models equipped with a diesel engine (RPO LM2, LZ0, L5P). Under high load towing conditions, the amount of DEF used may engage the DEF warning system before the DEF system can read the tank has been filled. If the tank is filled under these conditions, the DEF system will not see the fill and may not see subsequent fill attempts.

The vehicle should be driven to allow the DEF warning system to progress until a specific speed limitation warning is displayed on the Driver Information Center before adding DEF to the tank. In the U.S., the speed limitation will be 65 mph (105 km/h).

**TIP:** Refer to Bulletin #22-NA-150 to verify the Reductant Control Module has the latest update available and that the Reductant Fluid Tank Level has been reset.

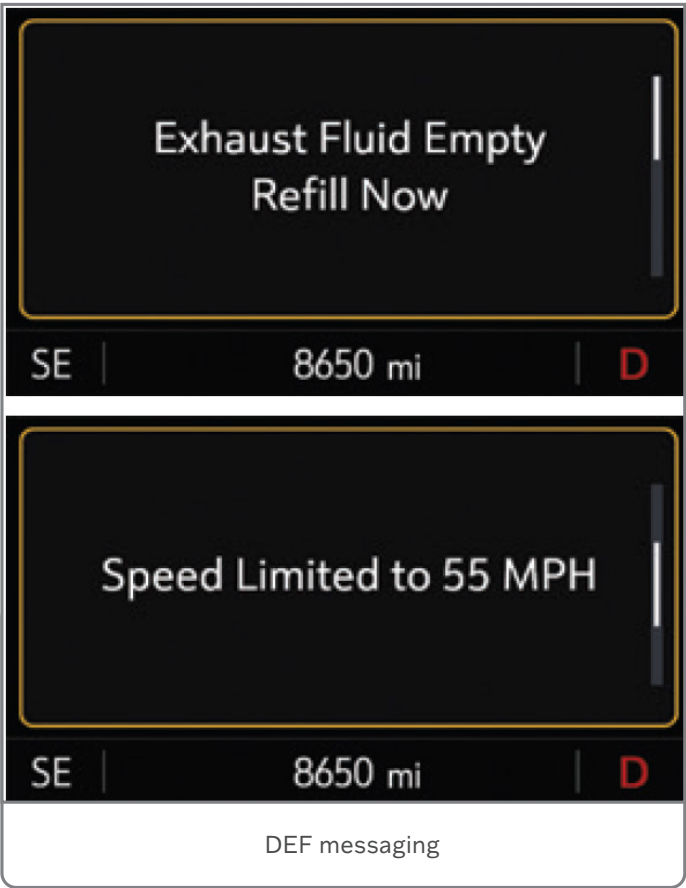
Do not immediately add DEF when there is a DEF system message and a low gauge reading in order to drive the gauge back up or to remove the DIC message. The accompanying chart shows the DIC messages that may appear while towing and the messages in red where it is not appropriate to add DEF to the tank. Areas in green indicate that at these warning levels and when these messages are displayed it is OK to add DEF to the tank.

Customers should be encouraged to not fill the DEF tank under these conditions until the warning strategy indicates a specific speed limitation will be reached (65mph/105 km/h). When the system message changes from "Speed Limited Soon" to "Speed Limited to 65mph in xx Miles" it is safe to add DEF and the fill will

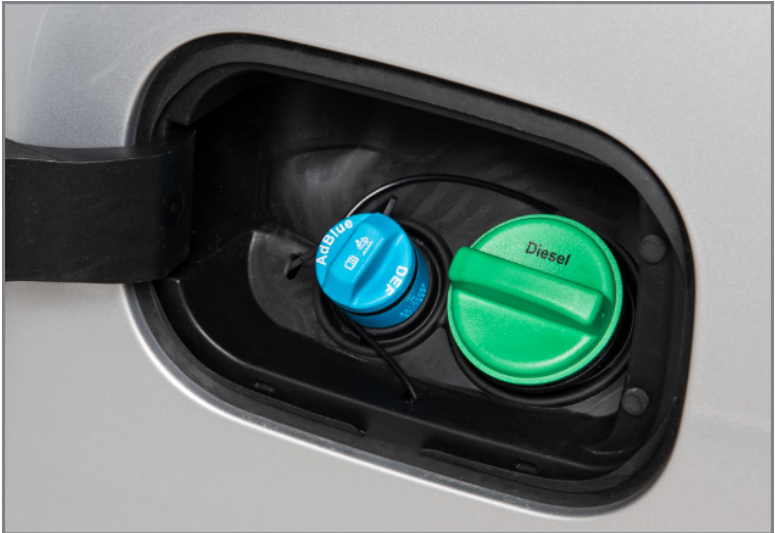
The best time to add DEF to the DEF tank (blue cap) is when a DIC message displays that inducement and speed reduction are imminent.

DIC messages that may appear while towing. Messages in red indicate when it is not appropriate to add DEF to the tank. Messages in green indicate when it is OK to add DEF to the tank.

**TIP:** When adding DEF to an empty or very low tank, always add at least 2 gallons (7.2 L) of DEF to release the vehicle from speed limitation.

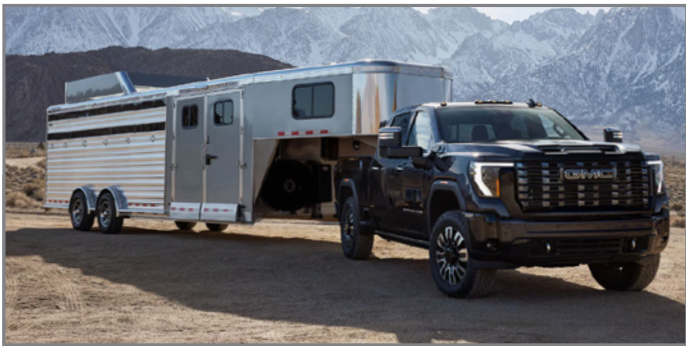
A GCW Overweight message may display on the Driver Information Center when towing a trailer.

If it's estimated that the combined weight of the vehicle and the trailer may exceed the vehicle's Gross Combined Weight Rating (GCWR), it will trigger the alert. However, it does not mean the vehicle is overloaded. The message is just a reminder that the GCW should be checked on an actual scale.

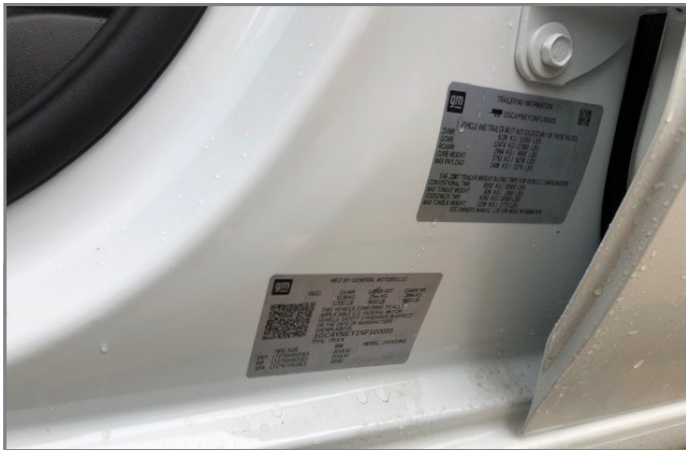
Trailing Information Label

The GCWR for the vehicle is on the Trailing Information Label. The weight of the loaded vehicle and trailer, including passengers and cargo, cannot exceed the GCWR.
