Mid-October 2024, Volume 26, No. 20

## **Follow All Guidelines to Determine Hybrid/EV Battery** Stability, Return Shipping Requirements

## Follow All Guidelines to Determine Hybrid/EV Battery Stability, Return Shipping Requirements

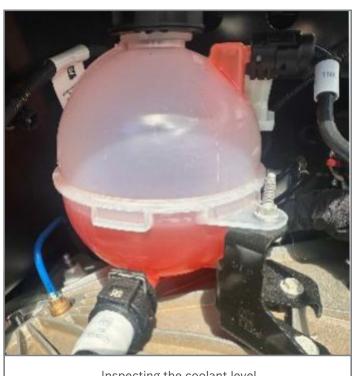
Inspecting the coolant level.

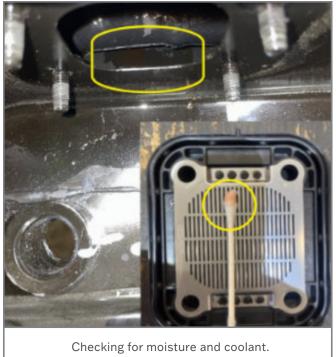
Battery pack HV connectors and headers
