10-Speed Automatic Transmission Diagnostic Tips

New bulletin provides examples of possible transmission sounds and the components that may produce those sounds to help with transmission diagnosis.

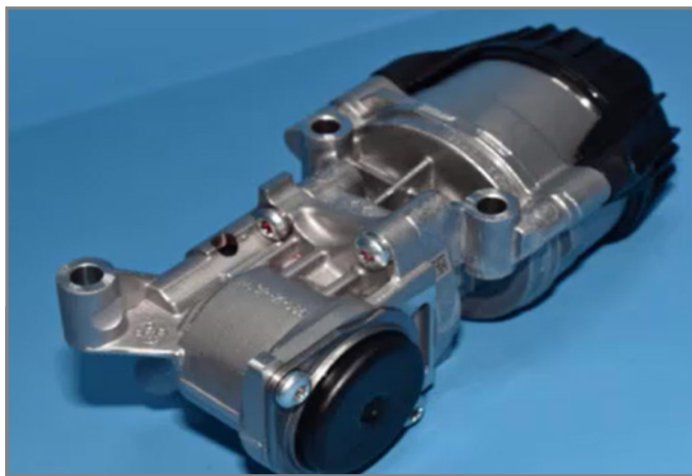
Transmission auxiliary pump

Transmissions equipped with automatic start/stop use an electronic G5 transmission fluid pump that maintains transmission fluid pressure during an auto stop event. With the engine off and the transmission in Park, the cycling of the auxiliary pump may be heard when approaching or unlocking the vehicle if the ambient background level is low, such as in a garage. This operation is normal.

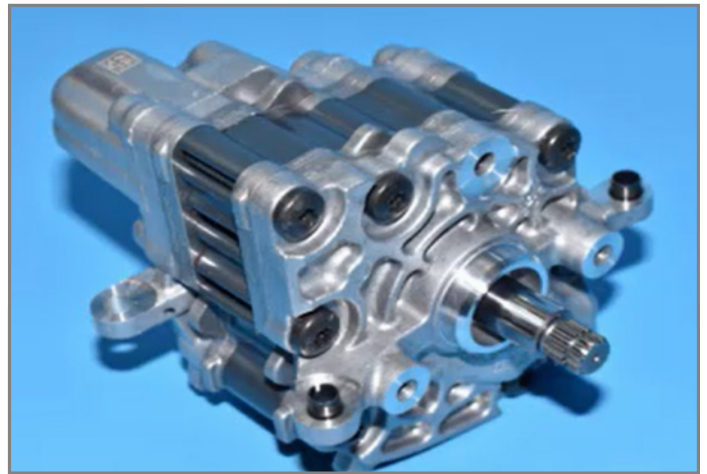
Transmission oil pump

Aeration — an introduction of air into the transmission fluid (pump inlet) — may lead to an erratic whining sound due to

uneven distribution of the air with the transmission in Park. Cavitation may occur when cavities are formed due to a drop in fluid pressure (outlet). Rattling, whirling/roaring or grinding sounds are all possible and may be the result of a low fluid level, a filter condition, a damaged O-ring or other condition with a DTC set.

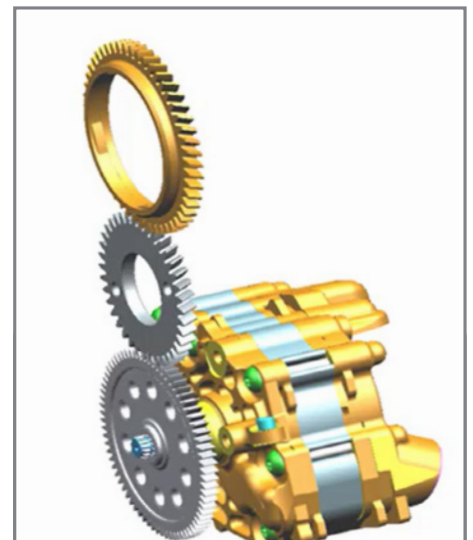
Transmission oil pump gears

The Allison 10-speed transmission uses a spur gear design to drive the transmission oil pump. Due to the 3-helical gear design, some transmissions may have a whine sound while in Park or driving, which may get louder as engine speed or transmission temperature increases.

Isolating the whine to the oil pump gears can often be done by sweeping engine speed slowly from base idle to 2,500 RPM while in Park. If the whine can be reproduced in Park, replacing the transmission front support and/or transmission oil pump often will correct the whine sound.

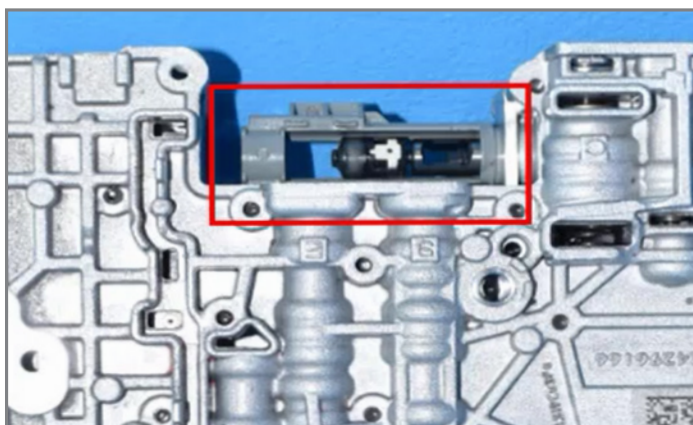
Blowoff valve

A faint, non-rhythmic chirping sound coming from underneath the vehicle with the transmission in Park and engine speed approximately 1,000 RPM (vehicles with ETRS only) may be caused by the Return-to-Park (RTP) blowoff valve becoming unseated due to line pressure spikes. The line pressure spikes occur because of clutch command cycling that takes place in Park. This condition is considered normal if the noise occurs just off idle speed.

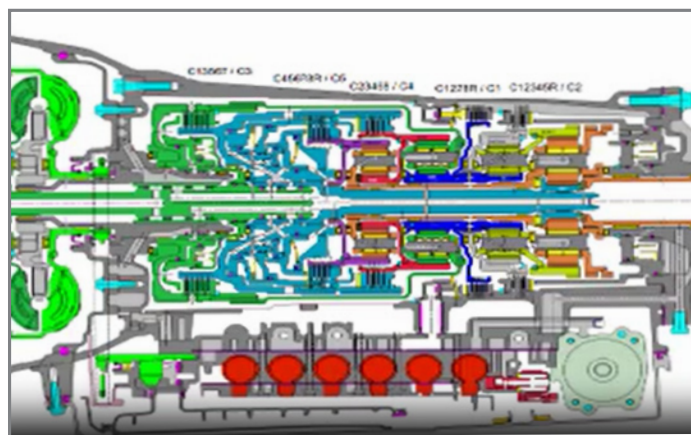
An infrequent audible thud that is delayed 400–700ms after either a key start or a garage shift event, with the severity of the sound depending on the load placed on the driveline, may be related to the C2 clutch application at high line pressure, which causes the rotating components in Park to stop too quickly.

The C2 clutch calibration has been modified to assure the C2 knockdown area is pressurized in Park and Neutral when C2 is being applied.

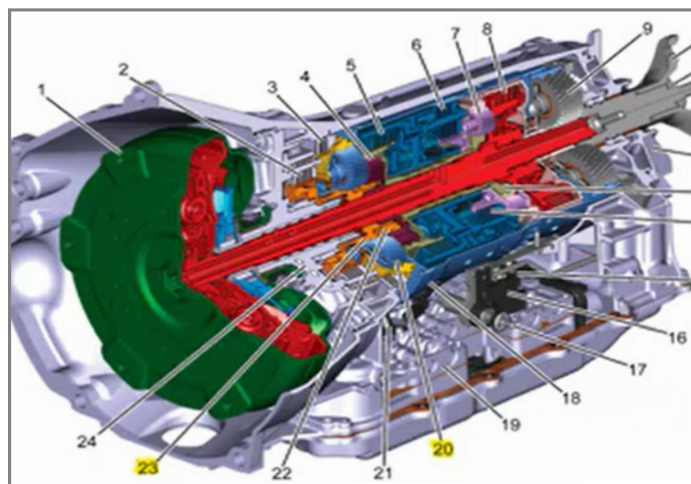
Reaction planetary gearset

A whine from the reaction planetary gearset may be heard during light-to-moderate driving conditions, especially when the reaction gearset is in 4th or 5th gear (20-35 MPH) (32-56 KM/H). The frequency of the whine will change as the transmission shifts gears due to component rotation speeds changing. Use the manual tap shift feature to shift through the gears to verify which gears have a whine sound present.

TIP: A whine sound from the reaction gearset should not be present in 7th gear due to the 1:1 ratio and the gears being locked. If a whine is present in 7th gear, check other components.

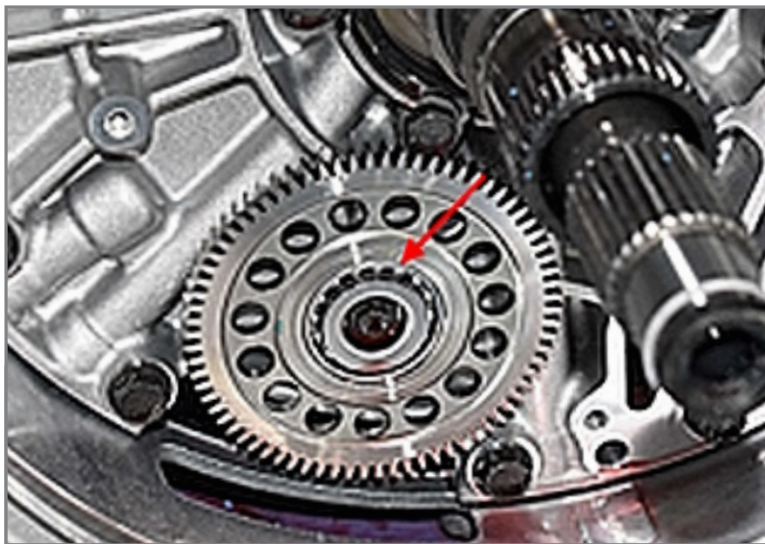
Idler gear

The size of the idler gear inner diameter can affect the interference fit of the pressed-in bearing, reducing the overall axial/radial clearance of the bearing balls, and may produce a rattle during light acceleration in 7th gear only. A high interference fit can create the gear rattle. Increasing line pressure can reduce the rattle by overcoming the drag torque.

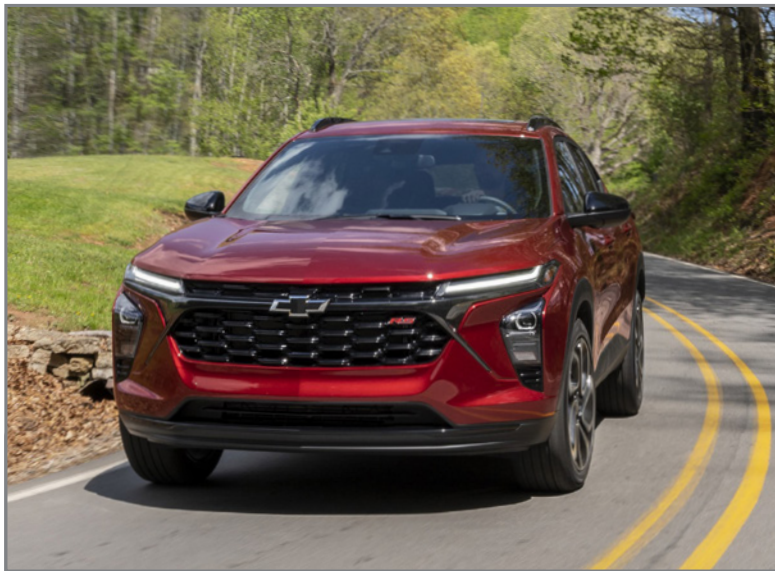
A vehicle shudder and a growl or humming sound may be present when driving between 28-53 mph (45-85 km/h) on some 2024 Envista and Trax models equipped with the 6T40 automatic transmission (RPO MNH). The shudder or noise may be due to an internal torque converter condition that causes slipping.

A vehicle shudder and a growl or humming sound may be present when driving between 28-53 mph.

If the radio software is up to date after following the service procedure in Bulletin #23-NA-194 and the shudder or noise still occurs, the torque converter should be replaced.

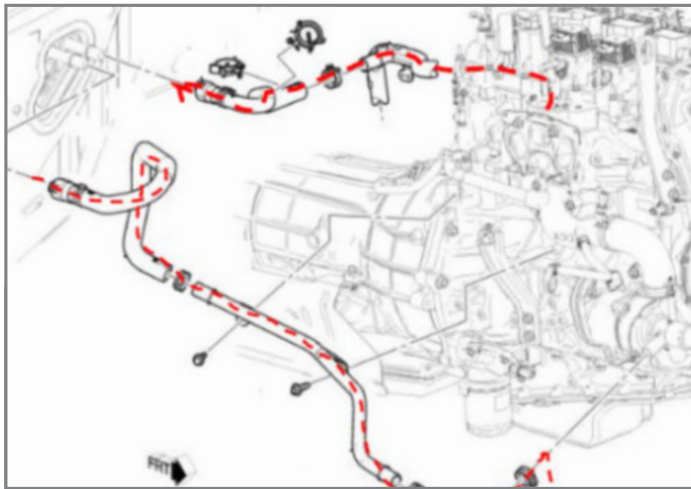
A kinked or twisted coolant hose on the 2.7L engine on some 2023-2025 Silverado 1500 and Sierra 1500 models may restrict coolant flow through the heater core.

Inspect all coolant hoses for proper positioning.

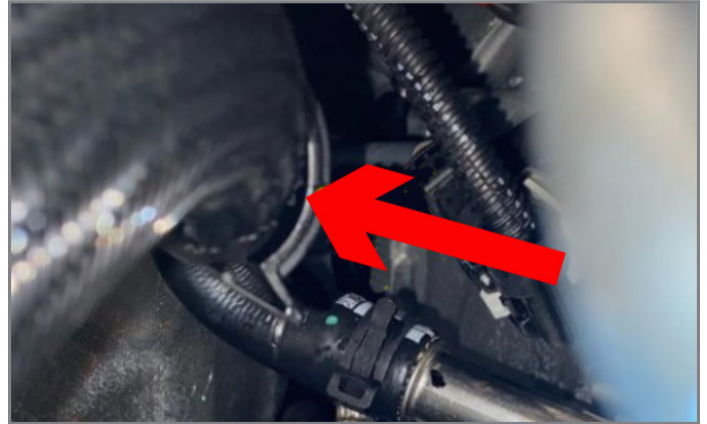
During inspection, it will be necessary to reposition the mesh covering on the coolant hoses in order to properly check the entire hose. In some cases, the hose may have twisted during installation, causing a kink approximately 2 inches above the hose clamp, which is covered by the mesh and is not visible.

Reposition the mesh covering on the coolant hoses in order to properly check the entire hose.

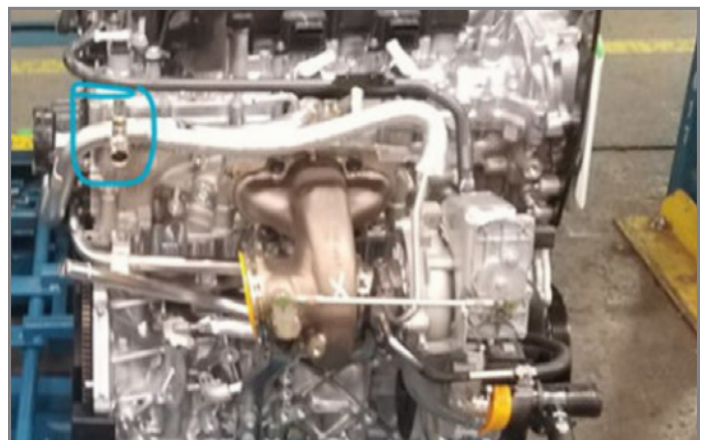
Exhaust manifold outlet pipe spigot connection location.

With the engine at operating temperature, check the temperature of the heater core feed pipe. If the coolant feed pipe is not near operating temperature, there may be an incomplete machining process where the pipe connects to the exhaust manifold coolant outlet pipe.

Once the engine cools down, disconnect the heater core coolant feed pipe at the exhaust manifold outlet pipe and inspect the outlet pipe spigot connection for any blockage. If there is blockage from an incomplete machining process, replace the exhaust manifold coolant outlet pipe.
