## Guidelines for Successful Installation of GM Accessories

Guidelines for Successful Installation of GM Accessories.....	2
MDI 2 Order Lead Times Update .....	5
DTCs Set Due to Wiring Harness Condition.....	6
Low Oil Pressure at Idle .....	7
Heavy Fuel Use Message .....	8

## TECH LINK

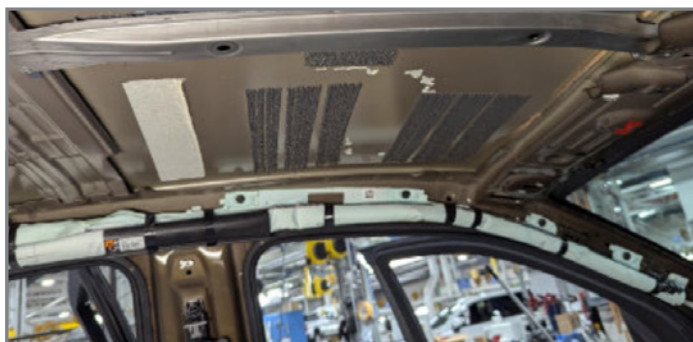
When driving through an automatic car wash, a loud pop (oil canning) sound may be heard on some 2023-2025 Colorado and Canyon trucks. The pop sound may be the roof panel flexing from the force of the industrial air dryer at the end of the car wash.

Stiffening patches and longitudinal roof bow

There is an updated repair procedure now available that applies to all 2023-2025 Colorado and Canyon models without a sunroof (RPO CAC), built before breakpoint 2/3/25. It addresses the flexing of the roof panel by applying stiffening patches as well as installing a longitudinal roof bow to the underside of the roof panel.

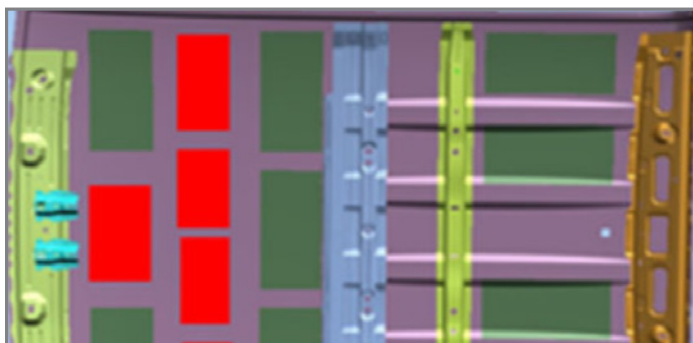
Five locations of the stiffening panels.

After completing any paint or body repairs needed to the roof, the stiffening panels should be installed to the underside of the roof panel in five locations at the front of the roof area.

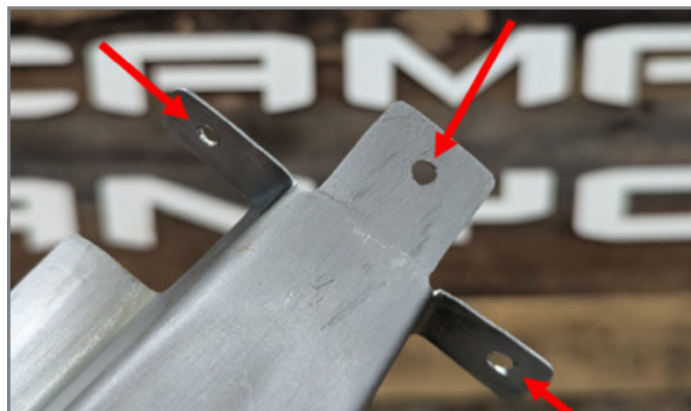
Pre-drill the holes for the rivets.

Begin installation by pre-drilling the five locations for the rivets on the roof bow.

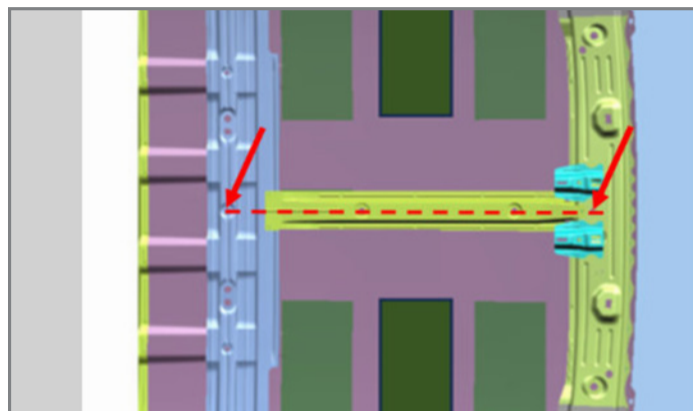
Align the center line of the roof bow to the center line in the roof bars.

The pre-drilled roof bow will be used as a template on the underside of the roof structure. Be sure to properly align the center line of the roof bow to the center line in the roof bars.

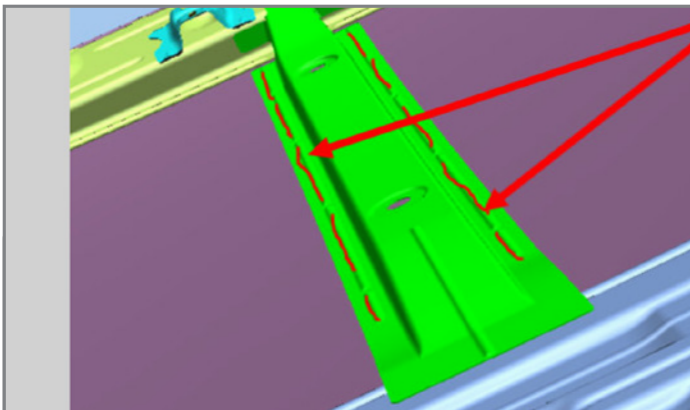
Panel-vibration control material along the length of the roof bow

Once all holes are drilled using a depth-control device on the drill bit, apply the appropriate structural adhesive to both ends of the roof bow and panel-vibration control material to the length of the roof bow. The roof bow should be installed to the vehicle with the rivets.

Once the stiffening panels and roof bow are installed, reinstall the headliner and verify the condition is corrected.

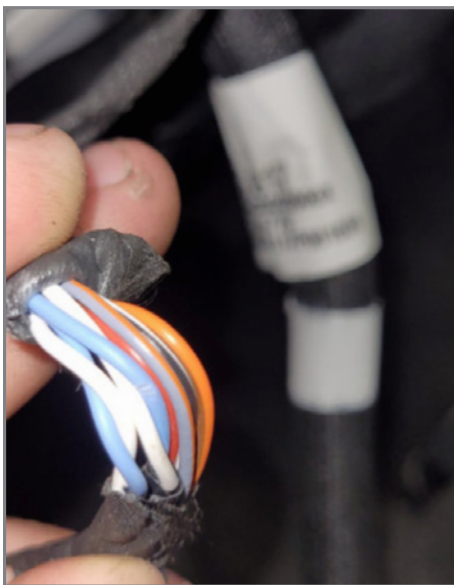
CAN 1 circuit 4987 BU cut

If these DTCs are set, inspect the passenger seat frame for a short of CAN 1 circuits 4986 or 4987. The wiring harness may be chaffing on the seat frame. .

If there is damage to the wiring harness, repair the harness following the wiring repair procedures in the appropriate Service Information.

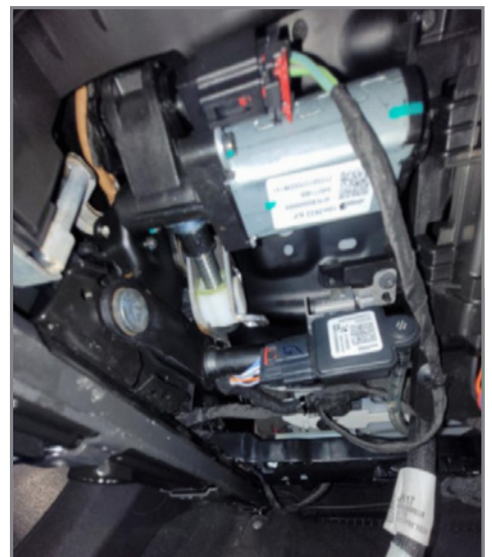
After wiring repairs are completed, reroute the wiring harness.

After repairs are completed, reroute the wiring harness to prevent any contact with the seat frame.

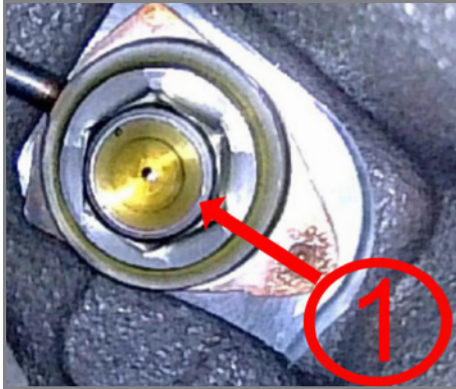
The center portion of the nozzle may be loose or missing from the piston nozzle.

Check for the center portion (#1) of each piston oil nozzle.

If any of the piston oil nozzles are found to be missing components or damaged, replace all nozzles following the procedures in the appropriate Service Information.

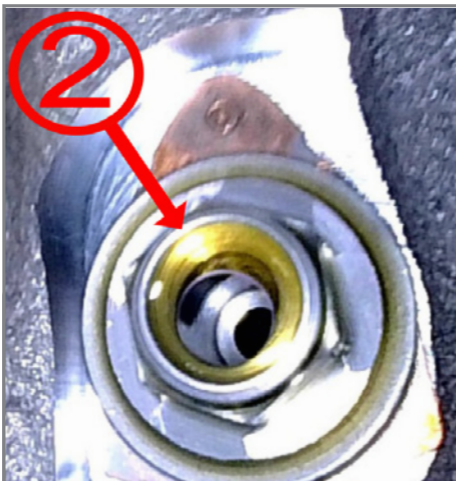
Piston oil nozzle with missing center portion

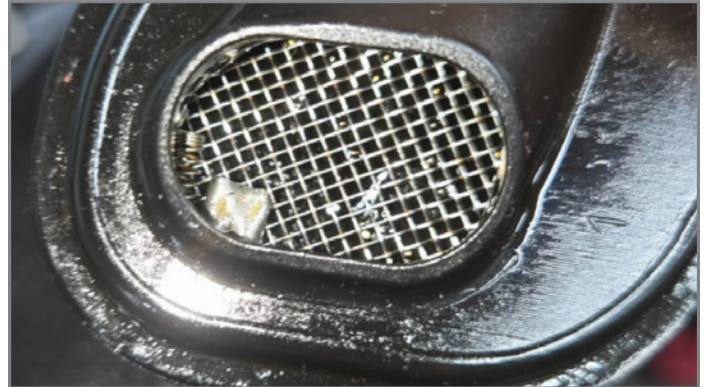
When the nozzle is removed, the center portion components may be sitting on top of the balancer shaft assembly in the oil pick-up screen or in the bottom of the oil pan.

Some components may be found in the oil pick-up screen.

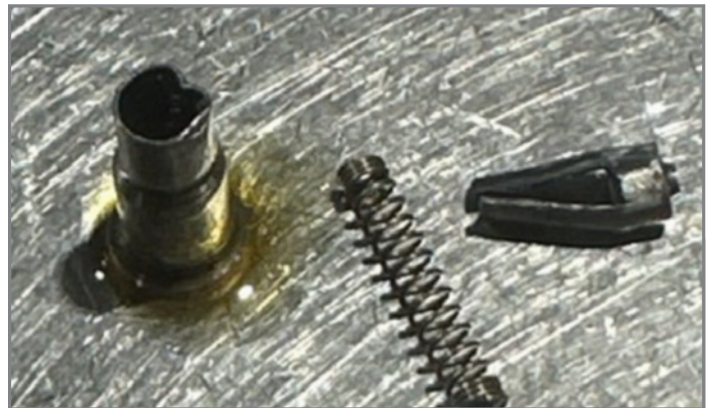
Some of the components from the center portion may not be found and may have exited the engine through the oil drain plug opening during an oil change.

Examples of components that may be missing from the center portion of the piston oil nozzles.

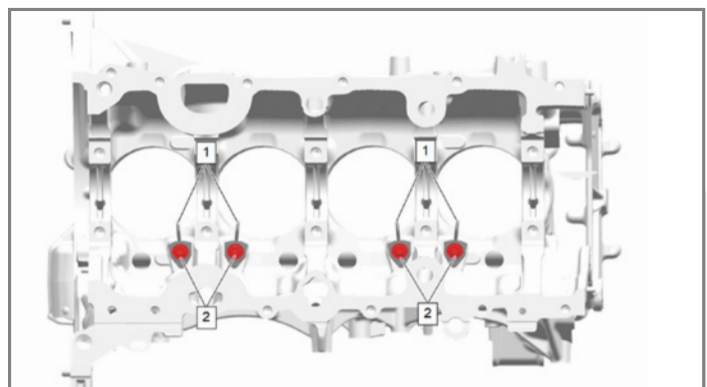
Piston oil nozzles (#1)

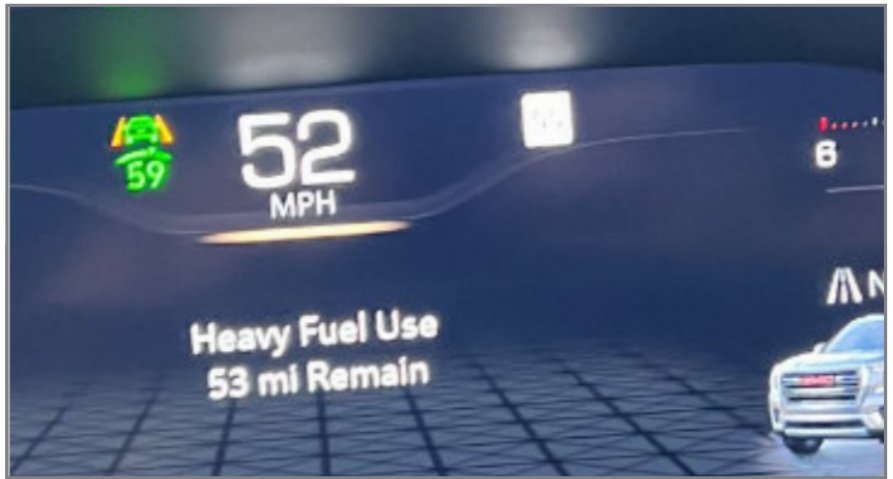
The “Heavy Fuel Use” message indicates that the fuel range may be decreased due to current driving habits. It is an informational message for the driver to help in understanding the current operating status of the vehicle and is a normal condition.

“Heavy Fuel Use” message

If this message is displayed, it does not indicate any concerns with the fuel system. No repairs are necessary.

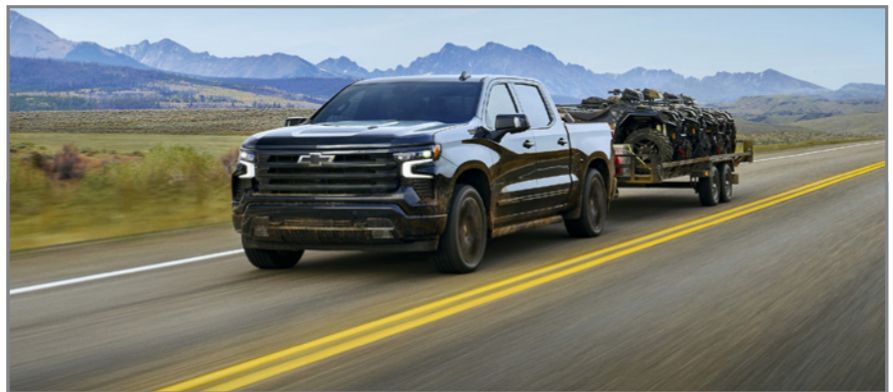
The DIC message will be displayed during aggressive driving or towing when the fuel range is low.
