# Keep Your Cool — Air Conditioning Refrigerant Leak Diagnostic Tips

# Unlatching the Front Compartment Hood with a Weak 12V Battery

# Super Cruise Disengages or is Unavailable

# Water Leak at the A-Pillar Body Plug

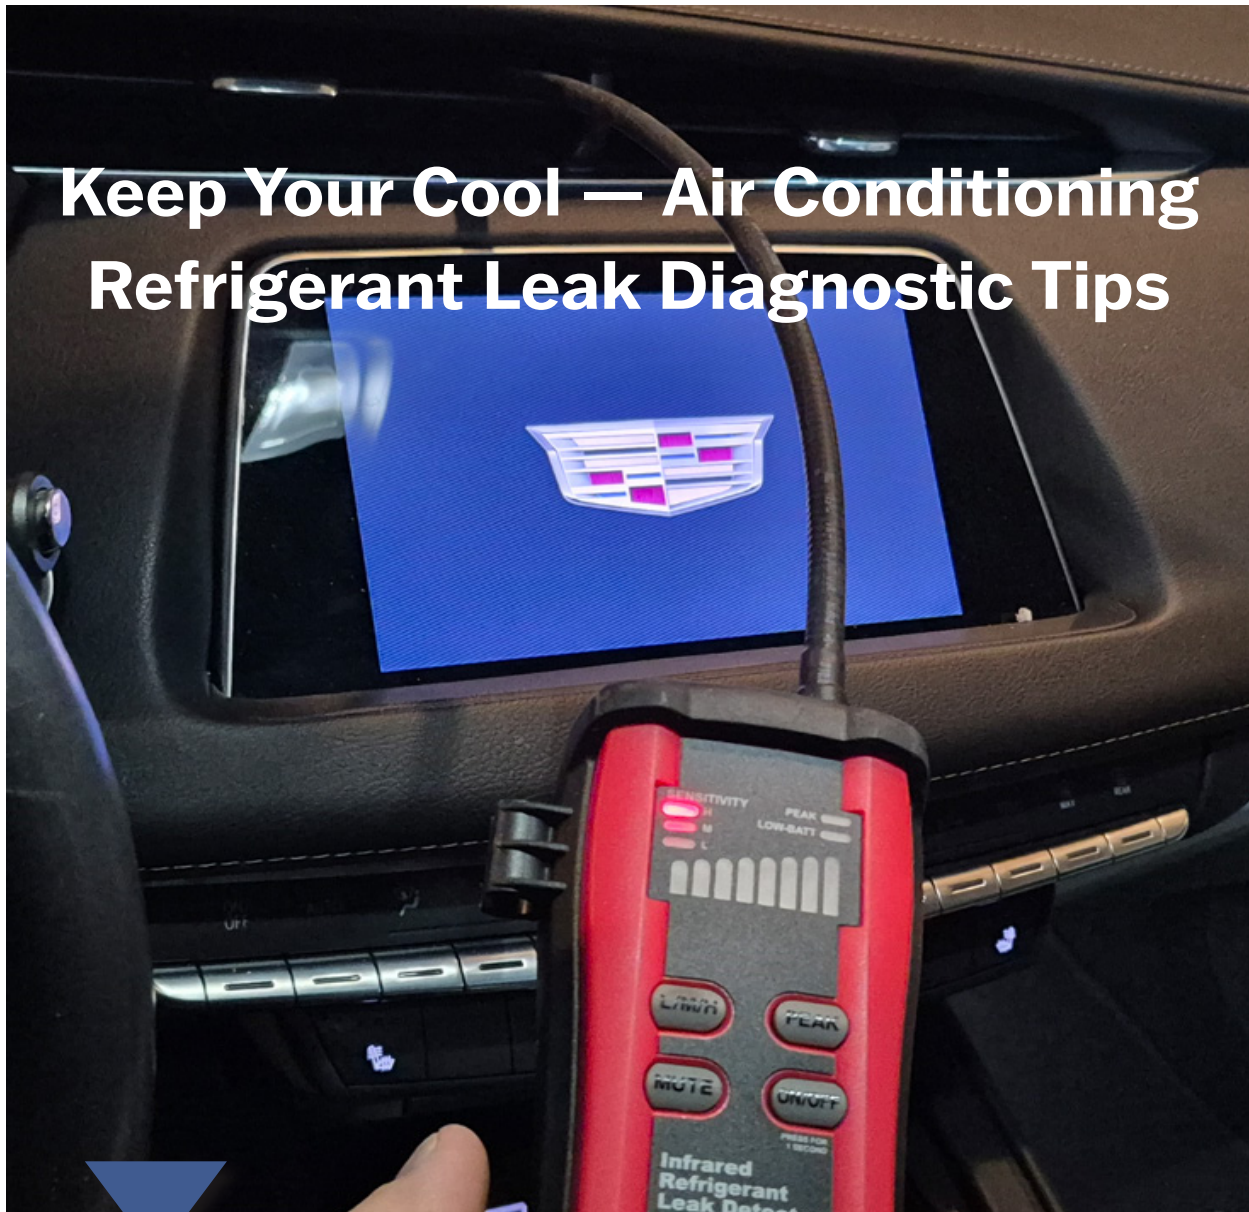
*Fluorescent dye helps locate most medium-to-large leaks in the A/C system but use the GE-50078 Electronic Leak Detector to verify smaller passive leaks.*

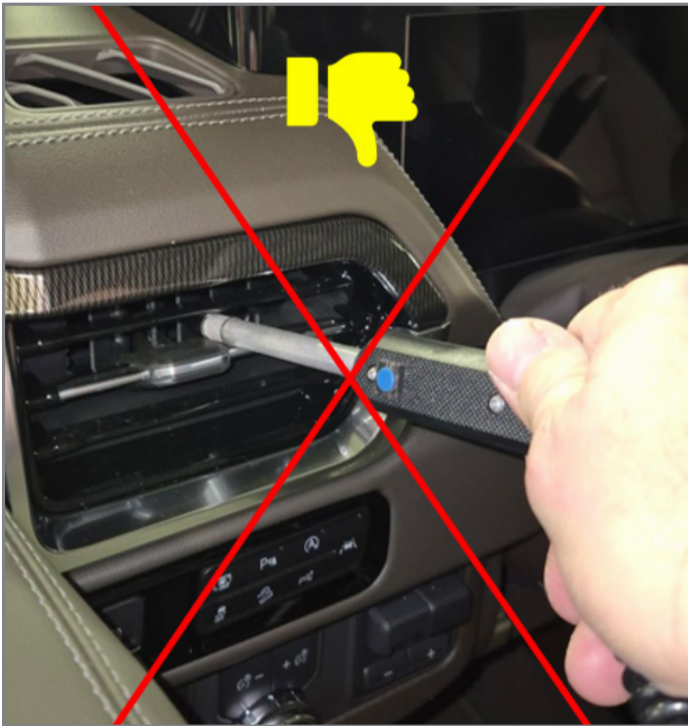
When using an electronic leak detector to check the evaporator, the probe should not be placed in the A/C vents or outlets. The outlets are too far from the evaporator to be effective.

In addition, HVAC module plastics and sealing materials can off-gas hydrocarbons, which may trigger the sniffer alarm. As a result, putting the sniffer probe in an A/C outlet introduces a high risk for a false trigger where the sniffer says there is a leak but there really is not.

Placing the probe in the A/C vents or outlets will not be effective in finding a system leak.

Instead of inserting the sniffer probe in an A/C outlet, the probe should be placed within 3/8-inch of the part, joint, seam, seal,

etc., being checked. The electronic leak detector will not be effective if the sensor is not within 3/8-inch of the component seam, joint, seal or interface being checked.

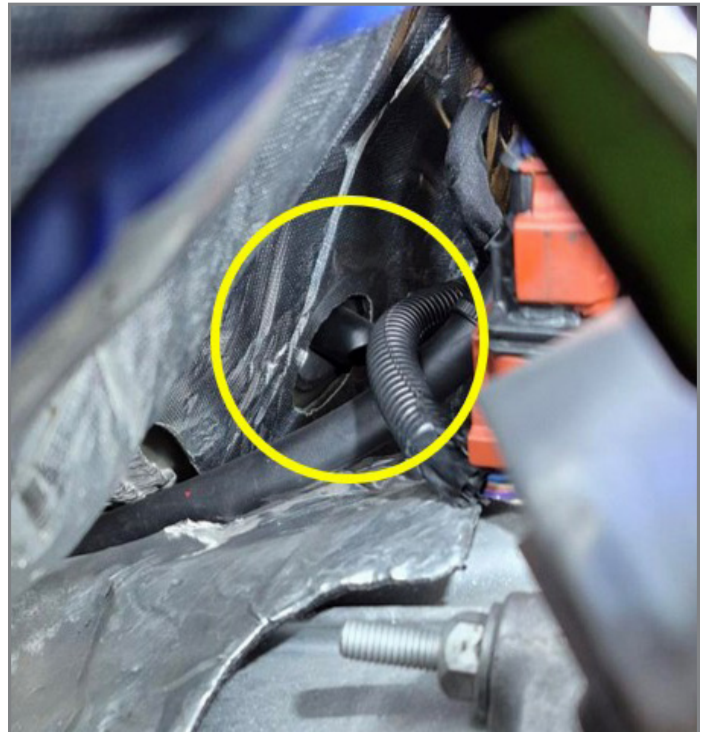
A/C evaporator drain tube

The preferred method for determining if there is an evaporator leak is by checking for the presence of fluorescent dye or excessive compressor oil on the HVAC condensation drain tube.

When looking at the evaporator during leak diagnosis, focus on the evaporator drain tube using a simple process:

- Confirm the system is low on refrigerant.

- Ensure the system has been fully checked, and there are not any refrigerant leaks anywhere in the plumbing connections, condenser, R/D tube/cap, etc.
- Check that there is a presence of oil residue and/or refrigerant dye under a black light at the evaporator drain tube.

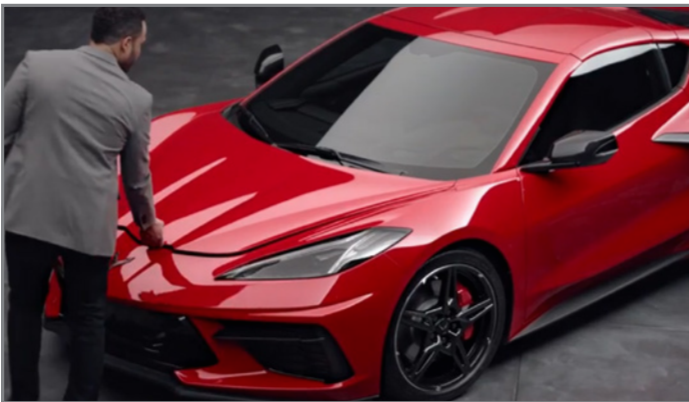
The front compartment hood on some 2024-2025 Corvette models may not fully unlatch when one of the hood release buttons is pressed if the 12V battery is weak, resulting in the hood getting stuck in the secondary latch position. If this occurs, pulling the manual release cable near the steering column also may not release the hood.

The front compartment hood on may not fully unlatch if the 12V battery is weak.

The hood release not fully unlatching may be caused by the 12V battery being too weak to start the engine, yet it may still be strong enough to electrically release the front compartment hood when commanded. The hood may release from the primary release latch, but it is possible that it may become stuck on the secondary latch. The secondary latch release requires more power than what may be available from the vehicle's 12V battery in that moment.

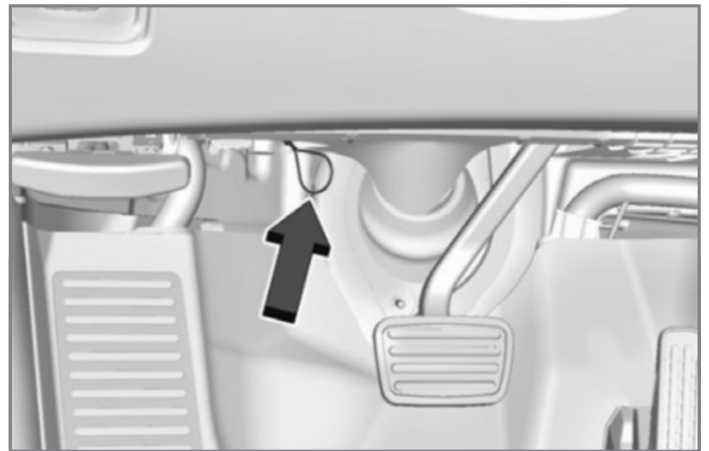
Manual release cable

manual release cable will require a fair amount of effort to pull. If a hook tool is available, it may work much easier than using just a finger.

The incomplete functionality of the hood release is a common condition when trying to access the front compartment to charge a weak 12V battery. In order to open the front compartment, first press down on the hood manually to close it completely. Next, firmly pull the manual release cable — located at the base of the steering column — twice to open the front compartment hood.

**TIP:** For the manual release cable to work properly, the front compartment hood must be fully closed on the primary latch. The

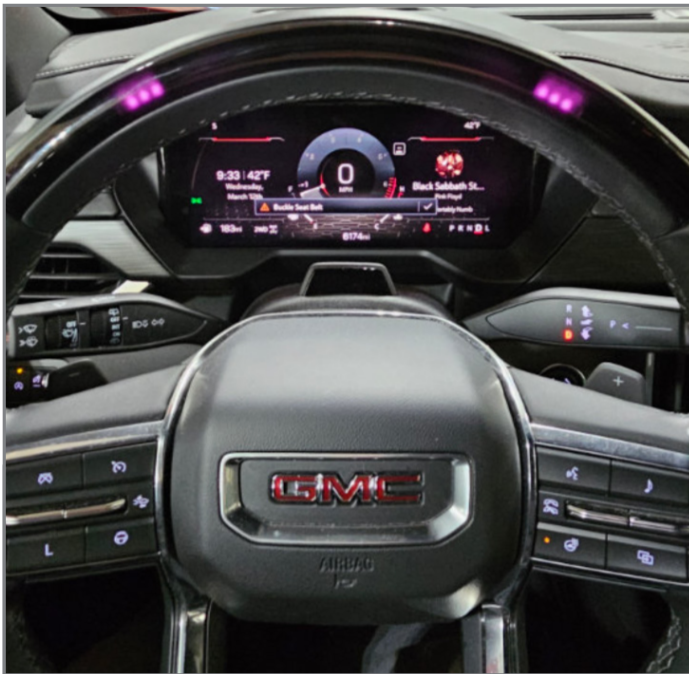
Infrared emitter LEDs on the steering wheel

The Super Cruise driver assistance technology may disengage or be unavailable on some 2021-2025 Escalade; 2023-2025 LYRIQ; 2024-2025 Traverse, Acadia; 2025 Enclave, CT5, ESCALADE IQ, OPTIQ, Blazer EV, Equinox EV, Silverado EV, Tahoe, Suburban, Sierra EV and Yukon models. A Driver Attention Assist Unavailable message or Can't See Face Clearly message also may be displayed on the Driver Information Center. These conditions may be due to inoperative infrared emitter LEDs on the steering wheel.

If the LEDs are inoperative on one side or both sides, replace the steering wheel. Do not replace the Image Processing Module.

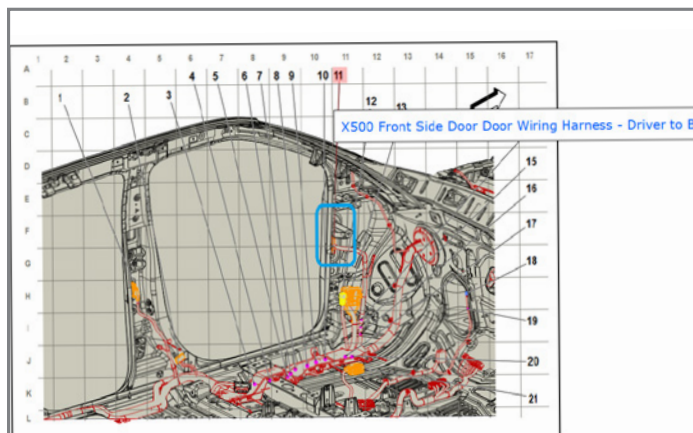
X500 connector

If any of these conditions are present, check for possible water intrusion into connector X500 (front driver's door wiring harness) or X600 (front passenger's door wiring harness). There may be water leaking past the A-pillar body plug.

Any corrosion in a connector should be repaired and, if necessary, replace any damaged terminals with terminated leads. Refer to Wire and Connector Repair in the appropriate Service Information.

To prevent future water intrusion, install a new body plug and apply a sealant.
