New Rear Heating/Cooling System Provides 3rd-Row Comfort

TECH LINK

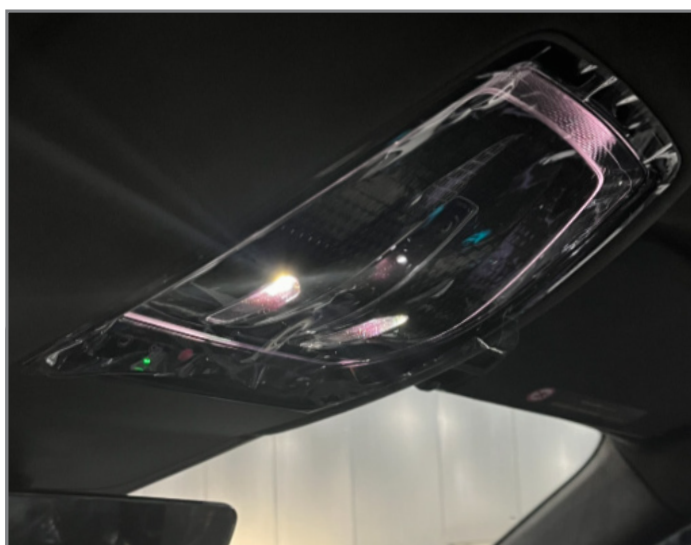
Remove both clear protective films covering the front overhead console.

There are two clear protective films on the front overhead console — a smaller film that covers the speaker grille and a larger film over the full console. Both protective films are neatly trimmed to match the shape of each part. The small film protects the surface of the speaker grille surround and sunroof controls while the large film protects the full console, including the OnStar buttons, hazard warning flashers button and passenger air bag indicator as well as the speaker grille.

In some cases, the smaller clear protective film covering the speaker grille may be missed during PDI, leading to an unnecessary return visit by owners to the dealership for service.

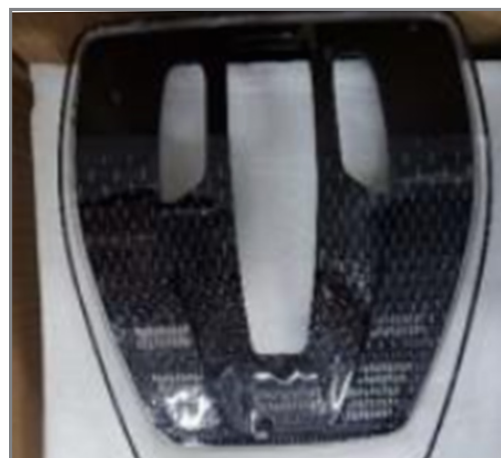
Clear film covering the speaker grille

If left in place after vehicle delivery, either of the protective films may trigger a false interior motion reading by the intrusion sensor of the Content Theft Deterrent System mounted in the overhead console.

TIP: Both protective films should be removed during PDI. Removing the films after vehicle delivery is not a valid warranty claim. Refer to the ESCALADE IQ Pre-Delivery Inspection Form for all inspection items.

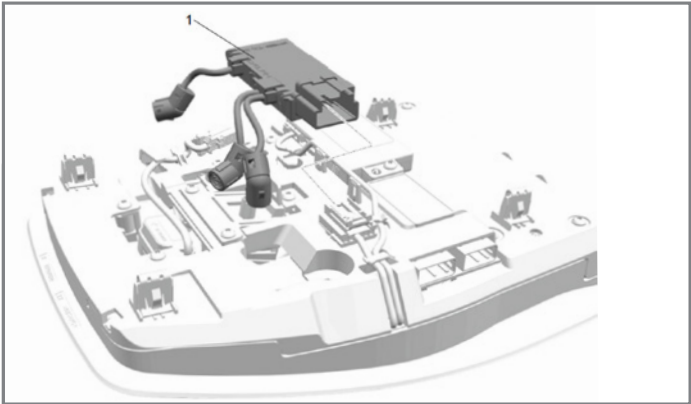
The intrusion sensor uses two ultrasonic sensors to detect any motion inside the vehicle. The false theft alarm also will result in a message from OnStar via the myCadillac mobile app notifying the owner about the alarm.

Intrusion sensor of the content theft deterrent system

If there is a false theft alarm condition on the vehicle, check that both protective films have been removed from the overhead console before making any repairs.

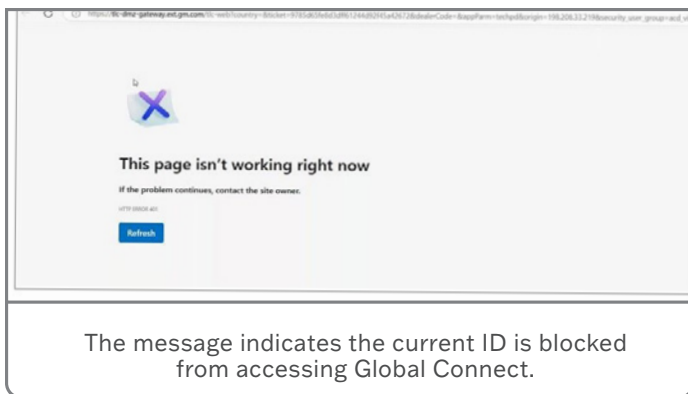
The message indicates that the current ID is blocked from accessing Global Connect. This can be for several reasons but typically is due to a counterfeit MDI device.

To unblock the account, reach out to TCSC via Dealer Case Management (DCM) with the following information:

TCSC will be able to reach out to the Cybersecurity team that will be able to determine the cause of the block and may be able to unblock the account. In the case of a counterfeit MDI, the counterfeit tool must be destroyed, and a legitimate Bosch device must be used to ensure the ID is not blocked again. Repeat offenders may not be unblocked from access.

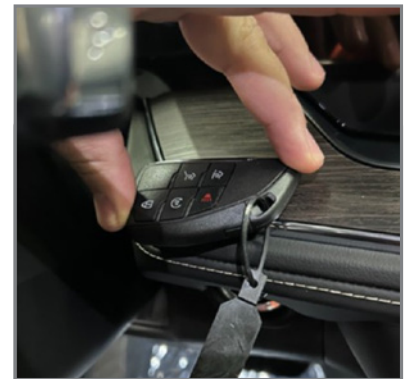
On these vehicles, it may be difficult to learn additional Remote Keyless Entry transmitters (key fobs) to the vehicle during the immobilizer learn procedure. To address this condition, updated Body Control Module (BCM) calibrations have been released to assist with the immobilizer learn process. Be sure to update the BCM with the latest calibrations before learning new key fobs.

In addition, the location of the immobilizer coil has changed slightly on 2025 Tahoe models. The immobilizer coil (T10JA Low Frequency Instrument Panel Number 2 Antenna) is located further away from the ledge where the fob is placed during the

TIP: If it is still difficult to learn the key fob with the fob in the new position on the center console, the fob can be placed in front of the Start/Stop Switch (just below the ledge) with the buttons facing towards the rear of the vehicle.

Position the key fob with the buttons facing upward and the base of the fob towards the instrument panel center stack.
