## Poor A/C Performance Due to Loss of Refrigerant

# Poor A/C Performance Due to Loss of Refrigerant

# Check Grounds for No Start Condition

# Loss of A/C and Warm Air Conditions

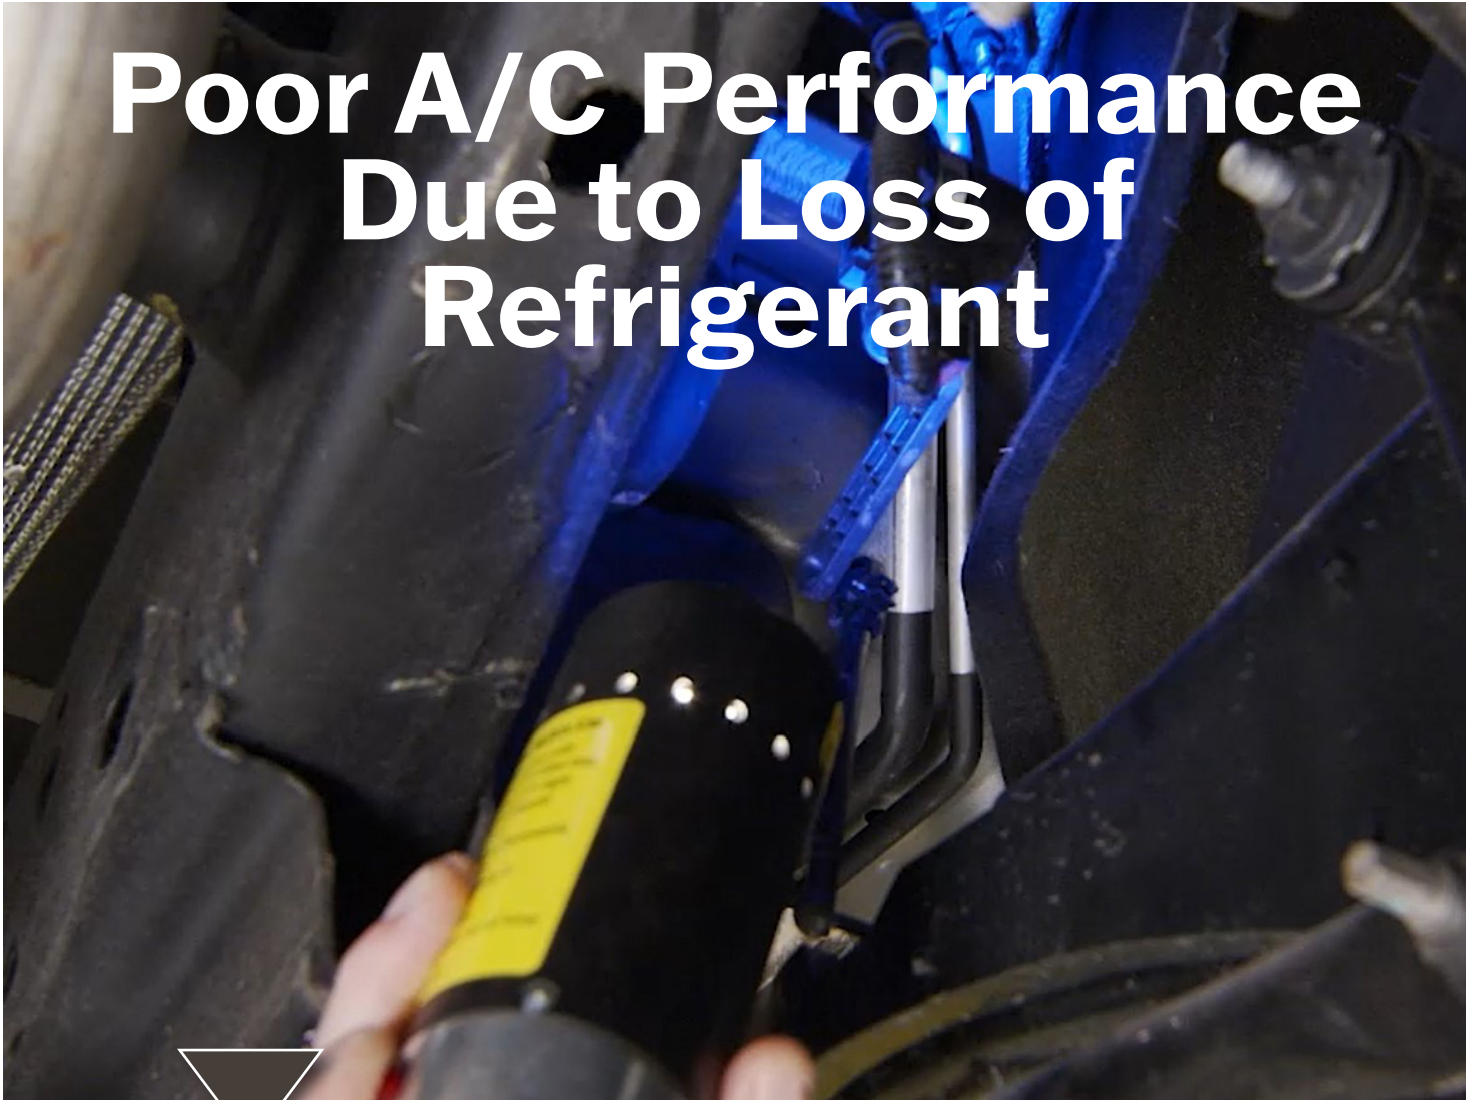
*Check for  
refrigerant leaks  
when there is poor  
A/C performance  
before replacing  
system components.*

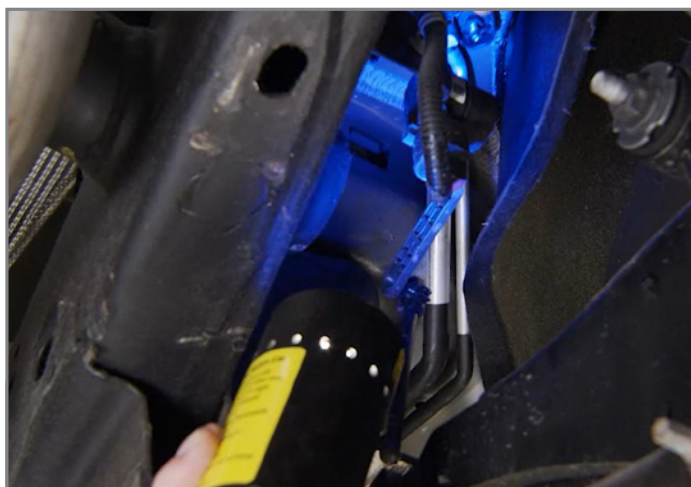
Use the GE-42220 Universal 12V Leak Detection Lamp to help locate leaks in the A/C system.

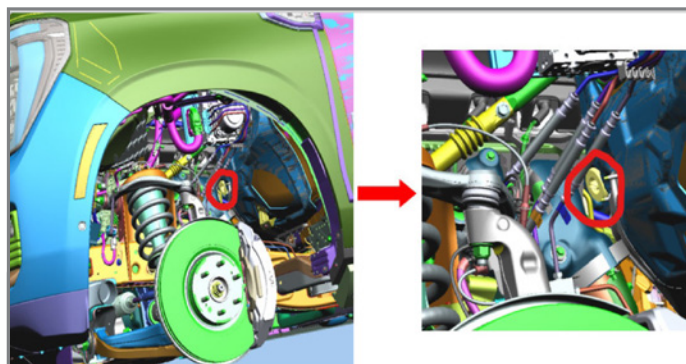
Front HVAC drain

- **Front HVAC drain**, located over the transmission case at the center of the vehicle. To access the drain, remove the left front wheel.
- **A/C refrigerant heat exchanger**

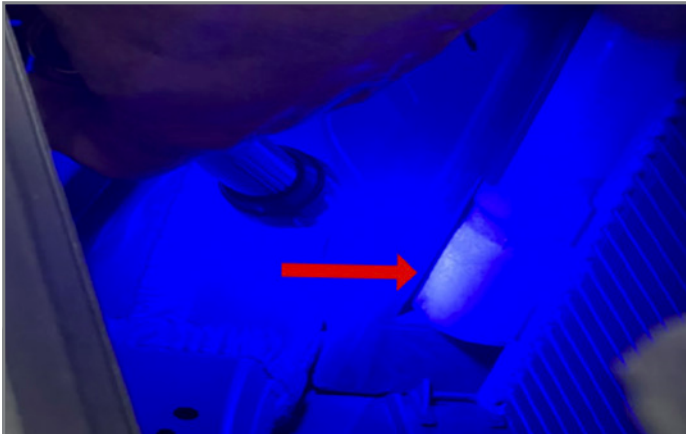
- **A/C condenser connections.** Remove the intake air splash shield for access.
- **A/C pipes and connectors.** Raise the vehicle for a better view under the components.

Remove the intake air splash shield to view the condenser connections.

**TIP:** To prevent false diagnosis in the future, thoroughly clean any residual dye from the area where a leak was found using a rag and GE-43872 Dye Cleaner.

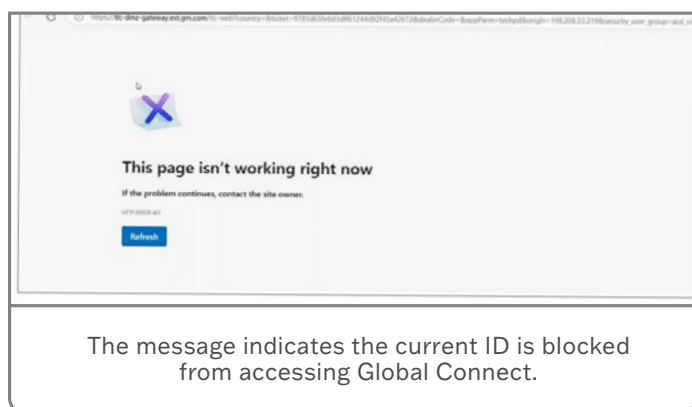
The message indicates that the current ID is blocked from accessing Global Connect. This can be for several reasons but typically is due to a counterfeit MDI device.

To unblock the account, reach out to TCSC via Dealer Case Management (DCM) with the following information:

TCSC will be able to reach out to the Cybersecurity team that will be able to determine the cause of the block and may be able to unblock the account. In the case of a counterfeit MDI, the counterfeit tool must be destroyed, and a legitimate Bosch device must be used to ensure the ID is not blocked again. Repeat offenders may not be unblocked from access.

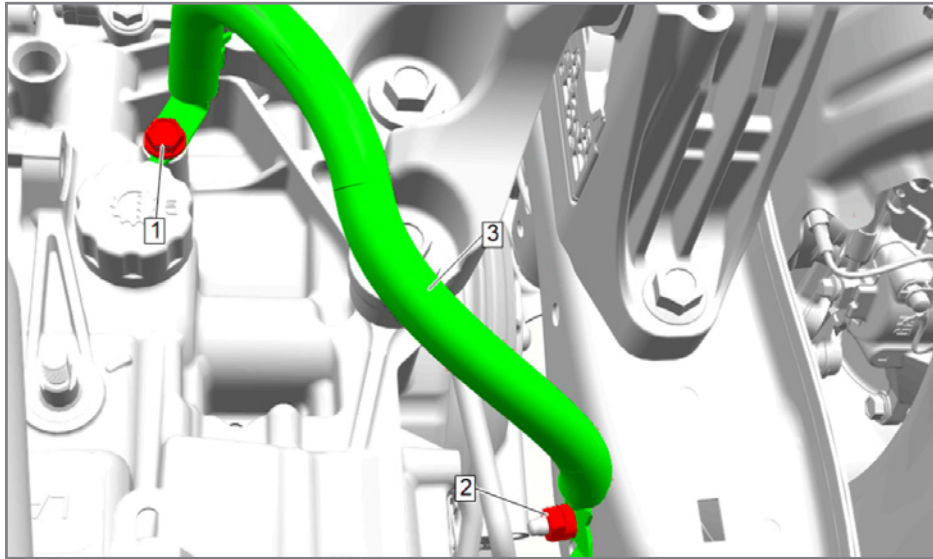
There may be a no start condition on some 2025-2026 Equinox and Terrain models. In addition, the starter may click and there may be several DTCs set in the Engine Control Module (ECM).

These conditions may be caused by the 12V battery, the battery connections or the G111 and G112 grounds.

Begin diagnosis by verifying the 12V battery state of charge. If the battery is good, check the negative battery cable extension.

Perform a voltage drop test from the battery negative terminal to the transmission case. If the voltage drop is 100mV or more, continue with diagnosis. If it is less than 100mV, diagnose any current DTCs following the appropriate Service Information.

Next, check that the G111 and G112 grounds are properly torqued and in good condition.

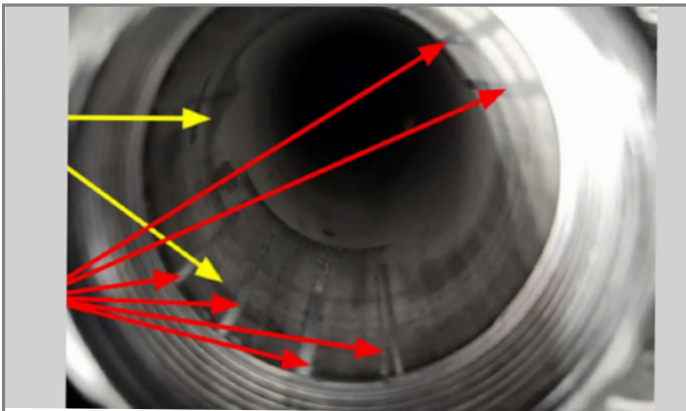
These conditions may be due to the desiccant chamber of the air conditioning condenser.

Check for scoring (red arrows) on the inside of the desiccant chamber.

Check for scoring (red arrows) on the inside of the desiccant chamber, which may cause a slow leak of refrigerant at the receiver/dryer desiccant cap. Inspect the cap extensively using a refrigerant sniffer (GE-50078 Electronic Leak Detector) or a soapy solution to identify any leaks. Replace the condenser if a leak is

found. Refer to Air Conditioning Compressor Replacement in the appropriate Service Information. :

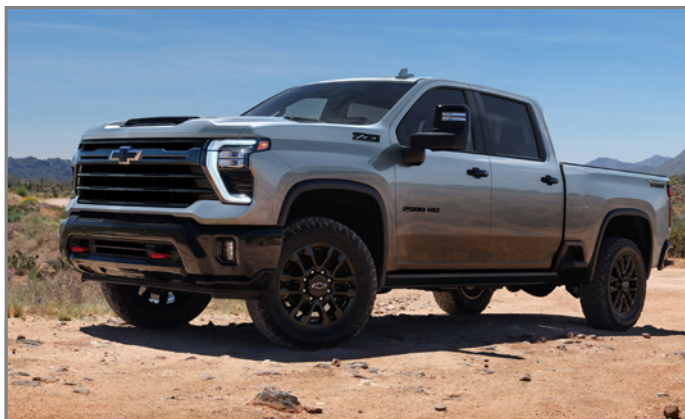
Anti-chip protection is applied to the lower painted surfaces.

However, trucks that are built at the Oshawa assembly plant go through a powder anti-chip material process for stone guard protection that does not have a textured appearance. The anti-chip performance meets all engineering criteria for durability and quality

without a visibly textured surface.

No repairs should be performed and no additional applications of any anti-chip coatings should be applied.
