## New Diagnostic Strategy: Reprogram Control Modules Before Replacement

# New Diagnostic Strategy: Reprogram Control Modules Before Replacement

# New Dash Cover Addresses Windshield Glare

# Corvette Center Console Latch Pushbutton Replacement

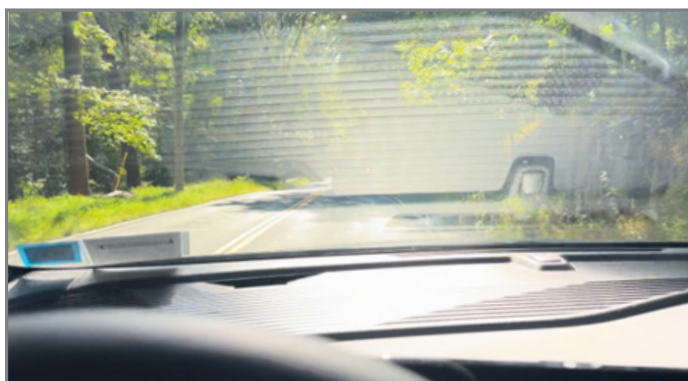
While driving into direct sunlight or under street lights at night, some drivers of 2024-2025 Equinox EV models may notice glare from the dash reflected onto the windshield. The dash valance panel has unique feature lines that may reflect on the windshield due to their reflective angles.

Glare may be seen reflecting on the windshield under some conditions.

In some cases, the glare may be distracting to the driver and passengers. Any customer concerns about the glare can be addressed with a new dash cover now available that can be installed over the top of the instrument panel.

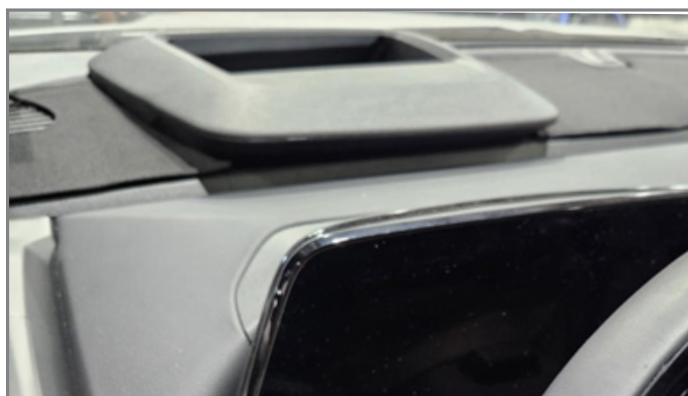
Two-piece dash cover for vehicles equipped with a HUD.

The two-piece design is for vehicles equipped with a Head-Up Display (HUD).

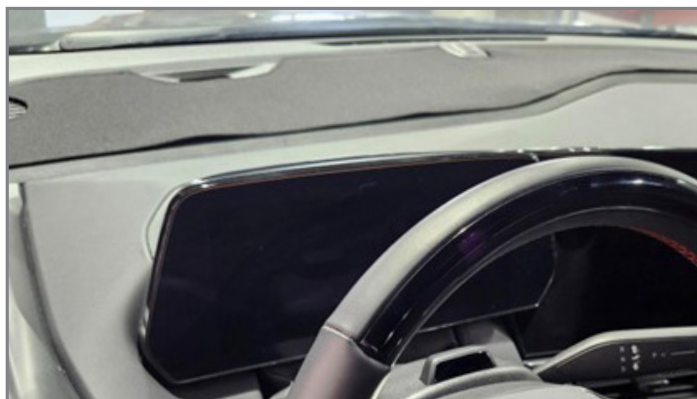
One-piece dash cover

The one-piece design is for vehicles equipped with Forward Collision Alert.

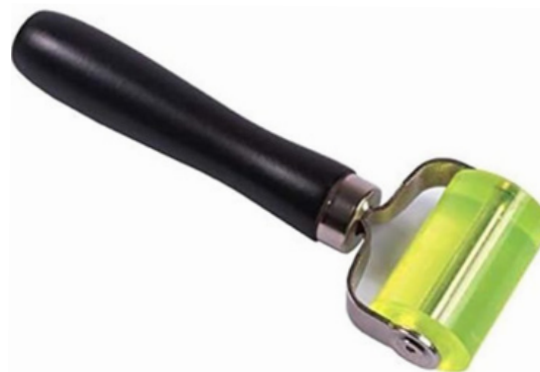
Use a roller tool to smooth out the cover.

It's recommended to stretch the cover over the valance panel by starting at the middle of the cover and working toward the A-pillars. Use a silicone or rubber seam roller to smooth out the cover after installation by hand is completed. It is normal to see some slight bumps where the adhesive pads/Velcro fasteners are located underneath the cover.

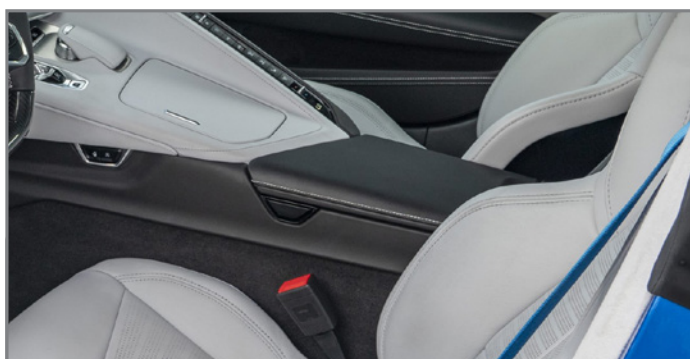
The center console compartment release button on some 2023-2025 Corvette models may become stuck in the depressed position or may extend out of the console compartment. If these conditions are found, the console compartment release button should be replaced. It's not necessary to replace the complete console armrest latch assembly.

Center console release button

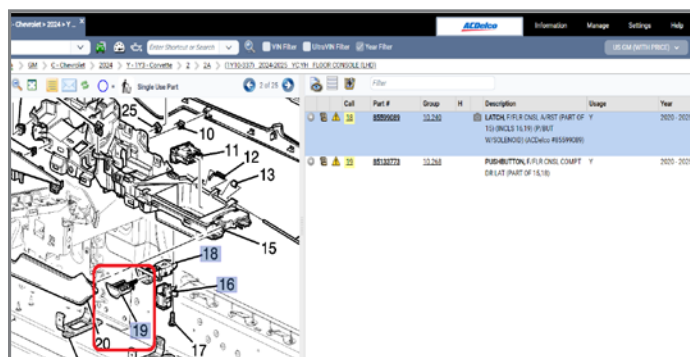
Console compartment pushbutton (PN 85133773)

To release the console compartment door when the pushbutton is inoperative, insert a plastic trim tool behind the button. With the compartment door open, use the trim stick to release the pushbutton from the latch assembly.

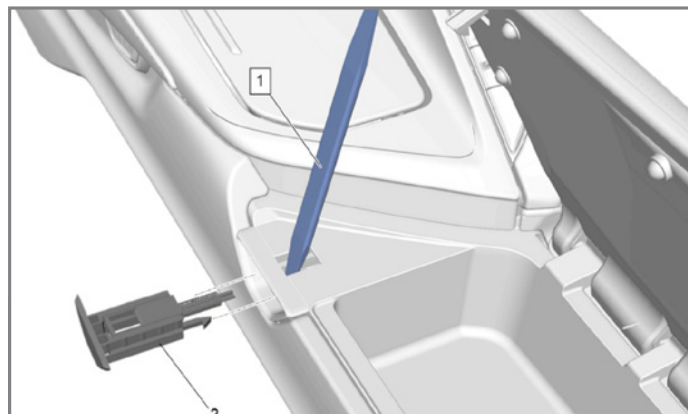
Console compartment pushbutton (PN 85133773)

Check that the spring remains with the pushbutton. If it does not, use a suitable tool to remove it from the armrest latch. The spring and latch slider should be transferred to the new pushbutton.

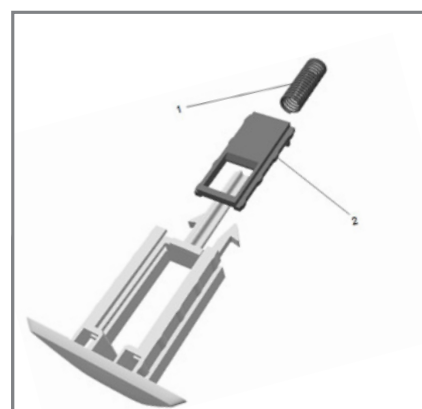
Spring (#1) and latch slider (#2)

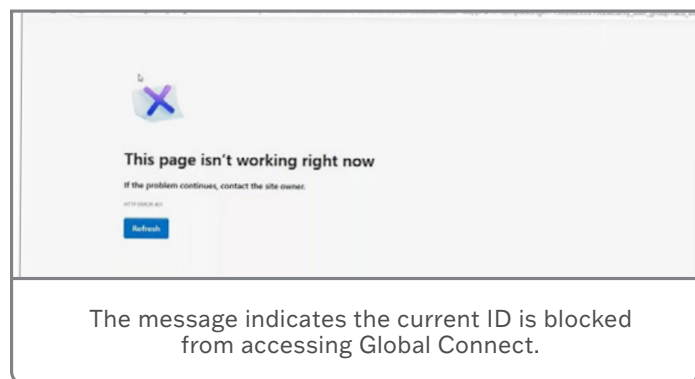
The following message may be seen when attempting to access Techline Connect:

The message indicates that the current ID is blocked from accessing Global Connect. This can be for several reasons but typically is due to a counterfeit MDI device.

To unblock the account, reach out to TCSC via Dealer Case Management (DCM) with the following information:

TCSC will be able to reach out to the Cybersecurity team that will be able to determine the cause of the block and may be able to unblock the account. In the case of a counterfeit MDI, the counterfeit tool must be destroyed, and a legitimate Bosch device must be used to ensure the ID is not blocked again. Repeat offenders may not be unblocked from access.
