GM TECHNICAL ASSISTANCE CENTER (TAC)

Dealer Tips and New Information Newsletter

AUGUST 25, 2025

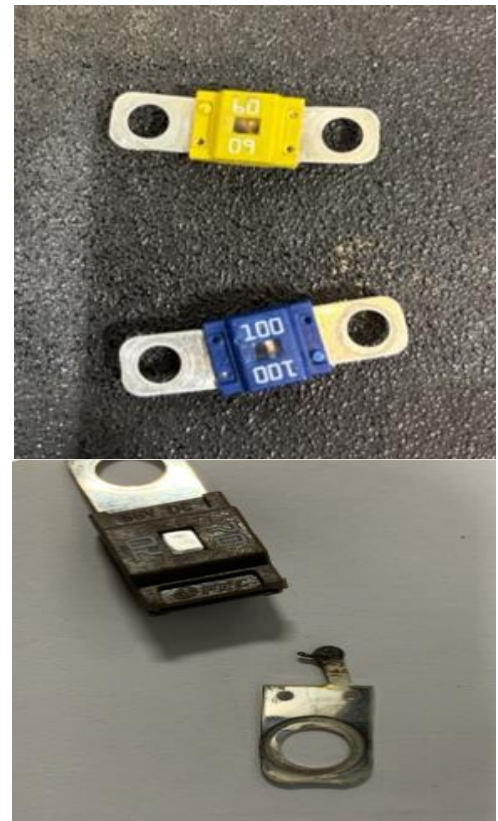
TAC is seeing an uptick in concerns rising from Maxi-type battery fuses being physically broken internally. An image of a broken fuse is shown (with the fuse in your hand, you can physically move the two blades independently of each other). This can and is leading to misdiagnosis and lost time due to the fuse checking ok while still bolted in the block due to the internal portion of the fuse barely making contact.

The damage is usually caused by some type of prior service requiring junction block removal or cable removal from the fuse.

Please exercise caution when removing these cables from the fuses for servicing components. The best practice is to remove the nuts securing these cables by hand, being careful not to twist the fuse blade itself in a manner that would damage the internal portion of the fuse.

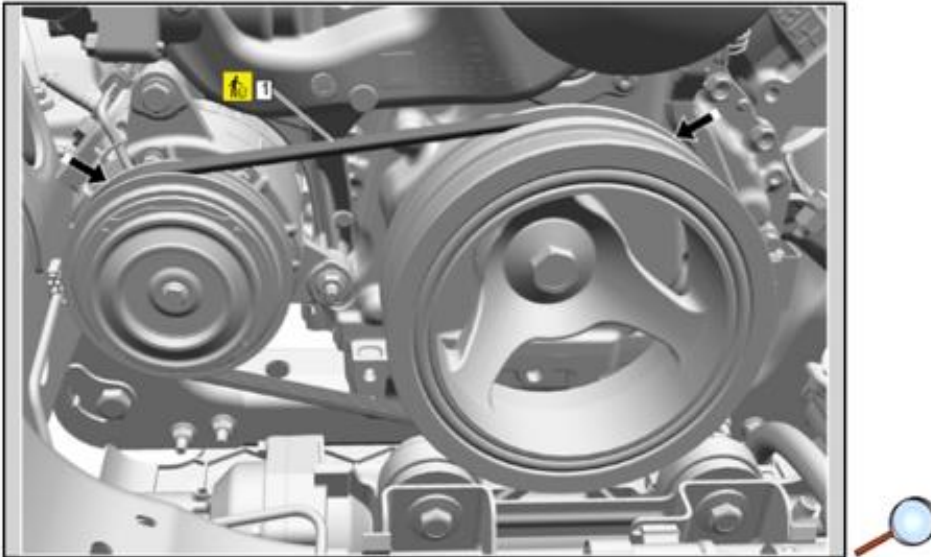
231. Prelube is necessary if the engine is replaced or overhauled. [Engine Prelubing](#)

Upon review of the Engine Removal and Installation service procedure and to help prevent bearing damage, the Engine Prelubing step has been moved before the installation of the accessory drive belts. The reason this change was made is to ensure the lower crankshaft bearings and journals have an adequate amount of oil before rotating the engine dry during drive belt installation.

Note: The OEM replacement accessory drive auxiliary belt (1) is packaged with a disposable installation tool and installation instructions.
232. Install the accessory drive auxiliary belt (1) following the instructions included with the accessory drive auxiliary belt.

233. Inspect the accessory drive auxiliary belt (1) for proper installation and alignment.
