Enhancing Diagnostic Accuracy with Thermal Imaging

Incorrect Brake Pedal Position Sensor Signal Input

EV Reduced Acceleration Conditions

Serial Data Authentication Configuration After Programming a Control Module

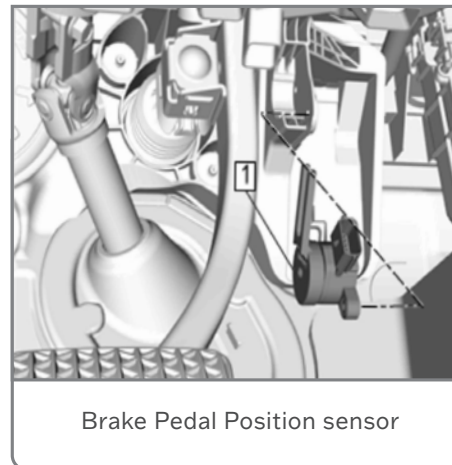
These conditions may be caused by an incorrect Brake Pedal Position (BPP) sensor signal input to the Engine Control Module (ECM), which may cause the ECM to read that the brake pedal is being applied when it is not. It may be necessary to adjust or replace the Brake Pedal Position sensor.

View the BPP data in the ECM to help determine the value the ECM has learned for the brake pedal learned released voltage as well as the actual BPP voltage. With the brake pedal released, the actual BPP voltage should be equal to or close to the BPP Sensor

- BPP Sensor (%) = 0% to 100% (should read 0% with brake pedal released)
- BPP Sensor (Voltage) = Voltage (typical voltage with pedal released is approximately 1 volt +/- 0.3 volt)

To inspect, adjust, or replace the BPP, refer to Brake Pedal Position Sensor Replacement in the appropriate Service Information. If the BPP sensor is replaced, be sure to follow the procedure for the BPP sensor calibration.

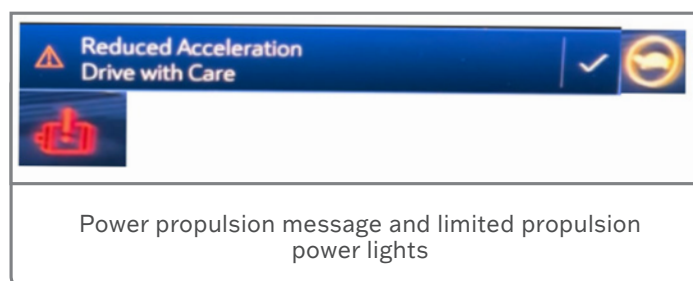
The high-voltage battery SOC level at which reduced power occurs varies based on battery temperature. When SOC is low or the battery pack temperature is too cold or too hot, the high-voltage battery pack may not be capable of meeting minimum expected power output. The temperature of the high-voltage battery pack will dictate the SOC percentage at which reduced propulsion may occur. At a moderate battery temperature of approximately 68°F (20°C), reduced propulsion typically occurs around 5-10% SOC. At colder battery temperatures of approximately 14°F (-10°C), reduced propulsion may occur with SOC at 45% and lower or 90% and higher. At very warm battery temperatures, such as immediately following a DC Fast Charging session in extreme ambient temperatures, reduced propulsion may occur at any SOC. The Reduced Acceleration, Drive with Care message will display under any of these conditions.

In addition, the Propulsion Power Reduced Due to Temperature message displays at any SOC with battery temperatures at or below -13°F (-25°C), 5°F (-15°C), or 14°F (-10°C), depending upon vehicle model.

In all temperatures, with the high-voltage battery pack at 20% SOC or less, charge the vehicle to regain normal power limits.

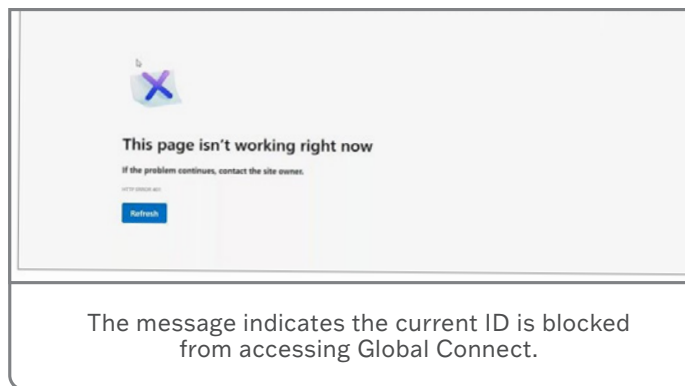
The message indicates that the current ID is blocked from accessing Global Connect. This can be for several reasons but typically is due to a counterfeit MDI device.

The message indicates the current ID is blocked from accessing Global Connect.

To unblock the account, reach out to TCSC via Dealer Case Management (DCM) with the following information:

TCSC will be able to reach out to the Cybersecurity team that will be able to determine the cause of the block and may be able to unblock the account. In the case of a counterfeit MDI, the counterfeit tool must be destroyed, and a legitimate Bosch device must be used to ensure the ID is not blocked again. Repeat offenders may not be unblocked from access.

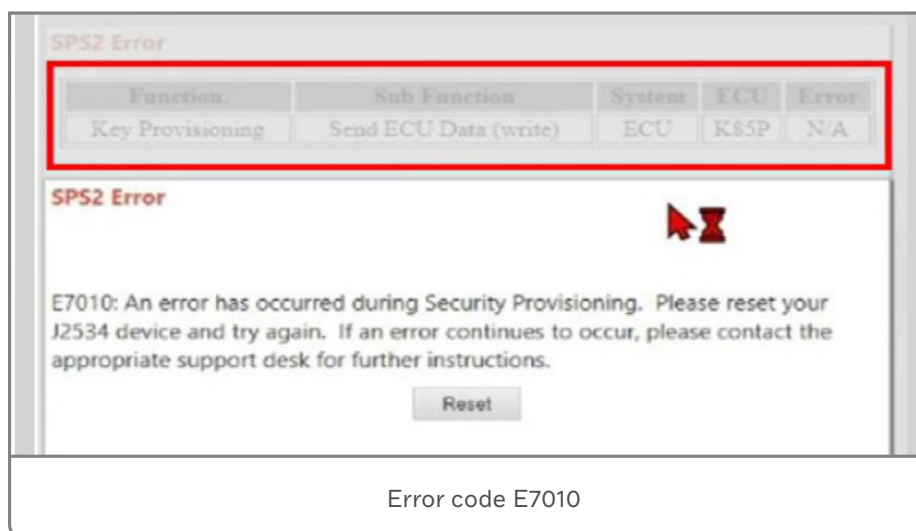
The SDAC will run up to 3 times before it fails. If a vehicle will not complete the SDAC, a pop-up box will display with information about what is causing the concern.

If SDAC does not complete, a pop-up box will display with more information.

There are 5 areas in the pop-up box that include the Function, Sub function, System, ECU, Error. Record the information or take a photo of the pop-up box and review the error types for the symptom with the chart in Bulletin #25-NA-192. The chart provides remedies for issues related to programming, communication and the control module.
