## New 12V Battery Ratings Chart

### for the 2026 Model Year

GM TechLink is published for all GM retail technicians and service consultants to provide timely information to help increase knowledge about GM products and improve the performance of the service department.

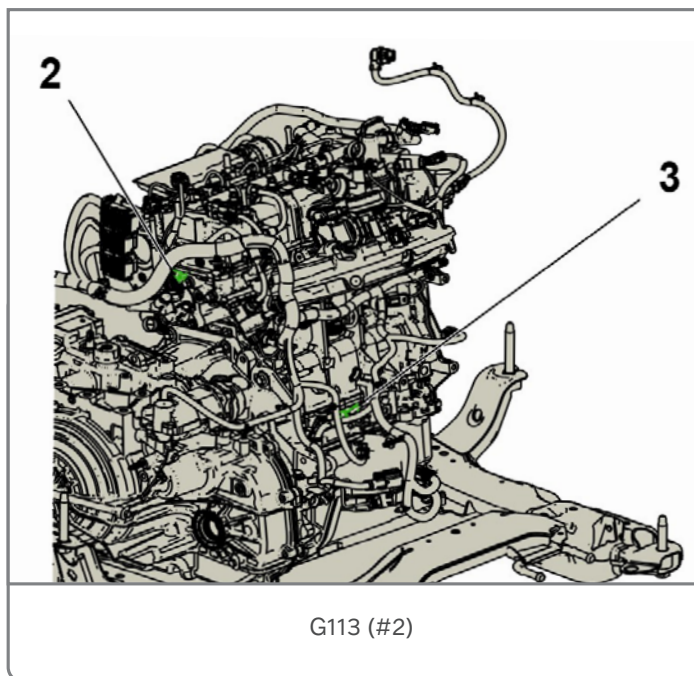
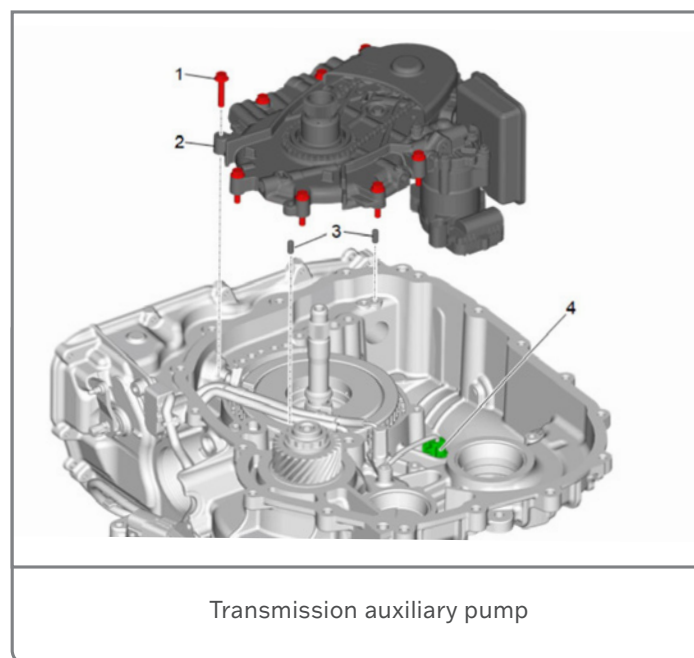
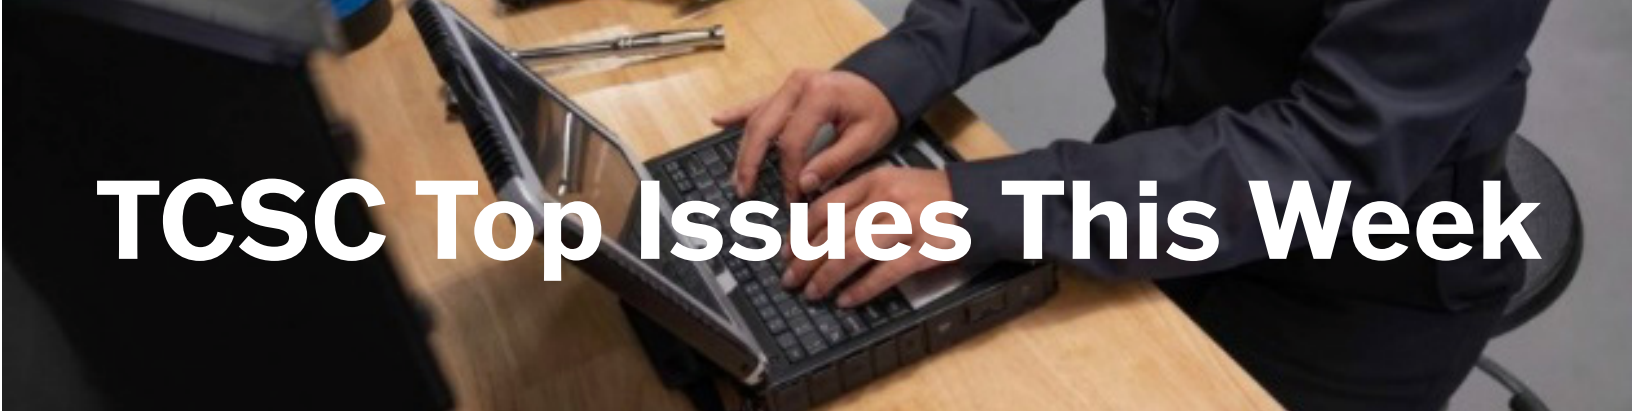
Some 2025-2026 Equinox and Terrain models equipped with the VT40 transmission (RPO MRQ) may have a no start condition with DTCs P27EC (Transmission Range Control Valve Position Sensor Circuit Performance) and P2797 (Automatic Transmission Electric/Auxiliary Fluid Pump Performance) set in the Transmission Control Module (TCM).

These conditions may be caused by a poor ground connection at G111, G112 and/or G113.

- G111 is located in the left side of the engine compartment, attached to the frame rail.
- G112 is located at the left side of the engine, attached to the top of the transmission.
- G113 is located in the engine compartment, attached to the left side of the cylinder head.

The transmission auxiliary pump and wiring harness also may need to be replaced. The electric auxiliary fluid pump is used to keep hydraulic circuits primed during an automatic stop/start event.

Next, verify torque and test G111, G112 and G113 for resistance.

If voltage drop is greater than 0.5 volts, remove the ground from the chassis and inspect for corrosion or paint, or for any damaged threads. If there are not any issues, replace the ground cable assembly and reevaluate the condition.

If voltage drop is less than 0.5 volts, replace the transmission auxiliary pump and wiring harness. Refer to Automatic Transmission Fluid Pump Removal and Automatic Transmission Fluid Pump Installation in the appropriate Service Information.

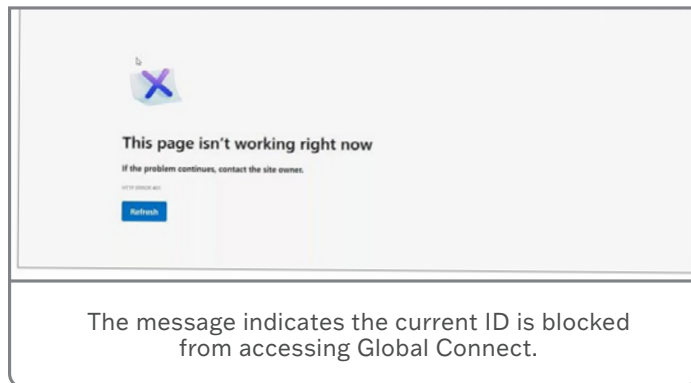
The following message may be seen when attempting to access Techline Connect:

The message indicates that the current ID is blocked from accessing Global Connect. This can be for several reasons but typically is due to a counterfeit MDI device.

To unblock the account, reach out to TCSC via Dealer Case Management (DCM) with the following information:

TCSC will be able to reach out to the Cybersecurity team that will be able to determine the cause of the block and may be able to unblock the account. In the case of a counterfeit MDI, the counterfeit tool must be destroyed, and a legitimate Bosch device must be used to ensure the ID is not blocked again. Repeat offenders may not be unblocked from access.

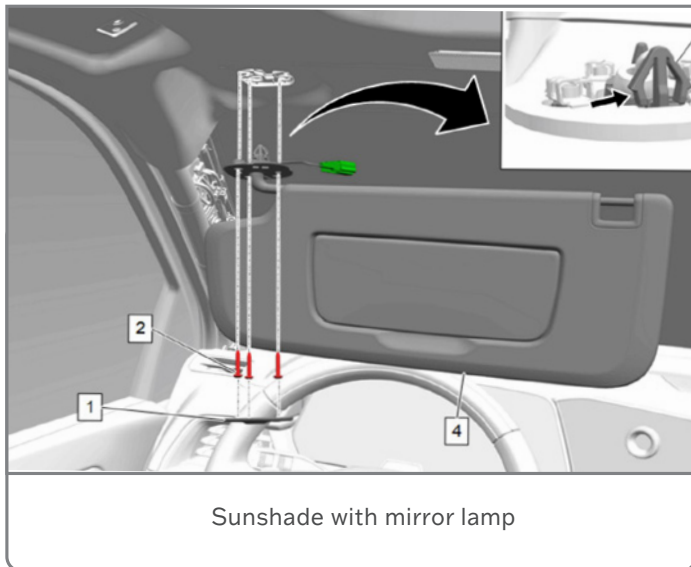
Some 2025-2026 Tahoe, Suburban, Yukon and Escalade models may experience a low or dead battery. During battery draw diagnostics, a 550 ma draw may be found, and which can be eliminated by removing a Body Control Module (BCM) fuse.

These conditions may be caused by unwanted voltage fluctuating on the sunshade lamp supply circuits from the overhead console (A103 Roof Console). The overhead console may see the voltage fluctuation as a new input each time the voltage dips low, resulting in the BCM staying active and causing the low battery charge condition.

while the sunshade mirror lamps are off/closed. A normally operating sunshade circuit should show a steady 12 volts when the sunshade mirror lamps are off/closed and then drop low and quickly recover back to 12 volts when the lamps are on/opened.

If these conditions are present, back probe the left (4785 LH) and right (2369 RH) sunshade lamp voltage supply circuits to ground at the overhead console using a Digital Multimeter

If voltage is found to be fluctuating from approximately 2–12 volts on either circuit while the sunshade mirror lamps are off/closed, disconnect the sunshade and check for draw. After 10 minutes, if the excessive draw has dropped to an acceptable level, replace the sunshade.
