**Transmission Park Lock Valve Parts Released**

# Headlamp Cooling Fan Humming Sound

# Automatic Transmission Fluid Appearance and Color

## TECH LINK

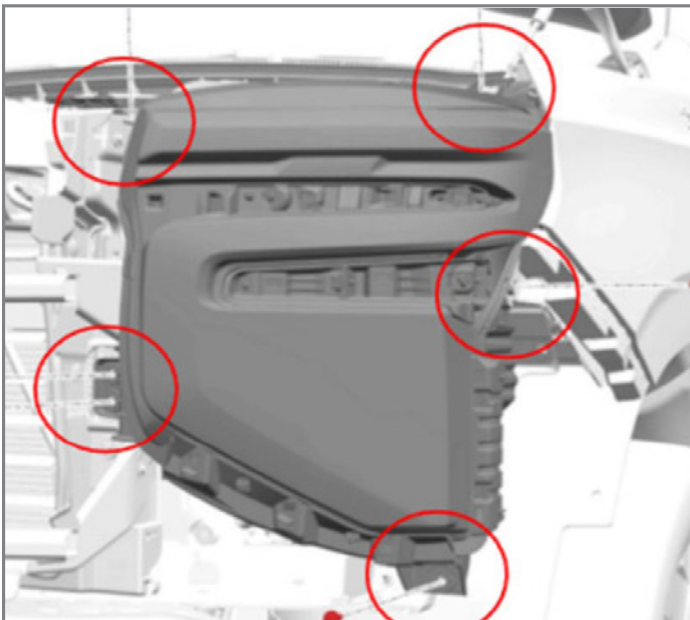
A humming or buzzing sound may be heard coming from the front of some 2025 Tahoe, Suburban, Yukon and Escalade models. The sound may be the headlamp mounting amplifying the normal resonance of the headlamp cooling fan.

The headlamp cooling fan directs airflow over the components to help dissipate heat, enabling the LED bulbs to operate at optimal temperature levels. Direct contact between the headlamp assembly and the vehicle body may lead to increased vibration and noise transmission.

Headlamp mounting locations (Tahoe shown)

If the headlamp assembly is confirmed as the root cause, apply 1-inch squares of foil-backed butyl tape to the headlamp mounting locations.

The foil-backed butyl tape will dampen vibration and eliminate resonance transfer to the surrounding body panels.

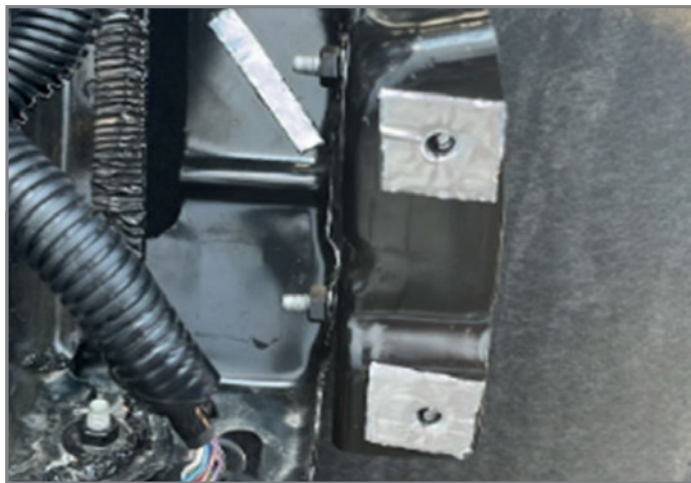
Apply 1-inch squares of foil-backed butyl tape

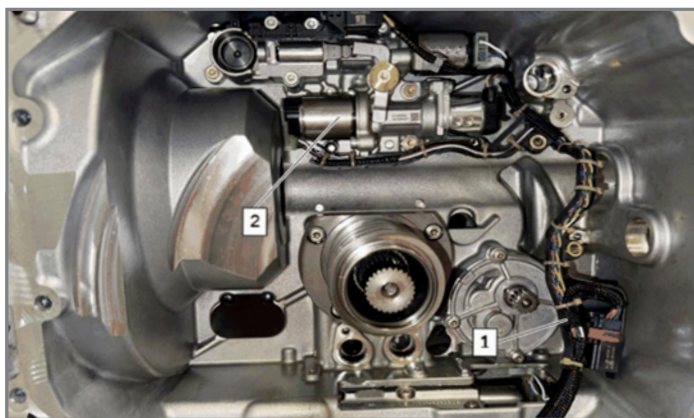
Park lock valve-related faults on 2020-2025 Corvette models were previously repaired by replacing the transmission assembly (RPO M1L, M1M, MLH). Parts and service procedures are now available for servicing the park lock valve and harness, eliminating the need for transmission assembly replacement.

Transmission wiring harness (#1) and park pawl actuator (#2)

Refer to Service Information Doc ID 6837160 for park pawl actuator replacement instructions.

After repairs, the Transmission Control Module (TCM) will need to be programmed with a VCI number from TCSC. The new park pawl actuator will need to be fine-tuned to the particular transmission being repaired, and the calibration allows for the learn to be performed.

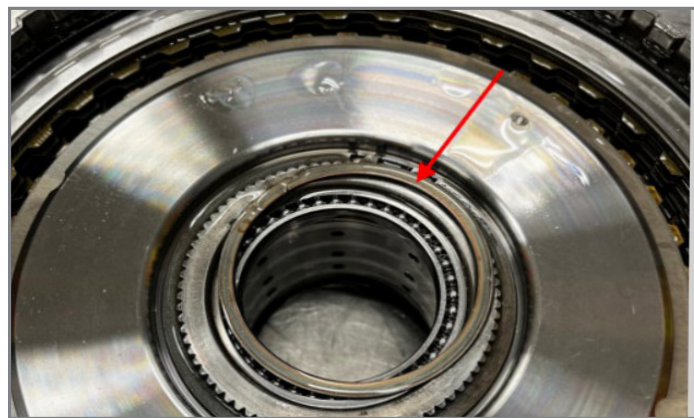
Bulletin #23-NA-197 covers repairs for a dislodged snap ring.

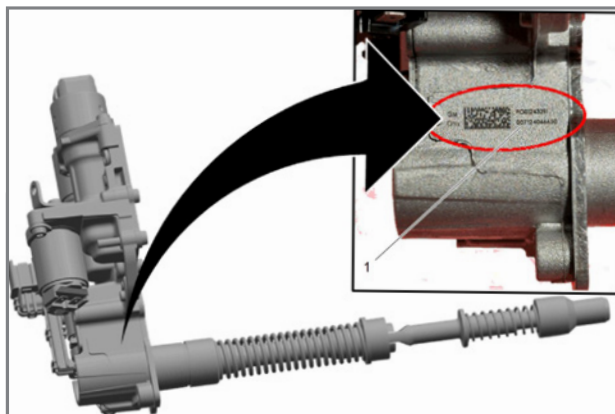
The park pawl actuator PUN will need to be characterized, so it will be helpful to take a picture of the PUN before transmission reinstallation. The PUN is 22 digits and etched/printed number is very small. It begins with PO. If the PUN is not characterized, the vehicle may not start. The vehicle must be able to be started to perform the relearn. If the correct PUN is not used, it may be necessary to remove the transmission again to confirm the PUN.

22-digit park pawl actuator PUN

The park lock valve learn must be run after TCM reprogramming and characterization, improper calibrations in the TCM will result in a failure 2F01 when attempting to run the learn.

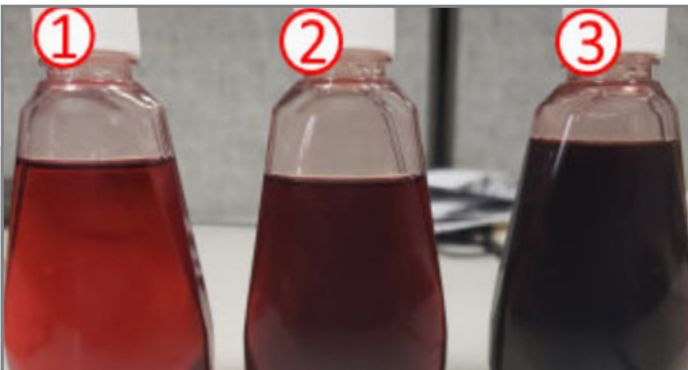
The automatic transmission fluid in these transmissions may be red, brown, or black. It often will be darker as mileage increases. The fluid in these transmissions also tends to turn darker due to rust inhibitors used on internal transmission parts during assembly.

If transmission fluid appears dark, do not assume that the transmission has internal damage, and continue with diagnosis

Automatic transmission fluid may be red, brown, or black.

of the concern. The transmission as well as the transmission fluid should not be replaced based only on the appearance of the transmission fluid.

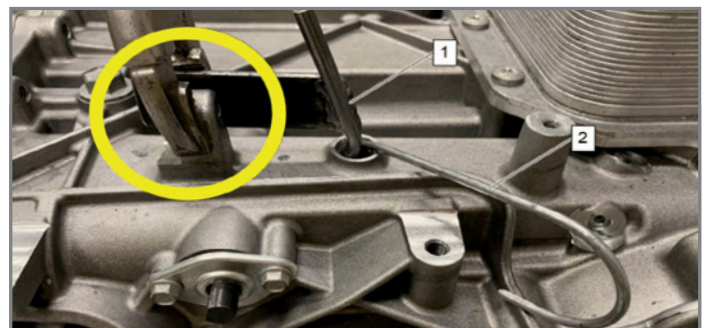
Plunger Shaft Lifting Tool (#1) and Park Pawl Engagement Tool (#2)

Check out the December 2024 Emerging Issues seminar for a video providing detailed instructions on feeding the park rod back into the transmission using the Plunger Shaft Lifting Tool and Park Pawl Engagement Tool.

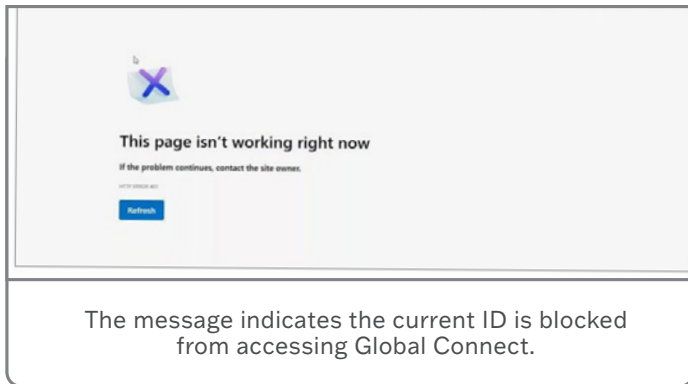
The message indicates that the current ID is blocked from accessing Global Connect. This can be for several reasons but typically is due to a counterfeit MDI device.

To unblock the account, reach out to TCSC via CX Connect with the following information:

TCSC will be able to reach out to the Cybersecurity team that will be able to determine the cause of the block and may be able to unblock the account. In the case of a counterfeit MDI, the counterfeit tool must be destroyed, and a legitimate Bosch device must be used to ensure the ID is not blocked again. Repeat offenders may not be unblocked from access.

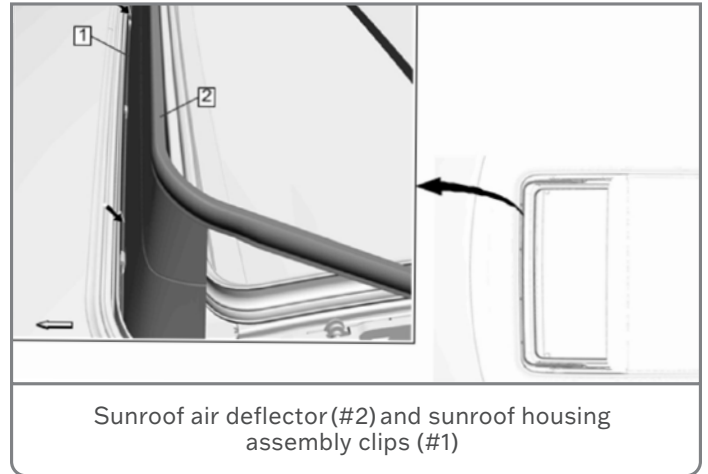
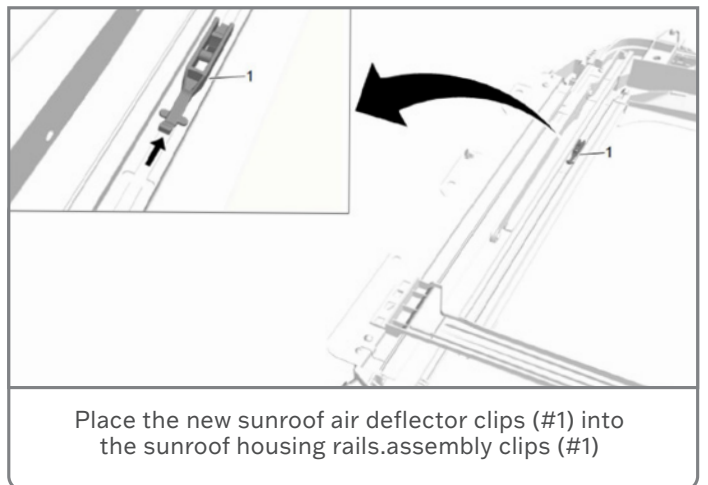
The sunroof may not be operating properly and/or the sunroof air deflector may not be functioning properly on some 2017-2023 Acadia; 2018-2023 Enclave, Traverse; and 2024 Enclave and Traverse Limited models. The clips securing the wind/air deflector may not be secure or may have broken, causing the sunroof to be inoperative.

Replace the clips by opening the sunroof to the fully open position. Push the sunroof air deflector down and back using a suitable tool to release it from the sunroof housing assembly clips. Pull the air deflector up and back to remove it. If the clips are broken, be sure to remove all pieces.

Place the new sunroof air deflector clips into the sunroof housing rails. Gently slide each clip back until the wings of the clip are fully seated into the rail cutouts. Very little downward force is needed. Complete repairs by reinstalling the air deflector and verifying proper sunroof operation.
