# HUMMER EV Sky Panel Adjustment Tips

## TECH LINK

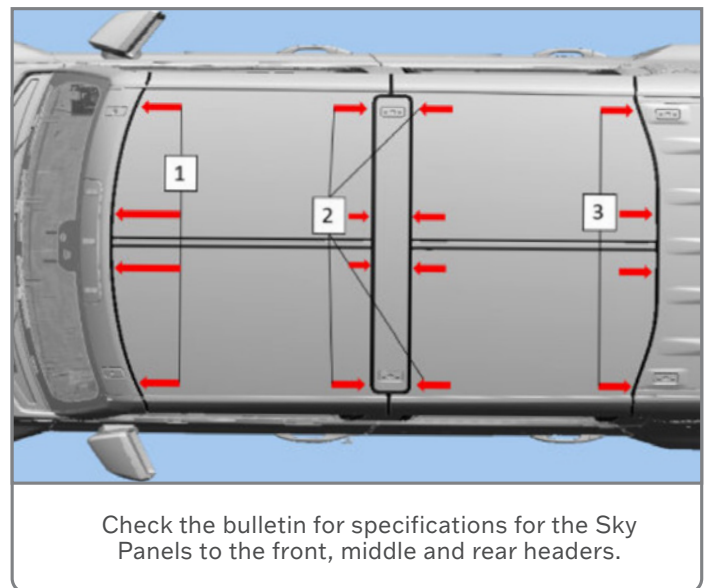
With the sky panels installed, inspect the alignment of the Sky Panels for proper gaps. The specifications for the gaps for the front Sky Panel to each header are:

### 1. Front Sky Panel to Front Header

Gap Fore/Aft: 8.0mm  $\pm$  1.5 // 1.0 Flushness: 0.0  $\pm$  1.5

### 2. Front and Rear Sky Panel to Middle Header

### 3. Rear Sky Panel to Rear Header

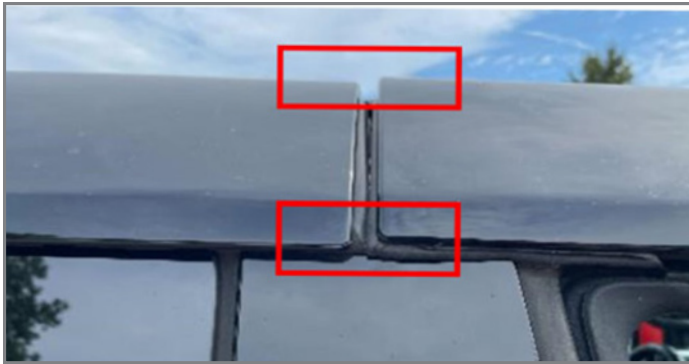
Incorrect panel alignment

If the measurements are out of specification, refer to the appropriate Service Information to make adjustments. Incorrect Sky Panel alignment may lead to wind noise as well as water leaks.

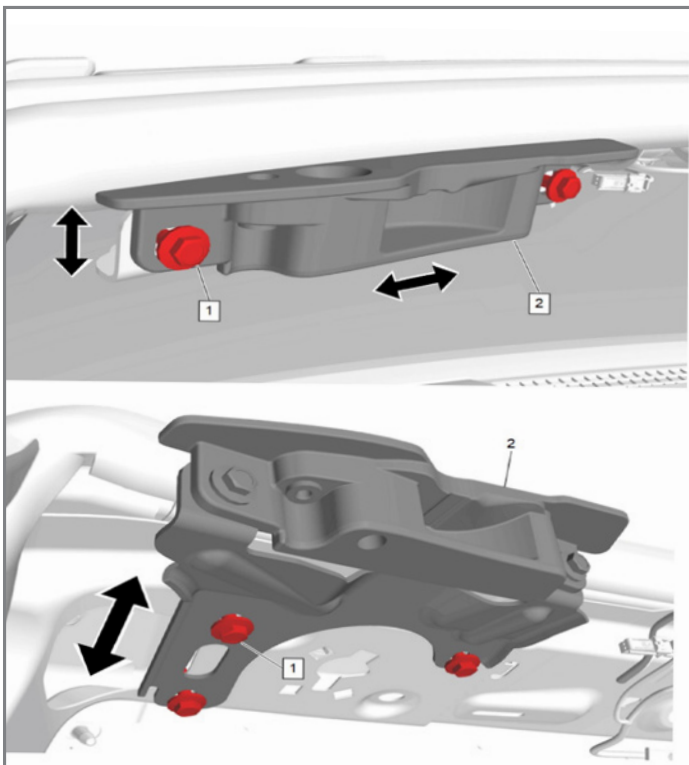
The Sky Panel can be adjusted cross-car, up/down and fore/aft.

Sky Panel alignment is controlled by two receivers on each panel. The Sky Panel can be adjusted cross-car, up/down and fore/aft.

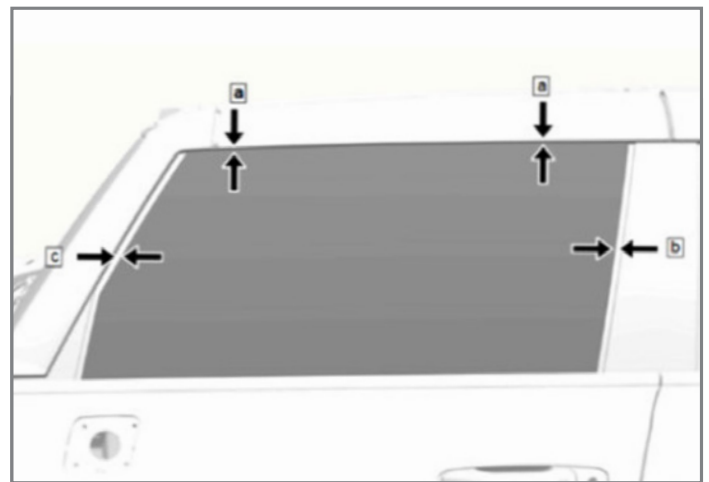
Check the specifications for the height and position of the side door glass.

The height and position of the side door glass for all four windows are the same:

A. Glass should penetrate top seal 4.5mm +/- 1.5mm

B. Gap should be 10mm +/- 1.5mm

C. Gap should be 10mm +/- 1.5mm

The frameless door glass must be properly aligned to ensure a good seal and prevent wind noise and water leaks. Inspect each window for correct horizontal alignment as well as the tip of the glass being fully seated into the Sky Panel window weather strip. Refer to either Front or Rear Window Adjustment in the appropriate Service Information for the alignment procedures and specifications.

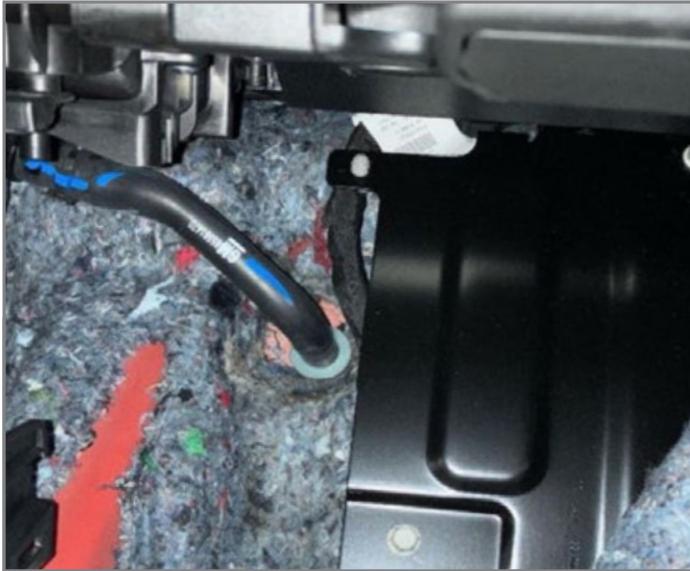
Water may be found on the front passenger floor of some 2024-2026 Equinox EV and 2025 OPTIQ models. The water leak may be caused by an unseated A/C drain tube in the instrument panel bulkhead.

If the passenger-side front carpet is wet, inspect the A/C drain tube and reseal it if it is disconnected. If there is a visible

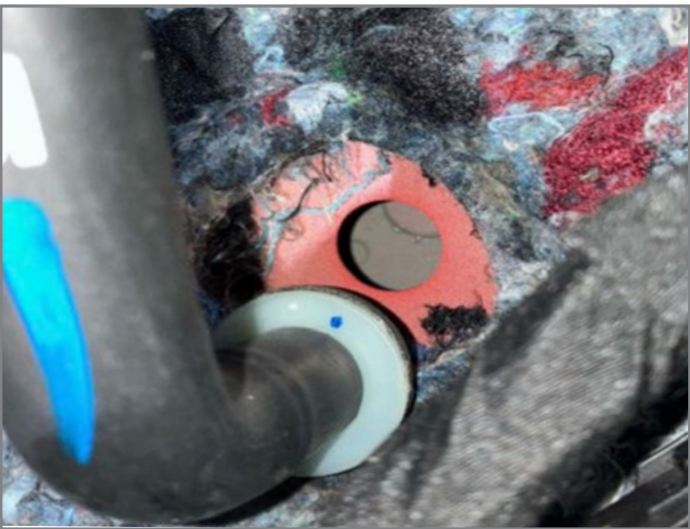
Disconnected drain tube

discoloration on the underside of the carpet or any odor retention, the carpet may need to be dried out or replaced.

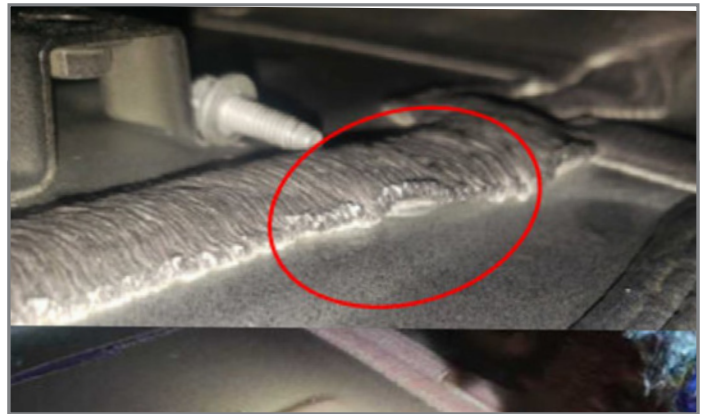
Body seam

On Equinox EV models, also check the body seam under the passenger-side front carpet. If the drain tube is seated properly, the body seam may be allowing water to intrude into the passenger compartment.

To access the body seam, it will be necessary to remove the passenger seat, disconnect the seat harness, remove the door sill and center console side trim, and then remove the passenger-side carpet. Also remove the Brake Electronic Control Module (BECM) bracket. The BECM does not need to be disconnected; just lift up the module and set it aside.

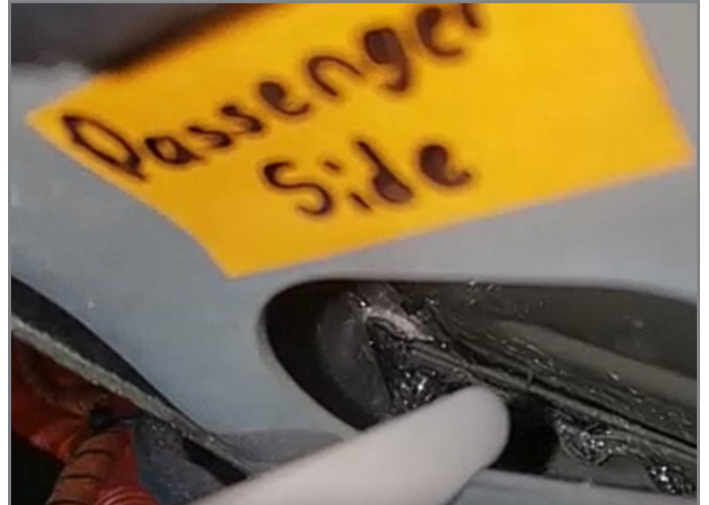
Apply sealer along the seam

Check for a leak in the paint shop sealer by applying water from under the vehicle at the seam.

**TIP:** If excess sealer is present in this location, use a long pick or an 8-inch flathead screwdriver to remove it from the underbody prior to cleaning and re-sealing the area.

Apply sealer along the seam between the sheet metal. Use a small brush to push sealer into the gap.

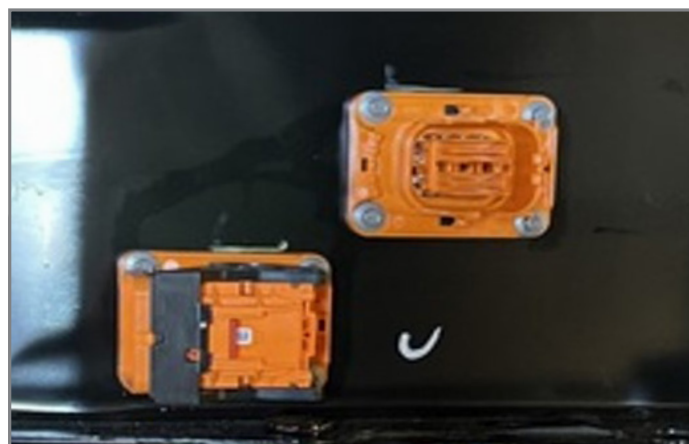
High-voltage battery pack without the rear ground strap bracket.

However, if there is not a bracket on the new high-voltage battery pack, remove the rear ground strap from the vehicle and discard the ground strap.

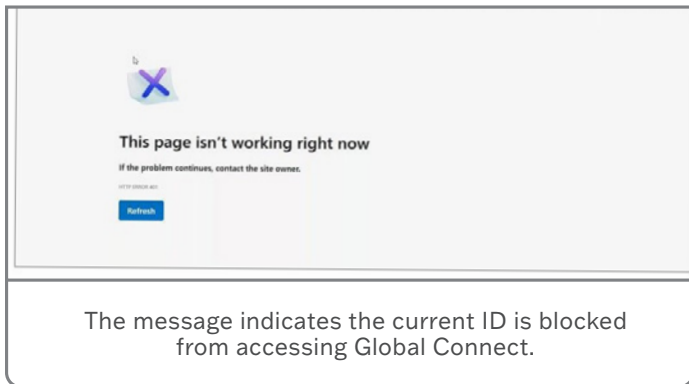
The following message may be seen when attempting to access Techline Connect

The message indicates that the current ID is blocked from accessing Global Connect. This can be for several reasons but typically is due to a counterfeit MDI device.

To unblock the account, reach out to TCSC via CX Connect with the following information:

TCSC will be able to reach out to the Cybersecurity team that will be able to determine the cause of the block and may be able to unblock the account. In the case of a counterfeit MDI, the counterfeit tool must be destroyed, and a legitimate Bosch device must be used to ensure the ID is not blocked again. Repeat offenders may not be unblocked from access.

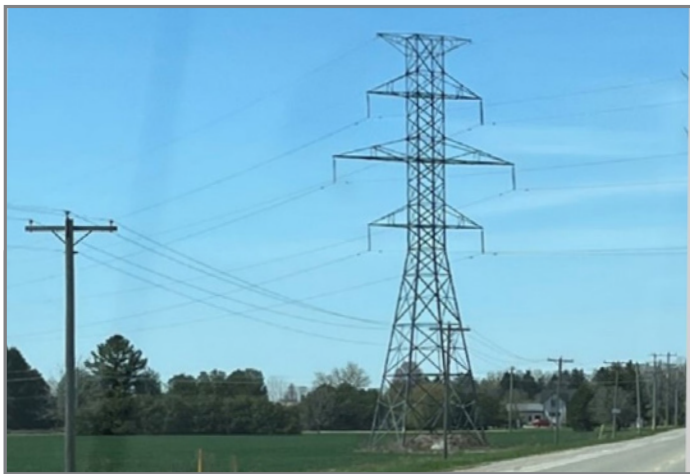
These conditions may be caused by the aluminum roof bows of an upfitter box, which may be acting as an antenna when passing under the high-voltage lines. The roof bows will dissipate electrical spikes into the vehicle's electrical system. The proximity of the EBCM to the ungrounded portion of the vehicle may be why most of the DTCs are related to the EBCM.

Aluminum roof bows of an upfitter box may act as an antenna when passing under high-voltage lines.

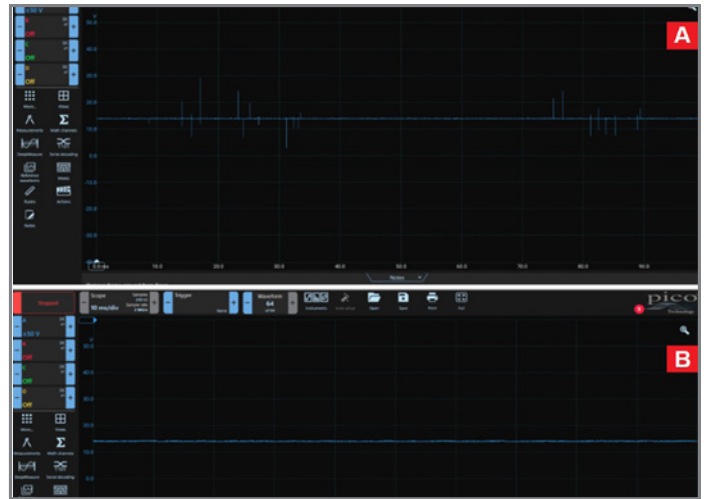
GDS2 Freeze Frame Data may show that the rear wheel speed sensors appear to have momentarily increased in speed. PicoScope voltage measurement across battery terminals will intermittently spike in voltage to over 30V at times.

PicoScope reading prior to adding ground cable (A) and after ground cable installation (B).

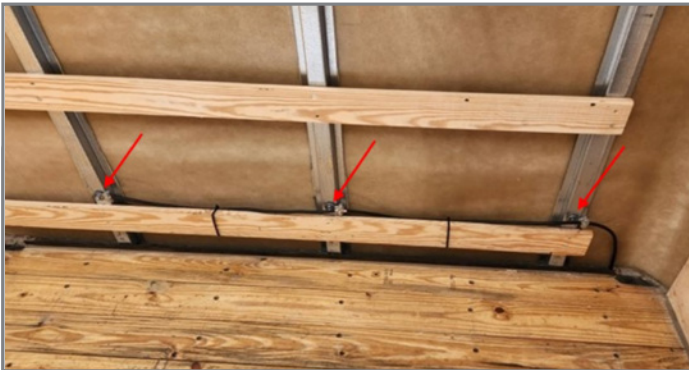
Ground cable installation across the first three roof bows.

The movement in a fiberglass box may have the roof bows touching the lower grounded angle bracket at times, which explains why the conditions can be very intermittent. In order to alleviate interference into the electrical system, at least the first three roof bows of the upfitter box need to be grounded.

Ground cable and cable ground eyelets can be purchased through most local auto parts stores. The ground cable installation across the first three roof bows requires 7 feet of #4-gauge ground cable, which should be attached to the bottom of the first three roof bows and then grounded to the vehicle frame.

**TIP:** The roof bows must use a flexible ground cable when installing directly to the floor angle brace. Using the incorrect

length or type will limit movement of the fiberglass box sides and lead to stress cracks in the fiberglass box.

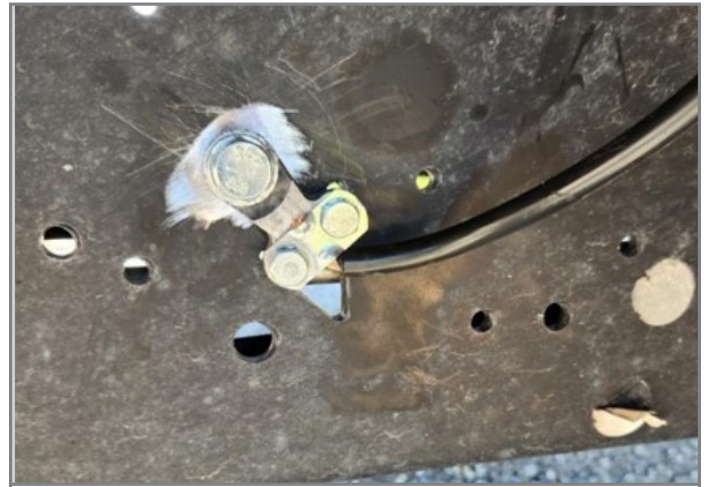
Ground cable attached to the vehicle frame

Spray or coat the ground bolt/ring terminal on the frame with an anti-corrosion sealant in order to prevent rusting.
