# GM TECHNICAL ASSISTANCE CENTER (TAC)

## Dealer Tips and New Information Newsletter

OCTOBER 27, 2025

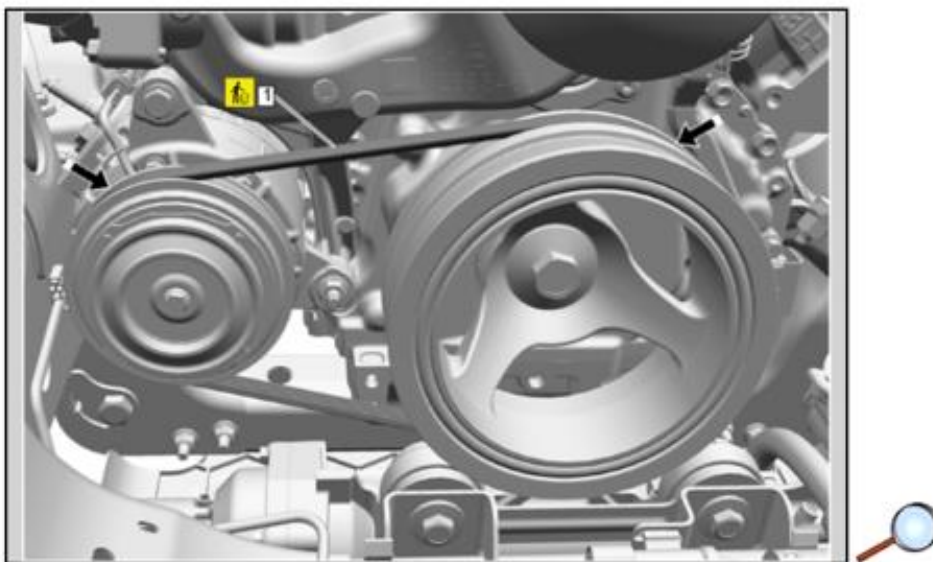
Upon review of the Engine Removal and Installation service procedure and to help prevent bearing damage, the Engine Prelubing step has been moved before the installation of the accessory drive belts. The reason this change was made is to ensure the lower crankshaft bearings and journals have an adequate amount of oil before rotating the engine dry during drive belt installation.

**Caution:** Refer to [Engine Prelubing Caution](#).  
231. Prelube is necessary if the engine is replaced or overhauled. [Engine Prelubing](#)

**Note:** The OEM replacement accessory drive auxiliary belt (1) is packaged with a disposable installation tool and installation instructions.  
232. Install the accessory drive auxiliary belt (1) following the instructions included with the accessory drive auxiliary belt.  
233. Inspect the accessory drive auxiliary belt (1) for proper installation and alignment.

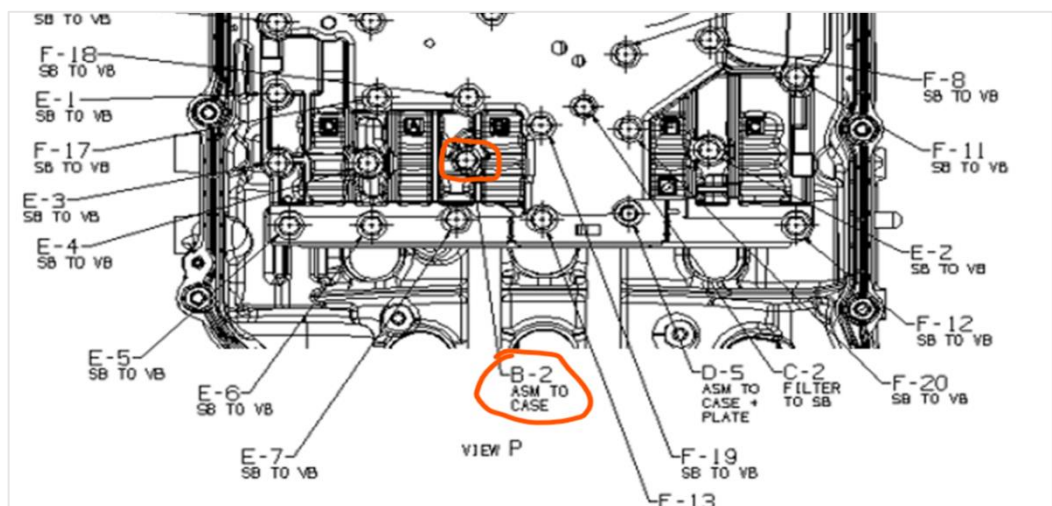
**Concern:** DTC P0777 setting after valve body repair or replacement.

**Cause:** Engineering has requested to remove the valve body bolt and reinstall to 8 Nm, which is 1 Nm less than torque spec to see if the DTC is no longer setting. They are also requesting feedback if the bolt retorquer corrects the concern. See image for the exact bolt location.

Also, if there is a new concern other than DTC P0777 after the listed TSBs for the valve body assembly repair, the request is to remove the repaired valve body assembly to inspect for possible misplaced or missing check balls.
