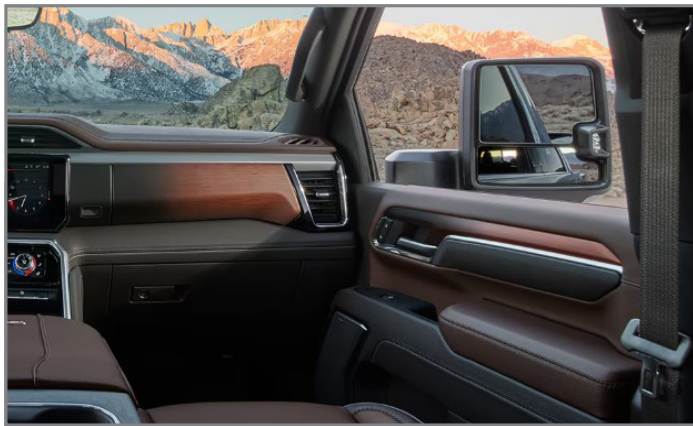
Some 2022-2025 Silverado 1500, Sierra 1500; 2024-2025 Silverado 2500HD/3500HD and Sierra 2500HD/3500HD trucks may have a bubbling or delaminating condition on the wood trim of the door panel.

Sierra HD door trim

If delamination of the wood trim is found, remove the door trim panel.

Refer to Bulletin #25-NA-141 for additional information, including part numbers for the decorative trim part.

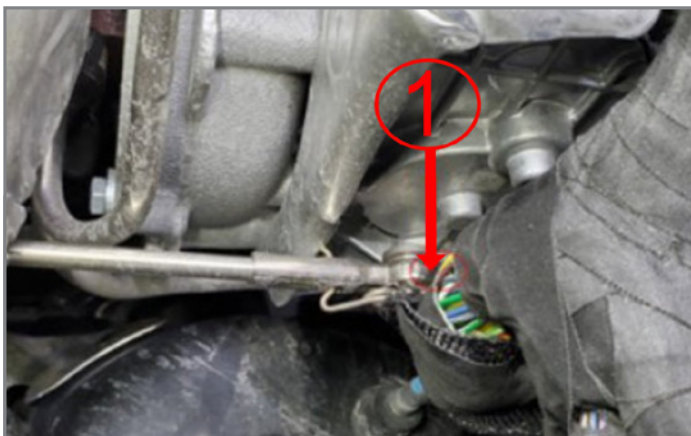
Engine wiring harness chafing at the wastegate linkage.

- Bulletin #25-NA-197: Engine wiring harness chafing at the turbocharger heat shield or wastegate linkage – 2023-2025 Colorado, Canyon

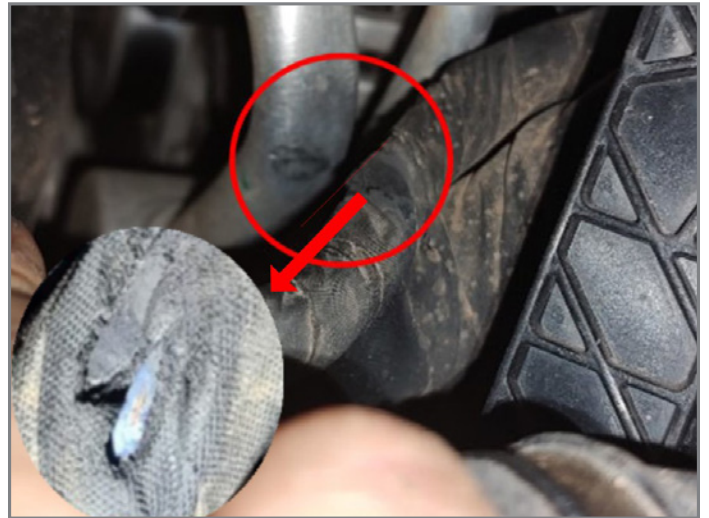
Engine wiring harness contacting the A/C lines.

- Bulletin #25-NA-301: Engine wiring harness chafing at multiple locations in the engine compartment, including the engine cover, cylinder head bolts or A/C lines – 2022-2025 Silverado, Sierra
- #PIP6023C: Poor connection at the X160 connector between the engine wiring harness and the fuel injector wiring harness. The X160 connector connects the engine wiring harness to the fuel injectors, the fuel rail pressure and temperature sensors, and the knock sensors – 2023-2025 Colorado, Silverado, Canyon, Sierra
- Bulletin #24-NA-180: Knock sensor service calibration update – 2024 Colorado, Canyon

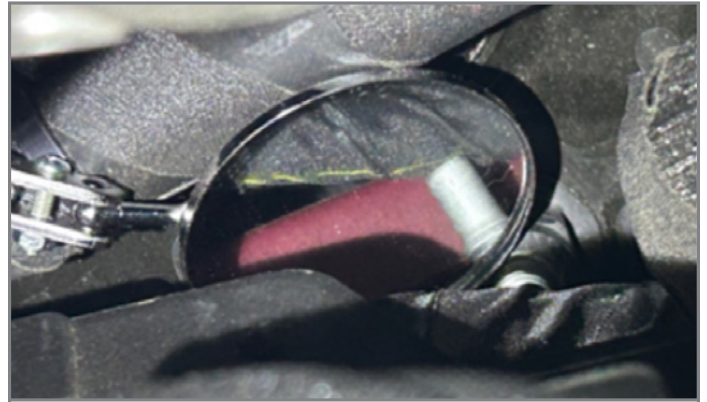
- Bulletin #25-NA-347: Engine wiring harness chafing between the ECM connector X2 and X201 at roughly 5 to 7 inches from the ECM. The contact and subsequent harness chafing point may be at the right-front suspension shock absorber mounting stud – 2023-2026 Colorado, Canyon

Right-front suspension shock absorber mounting stud

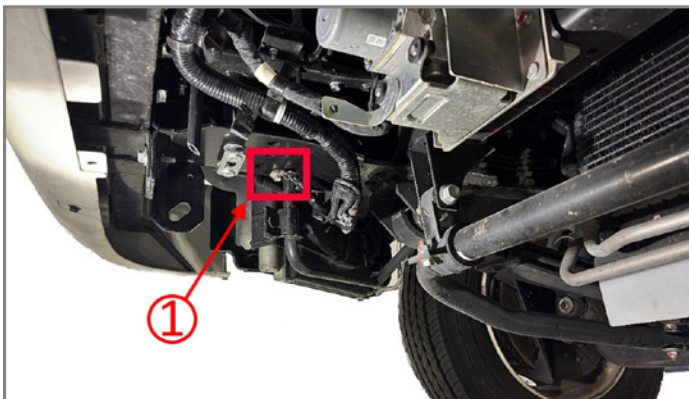
TCM chassis ground terminals J-400 and J-11 (#1)

Lamp Illumination) may set in the TCM due to corrosion of the TCM chassis ground terminals. This condition may be found more often on vehicles driven in cold climate regions where salt is spread on the roads.

If DTC P0711 is set, inspect the TCM chassis ground terminals J-400 and J11, located on the bottom of the right-front frame rail behind the front bumper.

Remove the ground bolt from the frame rail and use a wire brush to clean the bolt, ground terminals and frame contact area. All bare metal surfaces should be completely clean of any corrosion. Install the bolt with both grounds and torque to specification.

In addition, check that the connector cavities are clean and dry. Apply dielectric silicone lubricant to the ground terminals and bolt.

Test drive the vehicle and confirm the DTCs have not returned. If DTC P0711 sets, the vehicle should be referred to a certified Allison repair facility.
