## Heated Steering Wheel Replacement

# Heated Steering Wheel Replacement

# Stay Updated — IOK Radio Software and Connection Conditions

# Verify Vehicle Settings After Rocker Panel Ground Lamps Installation

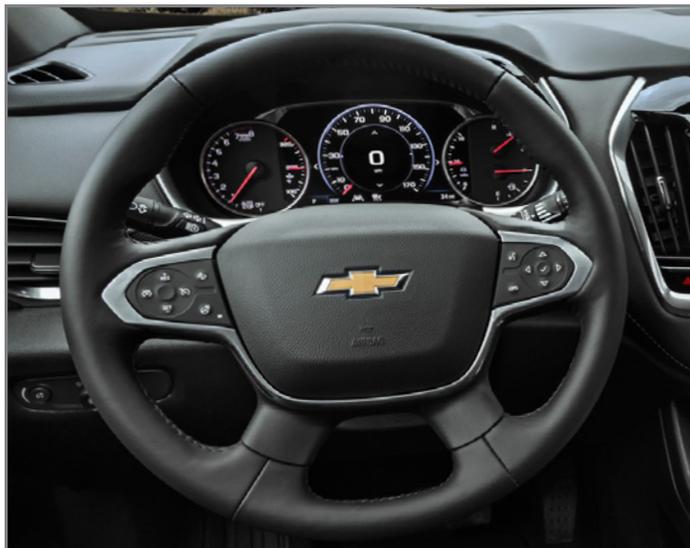
If the incorrect steering wheel is installed, the cruise control switch and heated steering wheel switch will be inoperative.

Check that the correct steering wheel for the vehicle application has been ordered.

The Engineering Year RPO in the vehicle build should be used to determine if a 2022 model year part is for Global A or Global B applications. Vehicles with J21 (Engineering Year 2021) use Global A and J22 (Engineering Year 2022) use Global B.

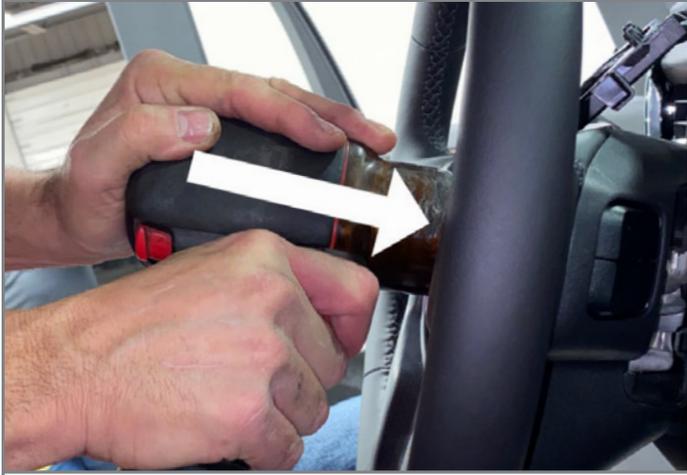
The power tool and the T50 Torx bit must be positioned perpendicular to the bolt recess.

Steering wheel bolts installed during manufacturing require high torque efforts to remove. The only acceptable bit for removing and installing the steering wheel bolt is a T50 Torx bit. Do not use any other size bit or a worn bit.

If a power tool is used to remove the steering wheel bolt, the tool must have a minimum torque rating greater than 75 Nm (55 lb.-ft.) and both the power tool and the T50 Torx bit must be positioned perpendicular to the bolt recess.

Apply appropriate downward force to maintain engagement of the bit-to-bolt recess during bolt removal.

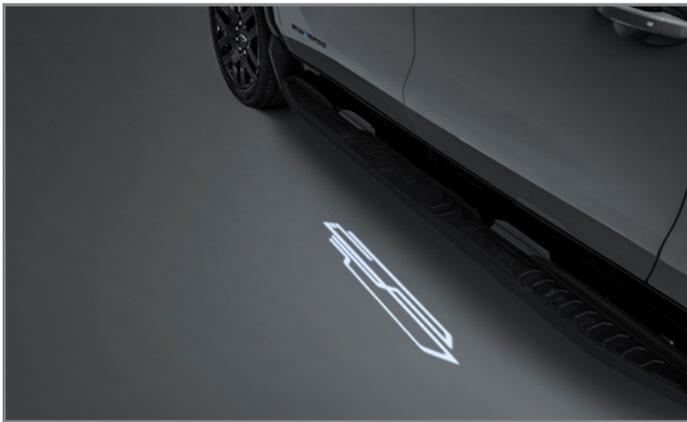
The GM Accessory Rocker Panel Molding Ground Lamps (PN 85155377) may not illuminate after installation on some 2024-2026 Silverado EV and Sierra EV models.

The exterior illumination setting in the Vehicle Settings menu on the infotainment screen may be in the Off position. In order for the ground lamps to illuminate properly, the illumination setting must be in the On position.

After installation, verify that the exterior illumination setting in the Settings > Vehicle > Lighting > Approach and Departure lighting menu is set to Animated or Static, and then check the operation of the ground lamps by covering the light sensor on top of the instrument panel.

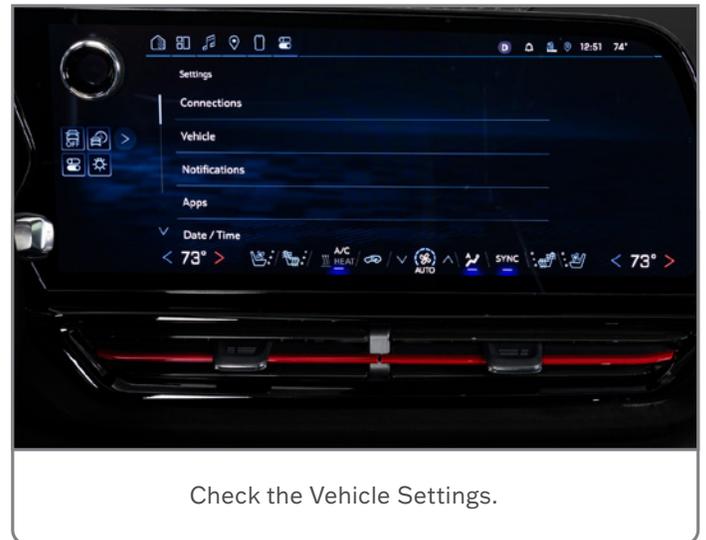
Check the Vehicle Settings.

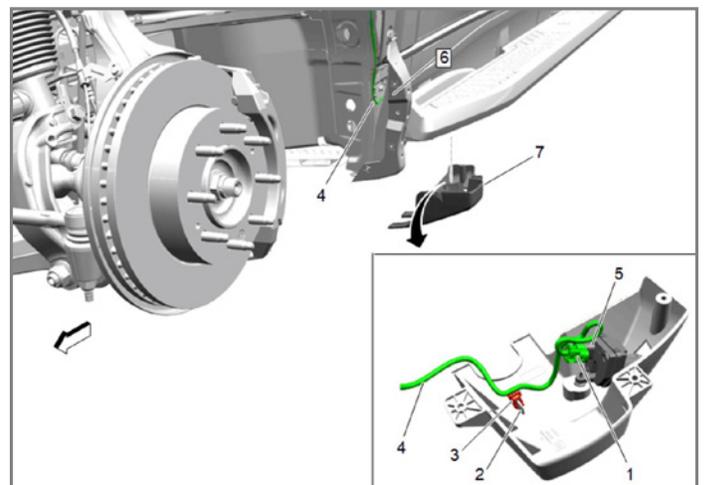
Lamp assembly (#7), harness connector (#1) and lamp harness (#4). Route between stone guard structure (#6) and vehicle body.

The ground lamp assemblies are market LH (driver's side) and RH (passenger's side). Identify the correct part for each side before installation by checking the markings on the lamp body. Route the specific-side lamp harness between the stone guard structure and the vehicle body, pulling the harness through below the assist step.

The wiring harness should be routed up through the wheel well on each side of the vehicle into the front compartment and then into the engine bay. The harness connects to the body wiring harness to engine wiring harness connector X403. Be sure

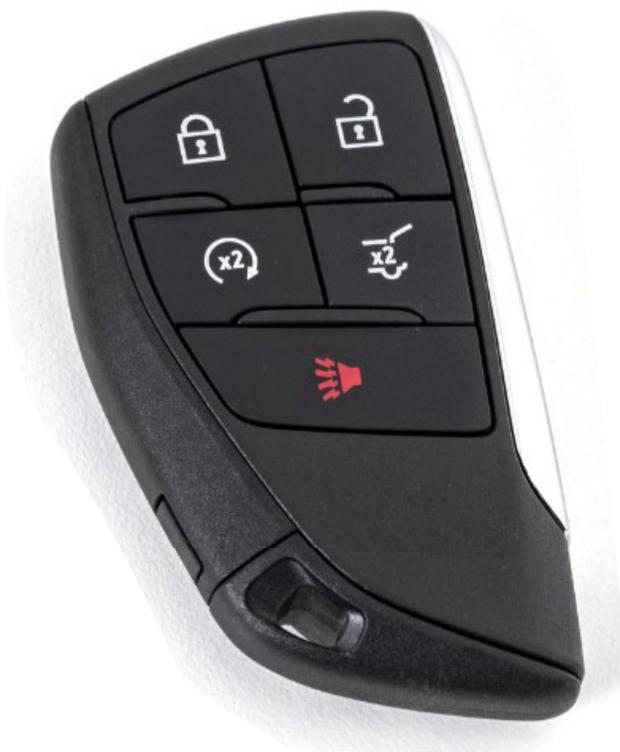
After verifying the fob battery is good, go to Module Diagnostics > Body Control Module > Data Display > Keyless Entry Data list using

GDS2 and view parameters "Synchronization Counter" and "Synchronization Status." Both values should be the same.

If the Synchronization Status is lower than the Synchronization Counter, press any of the key fob buttons repeatedly to have the values match, which may take up to 255 button presses to resynchronize the fob with the BCM. When the values match, the key fob should begin working properly again.
