# Front Brake Caliper Sound and Uneven Pad Wear

*There may be a front caliper brake noise or uneven front brake pad wear on some 2023-2026 Colorado and Canyon trucks*

GM TechLink is published for all GM retail technicians and service consultants to provide timely information to help increase knowledge about GM products and improve the performance of the service department.

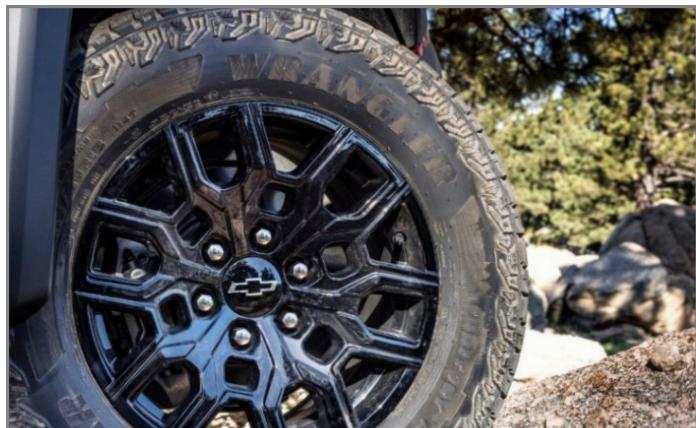
There may be a squeal or tick (rotational type noise) heard coming from the front brake calipers when the brakes are not applied on some 2023-2026 Colorado and Canyon trucks. In addition, the front brake pads may appear to be wearing unevenly.

Front brake caliper (Colorado shown)

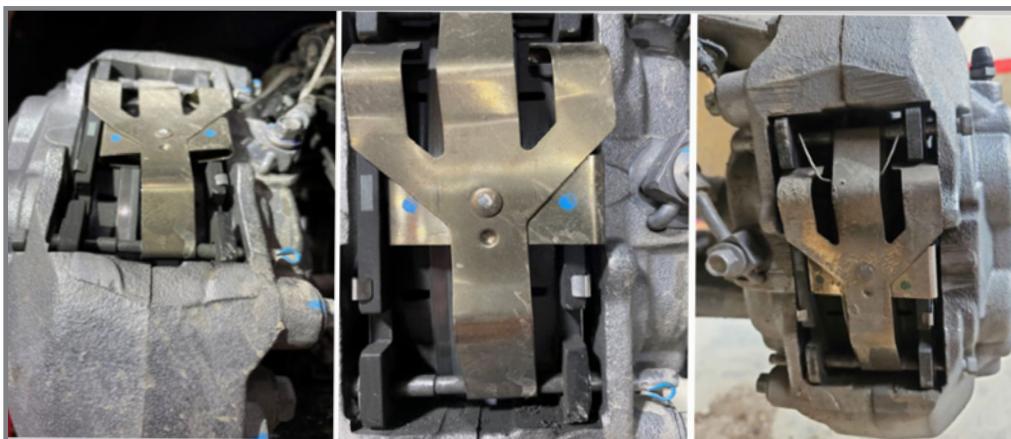
The brake sound and pad wear conditions may be due to a missing front brake caliper spring or an incorrectly positioned front disc brake pad retainer.

Front brake caliper spring missing and front disc brake pad retainer in the incorrect position

Inspect the front brake assembly and if the front brake caliper spring or the front disc brake pad retainer spring is not

positioned correctly, reinstall the caliper spring or the front pad retainer spring in the proper location. With the spring correctly positioned, recheck if the sound occurs with the vehicle moving and the brakes not applied.

If the front brake caliper spring is missing, or if the front brake pad thickness on one or both pads is less than 7mm, replace the front disc brake pads.

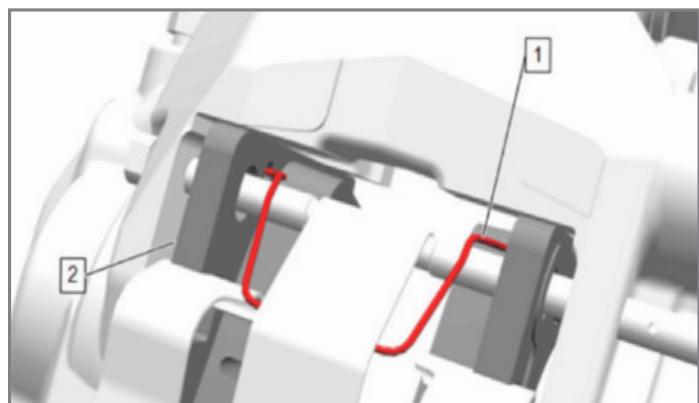
Front brake caliper spring (1) installed in the correct holes in the front disc brake pads (2)

The front brake caliper spring should be installed in the correct holes in the front disc brake pads.

Refer to Front Disc Brake Pads Replacement in the appropriate Service Information.

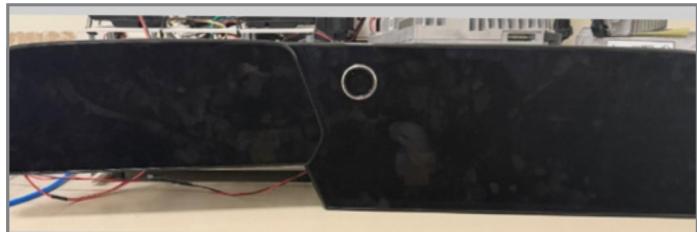
Display appears powered off.

**Display appears powered off (no backlight)** – If the radio is powered on and communicating with the scan tool, there may be an issue with the radio, not the display.

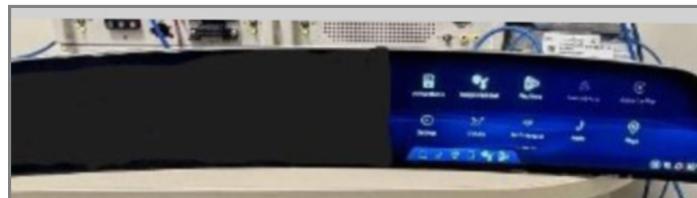
**One or both displays are flickering and going blank but come back** – The power and ground connections at the displays or the LVDS cable between the display and radio may have a connection issue.

One or both displays are flickering and going blank.

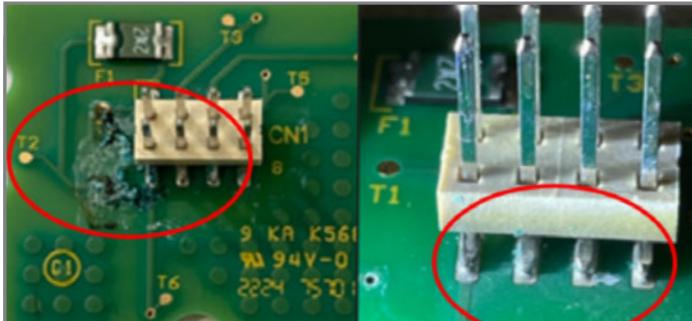
If diagnosis indicates the switch is inoperative, take the switch apart and inspect for signs of corrosion. The cause of the inoperative switch may be water leaking into the switch from the roof ditch molding area. A corroded switch will need to be replaced.

Corroded seat switch

Once the new switch is installed, check for water leaking into the vehicle. Before reinstalling the left-side D-pillar interior trim, spray water over the left-rear roof ditch molding area and inspect for a water leak in the vehicle. If water enters this area, it may run down the wiring harness that leads into the 3rd-row seat switches.
