Front Brake Caliper Sound and Uneven Pad Wear

There may be a front caliper brake noise or uneven front brake pad wear on some 2023-2026 Colorado and Canyon trucks

GM TechLink is published for all GM retail technicians and service consultants to provide timely information to help increase knowledge about GM products and improve the performance of the service department.

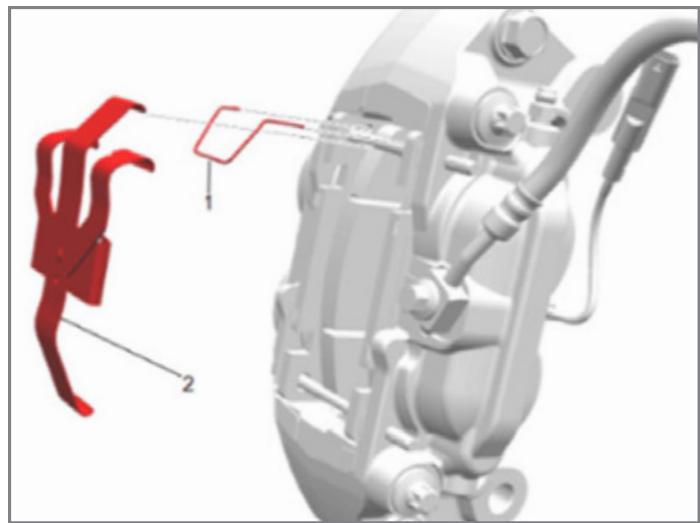
1. Front brake caliper spring
2. Front disc brake pad retaining spring

Ensure that the front brake caliper spring and front disc brake pad retainer spring are positioned correctly when installing the new brake pads. Install the front disc brake pad retaining spring with the three-tab side first.

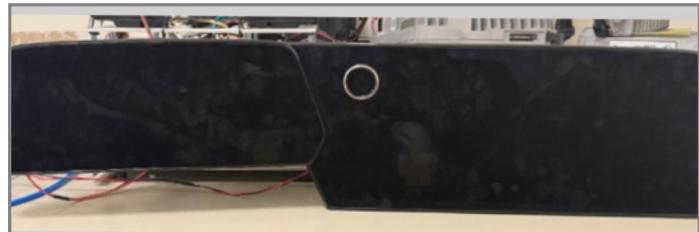
Display appears powered off.

Display appears powered off (no backlight) – If the radio is powered on and communicating with the scan tool, there may be an issue with the radio, not the display.

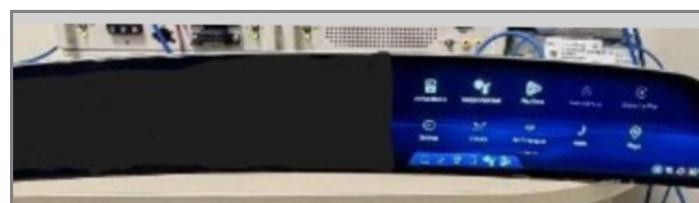
One or both displays are flickering and going blank but come back – The power and ground connections at the displays or the LVDS cable between the display and radio may have a connection issue.

One or both displays are flickering and going blank.
