# GM TECHNICAL ASSISTANCE CENTER (TAC)

## Dealer Tips and New Information Newsletter

JANUARY 29, 2026

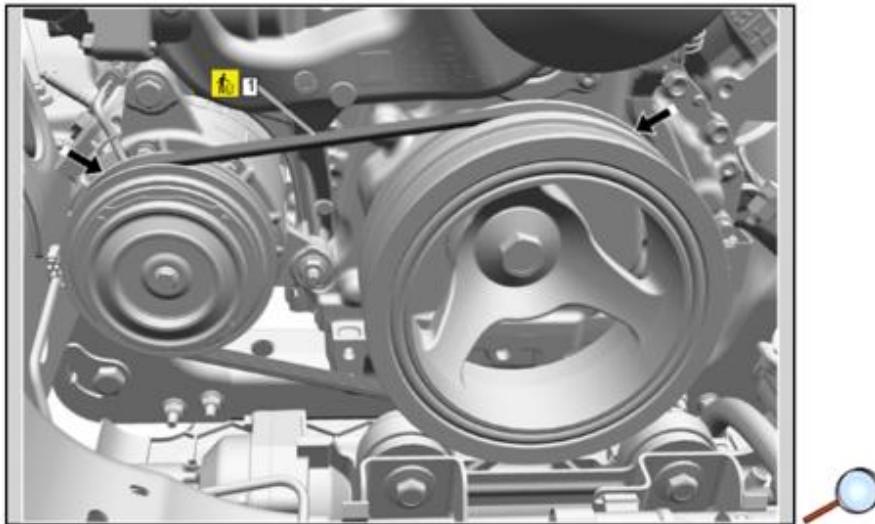
Upon review of the Engine Removal and Installation service procedure and to help prevent bearing damage, the Engine Prelubing step has been moved before the installation of the accessory drive belts. The reason this change was made is to ensure the lower crankshaft bearings and journals have an adequate amount of oil before rotating the engine dry during drive belt installation.

231. Prelube is necessary if the engine is replaced or overhauled. [Engine Prelubing](#)

**Note:** The OEM replacement accessory drive auxiliary belt (1) is packaged with a disposable installation tool and installation instructions.

232. Install the accessory drive auxiliary belt (1) following the instructions included with the accessory drive auxiliary belt.

233. Inspect the accessory drive auxiliary belt (1) for proper installation and alignment.

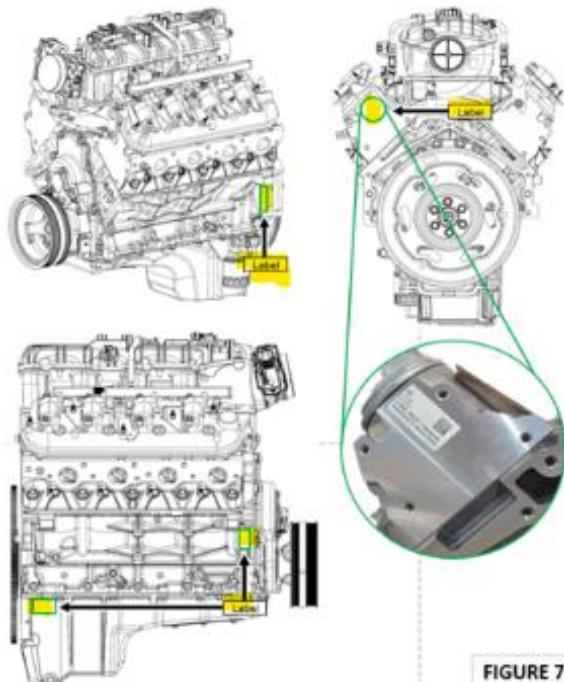
FIGURE 7

**Concern:** Placement and material of the engine ID tag (engine part #, serial # and build date etc.) has changed.

**Correction:** Tags are now made of paper and placed in 4 different locations: LH rear cylinder head; LH rear of engine above the starter boss; RH side timing cover; and RH side rear oil pan.

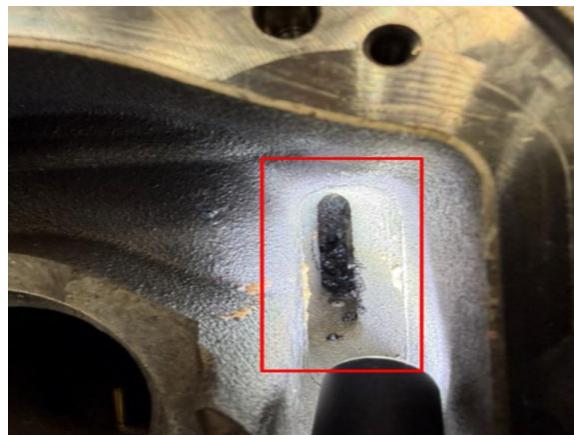
#### 15) Emerging Issue: 2023-2026MY 3.0L LZ0 Diesel Low Mileage Overheating

**Concern:** This may occur on a very low mileage engine that was recently replaced or a new vehicle (infant failure).

**Cause:** If normal diagnostics are inconclusive, there may be casting sand or a partial castover in the coolant port behind the water pump.

**Correction:** Example of restricted passage shown (water pump removal is necessary to view)

Please verify the port is restricted before replacing it again.

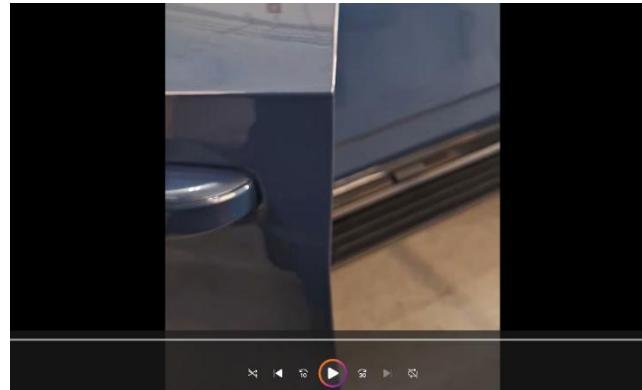
## 8) Emerging Issue: Driver-Side Power Door will not Close Properly or Auto Reverses when Closing

**Concern:** 2026 Escalade models equipped with power door option RPO APD. Other utilities may eventually be involved; however, at this time, this condition has been observed only on 2026 Escalade models.

Multiple cases have been seen in which the power door does not close properly or automatically reverses during closing. No DTCs are present. Technicians may observe that the door striker does not align correctly with the latch opening and is typically positioned too far forward. This condition is believed to be related to an assembly plant adjustment intended to improve the gap between the driver's front door and the front fender. Select the mp4 video link for a demonstration of the condition.

**Correction:** Engineering is actively investigating this issue, and Field Service Engineers (FSEs) have been deployed to validate the final repair procedures. Once the final root cause has been confirmed, a PI or bulletin will be released outlining the official repair strategy.
