The 2027 Chevrolet Bolt Makes Its Comeback

Intermittent Front Lighting Operation 6

TCSC Top Issues This Week 8

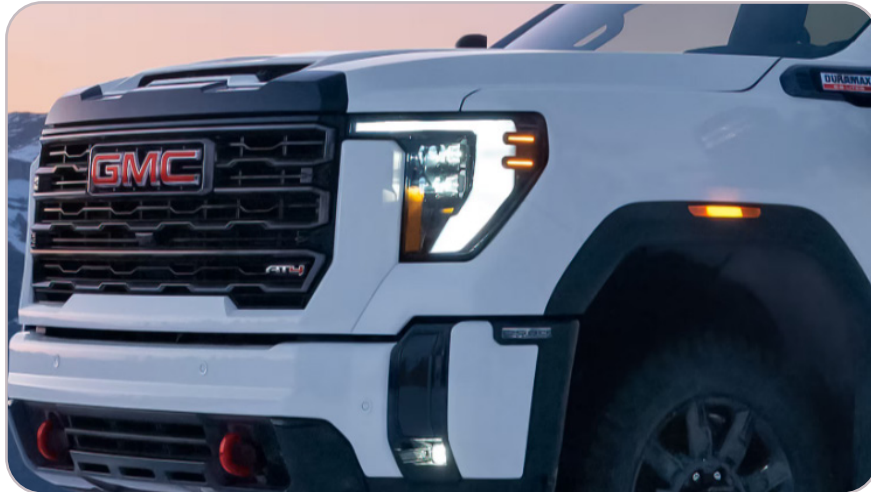
Intermittent Front Lighting Operation

The headlamps, Daytime Running Lamps (DRL), parking lamps and/or turn signals may be intermittently inoperative on some 2024-2026 Silverado 2500HD/3500HD and Sierra 2500HD/3500HD trucks. Lighting operation may recover after the ignition is cycled.

The intermittent operation of the front lighting may be due to an internal failure of the Multi-purpose LED Driver (MLD), which controls the lighting functions of the lamp assembly. If the MLD has failed, it must be replaced.

To replace the MLD, refer to Front Headlamp Replacement in the appropriate Service Information.

Once the headlamp has been removed, the MLD can be removed from the assembly. Install the new MLD in the assembly and confirm the seal is positioned correctly against the housing. The screws securing the MLD should be tightened by hand, taking care not to strip the holes in the housing.

TIP: Before replacing the MLD, refer to Bulletin #25-NA-337 and verify the Julian date and part number of the headlamp assembly. A soldering issue on some lamps may cause the lighting functions to become inoperative on some 2025 Sierra 2500HD/3500HD models. Affected headlamps should be replaced.

Before reinstalling the headlamp assembly, check for proper operation. If the lighting does not work properly, replace the headlamp assembly.

Refer to Bulletin #26-NA-002 for more information, including part numbers.

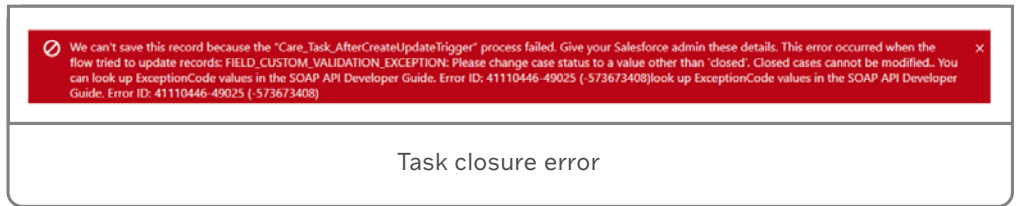
Non-case owners cannot close open tasks on a closed case and currently receive the following error:

A fix will be implemented for the following issue:

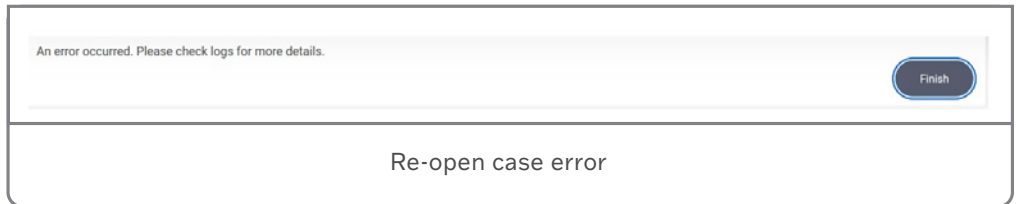
When submitting a case re-open request via the Re-Open Case button in CX Connect, the user receives the error shown.

This update will resolve this error, including properly routing the re-open request task

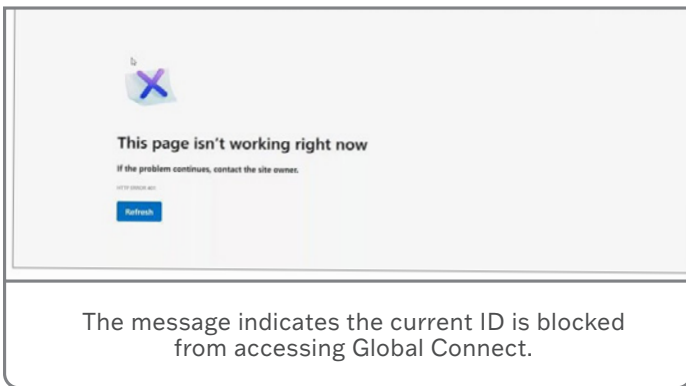
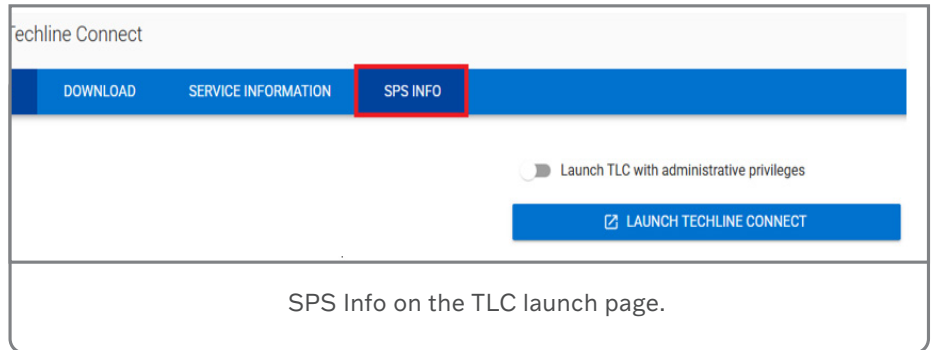
The following message may be seen when attempting to access Techline Connect:

The message indicates that the current ID is blocked from accessing Global Connect. This can be for several reasons but typically is due to a counterfeit MDI device.

To unblock the account, reach out to TCSC via CX Connect with the following information:

- User ID in Global Connect
- Email of User
- First and Last Name of User
- BAC/Dealer Code and Name of Dealership

TCSC will be able to reach out to the Cybersecurity team that will be able to determine the cause of the block and may be able to unblock the account. In the case of a counterfeit MDI, the counterfeit tool must be destroyed, and a legitimate Bosch device must be used to ensure the ID is not blocked again. Repeat offenders may not be unblocked from access.
