NACS and CCS1 Charging Adapter Options

**Loss of Reverse/
Forward Grid Lines
in Camera View**

TCSC Top Issues This Week..... 7

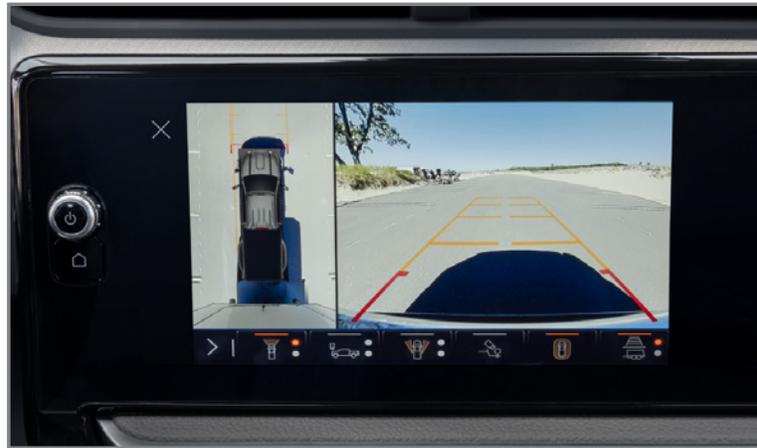
Some 2022-2026 Silverado 1500, Sierra 1500; 2024-2026 Silverado 2500HD/3500HD and Sierra 2500HD/3500HD models equipped with the Surround Vision Cameras may have a front-view or rear-view camera display that does not show the reverse or forward grid guidelines. An hourglass symbol may be displayed instead of the guidelines.

In some cases, the cameras may be in a state of failure and a DTC will not set until the camera fails. Until a code is set, the camera may randomly display an unlearned status after an ignition cycle. The camera may have a relearn status temporarily but may lose the learn status intermittently with a key cycle. In addition, a vehicle may need to sit more than 5 minutes with the ignition off to reproduce this issue.

If these conditions are found, inspect the views in all cameras thoroughly and check each camera for damage or moisture inside the lens. Camera images may appear slightly distorted or foggy. The corresponding camera may exhibit a non-learned status.

A camera that shows a Not Calibrated status should be replaced.

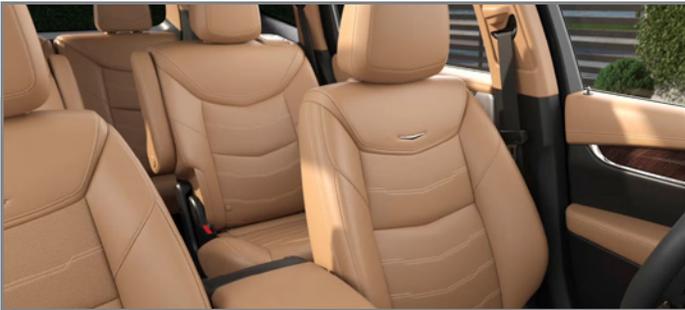
The driver's and front passenger's heated and ventilated seats may be inoperative on some 2021-2026 XT5 and XT6 models. Fuse F19RA also may be open.

These conditions may be due to circuit 639 shorted to ground on the driver's or front passenger's seatback frame.

The driver's and front passenger's heated and ventilated seats may be inoperative.

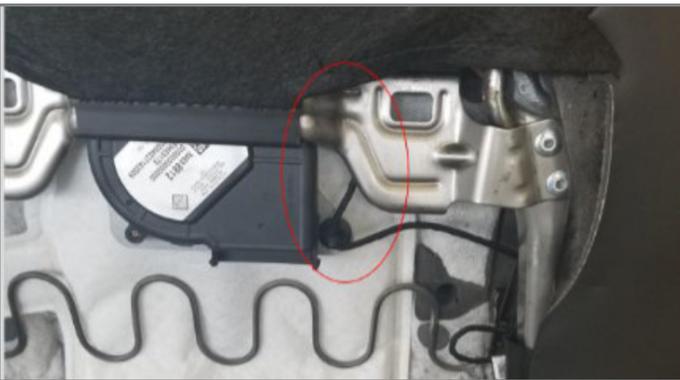
If fuse F19RA has been replaced before or goes to open immediately, remove the front passenger's seatback cover and inspect the harness in the seatback for chafing or damage. Check for any contact between the seatback and the harness. If there isn't any damage found on the front passenger's seatback, inspect the driver's seatback in the same areas.

Check for any contact between the seatback and the harness.

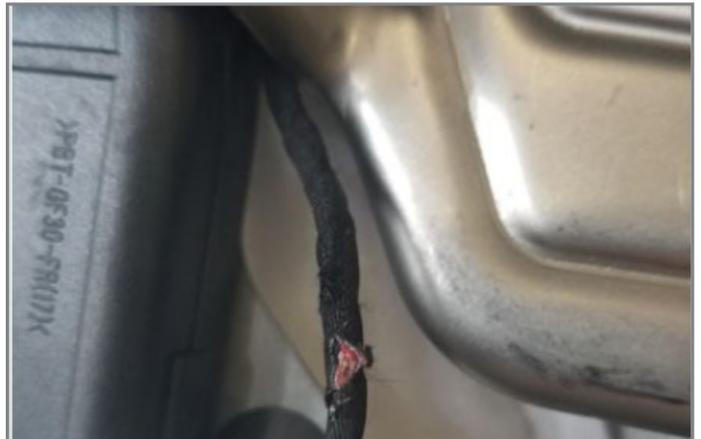
Harness damage

Repair any damaged circuits following the procedures for wire and connector repair in the appropriate Service Information

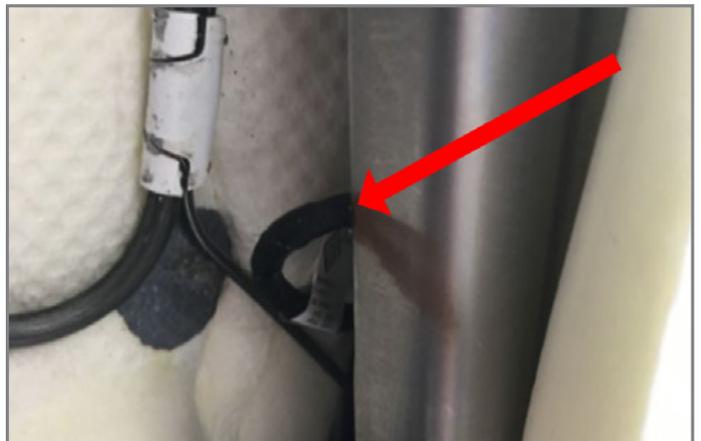
In addition, check the harness along the side of the seat frame.

Harness at the side of the seat frame

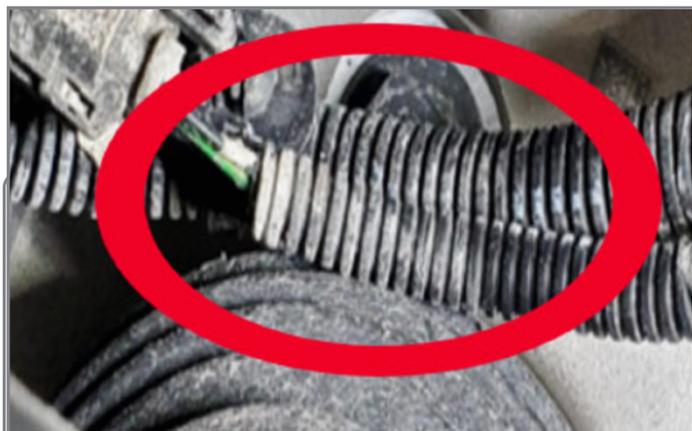
The rear half shaft boot on the left side of some 2021-2025 Tahoe, Suburban, Yukon and Escalade models may be leaking or damaged. The damage may have occurred due to the brake pad wear sensor being incorrectly routed, resulting in contact with the half shaft boot.

Wear sensor wiring harness contacting the half shaft boot.

Check the clearance from the half shaft outboard joint to the wiring harness. The clearance should be higher than 10mm. If the clearance is under 10mm, install the revised bracket that is available. The new bracket will reroute the brake pad wear sensor so that it is more than 10mm away from the half shaft boot.

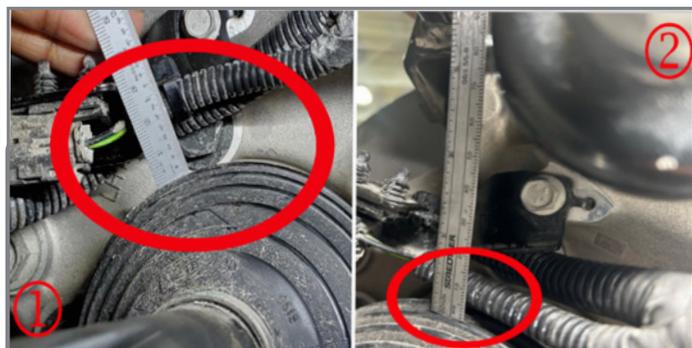
1. Clearance of more than 10mm
2. Clearance of less than 10 mm with possible half shaft boot contact
