CCND Labor Codes Updated for Infotainment Audio and Screen Conditions

Radiator Inlet Hose Coolant Leak

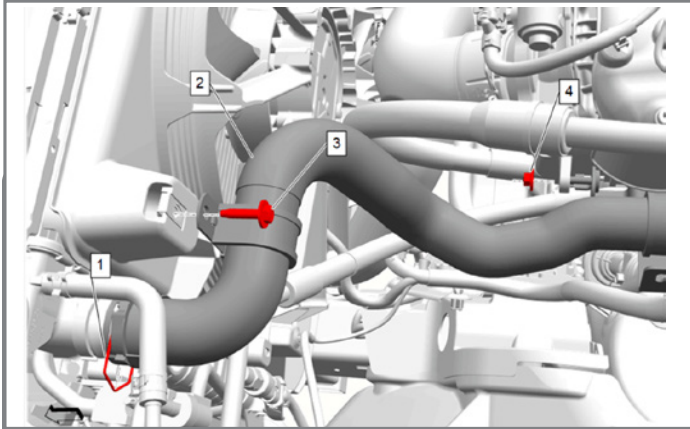
Inlet hose retainer at the radiator

Some 2023-2026 Colorado and Canyon models may have a visible coolant leak from the upper radiator inlet hose connection

or a low coolant level at the overflow reservoir. DTC P3075 (Engine Coolant Flow Too Low) may be set in the Engine Control Module (ECM).

The leak condition at the upper radiator hose quick-connect fitting may be due to a degraded inlet hose seal. The leak originates from the radiator inlet hose seal itself and is not the result of a radiator failure. The radiator should not be replaced for this condition.

If the leak condition is found, drain the cooling system and replace the radiator inlet hose. Be sure all debris is cleared before

removing the hose to avoid introducing any contaminants into the system.

Prior to installing the new radiator inlet hose, it's recommended to use a clean lint-free cloth to wipe the radiator spigot to remove any residual contamination that may be present from the coolant hose. The surface should be smooth and free of any contamination prior to installing the new hose.

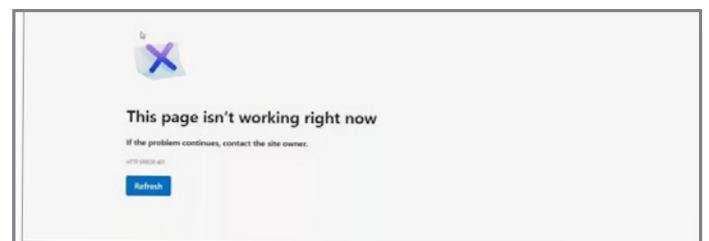
The message indicates the current ID is blocked from accessing Global Connect.

The message indicates that the current ID is blocked from accessing Global Connect. This can be for several reasons but typically is due to a counterfeit MDI device.

To unblock the account, reach out to TCSC via CX Connect with the following information:

TCSC will be able to reach out to the Cybersecurity team that will be able to determine the cause of the block and may be able to unblock the account. In the case of a counterfeit MDI, the counterfeit tool must be destroyed, and a legitimate Bosch device must be used to ensure the ID is not blocked again. Repeat offenders may not be unblocked from access.

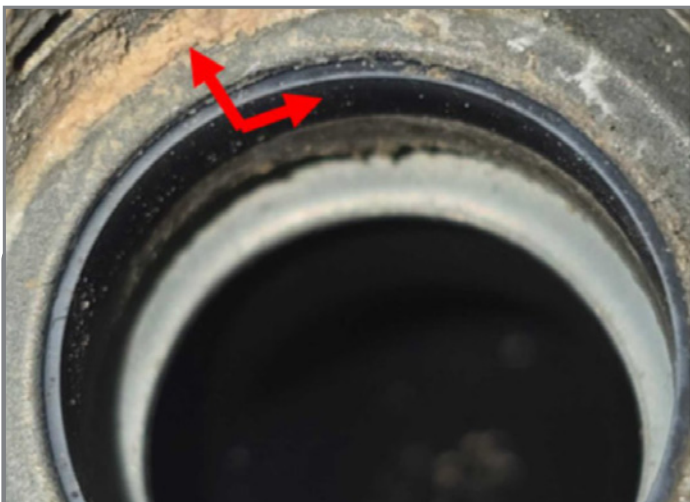
Seal wear may be seen with varying levels of residue or buildup depending on vehicle usage and operating environment. A failed lip seal, typically with material flattening and residue accumulation around the connection, indicates seal degradation rather than a radiator defect.

Failed lip seal

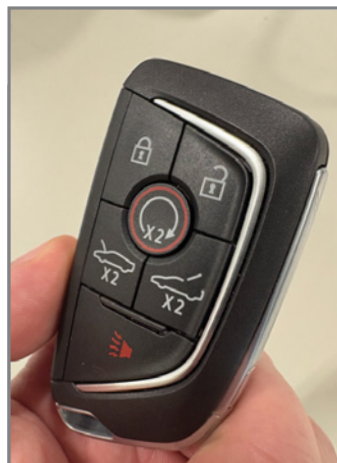
All buttons on one key fob (Remote Keyless Entry transmitter) may be inoperative on some 2023-2026 Escalade, LYRIQ, Corvette, Tahoe, Suburban, Yukon; 2024-2025 XT4; 2024-2026 BrightDrop, Envision, CT5, Colorado, Silverado EV, Traverse, Acadia, HUMMER EV, Sierra EV; 2025-2026 Enclave, CELESTIQ, ESCALADE IQ, OPTIQ, Equinox, Terrain; and 2026 VISTIQ models.

Key fob with six possible active command buttons

These conditions may be due to the key fob being out of synchronization with the Body Control Module (BCM). Do not replace the key fobs or the BCM for this concern.

To correct this issue, repeatedly pressing any button on the affected key fob until the counter in the key fob matches that of the BCM will synchronize the two devices. This may take up to 255 button presses until the counters become synchronized again.
