## Proactive Alerts — Parasitic Drain Detection

*Proactive Alerts —  
Parasitic Drain Detection ..... 2*

*TCSC Top Issues This Week..... 4*

*Tick Sound at Idle on V8 Engines ..... 9*

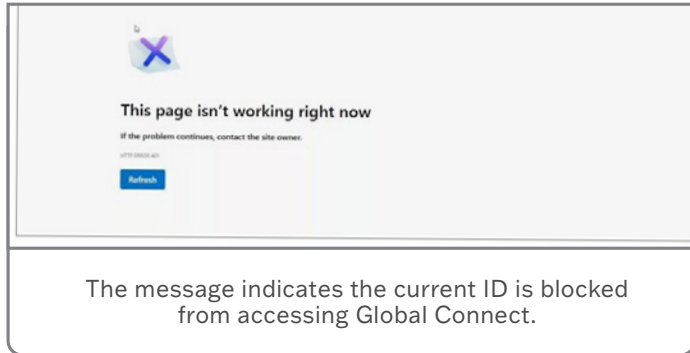
The message indicates that the current ID is blocked from accessing Global Connect. This can be for several reasons but typically is due to a counterfeit MDI device.

To unblock the account, reach out to TCSC via CX Connect with the following information:

TCSC will be able to reach out to the Cybersecurity team that will be able to determine the cause of the block and may be able to unblock the account. In the case of a counterfeit MDI, the counterfeit tool must be destroyed, and a legitimate Bosch device must be used to ensure the ID is not blocked again. Repeat offenders may not be unblocked from access.

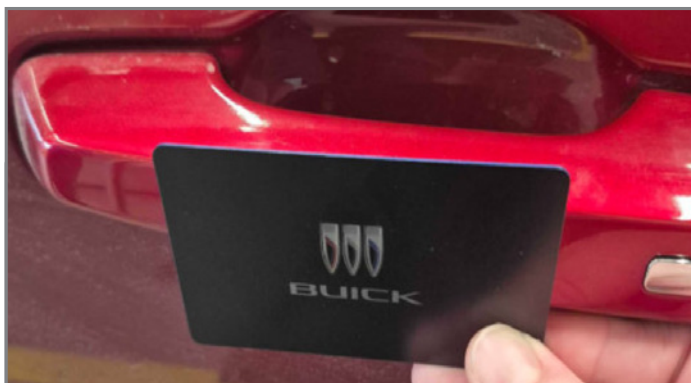
The card should be placed correctly next to the card reader location. The antennas in the door handle and B-pillar are specific to the card placement. Do not place the key card over the door handle's unlock button. It should be placed in the center of the handle over the opening.

Place the key card in the center of the handle over the opening.

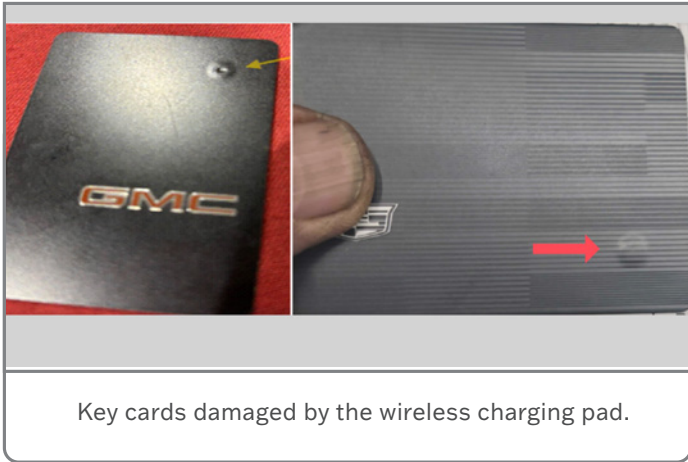
It is important to avoid placing the key card on the wireless charging pad under any circumstance. Customers who keep their key cards in a phone case-style card holder may experience loss of key card function. This is caused by the wireless charger

Key cards damaged by the wireless charging pad.

damaging the NFC chip within the key card. If the NFC chip is damaged, there will be a visible blister in the key card. pad.

When diagnosing a key card that is inoperative, check the key card for any signs of bubbling or damage. Once the card is damaged, the card should be terminated, and a new card should be learned in its place.

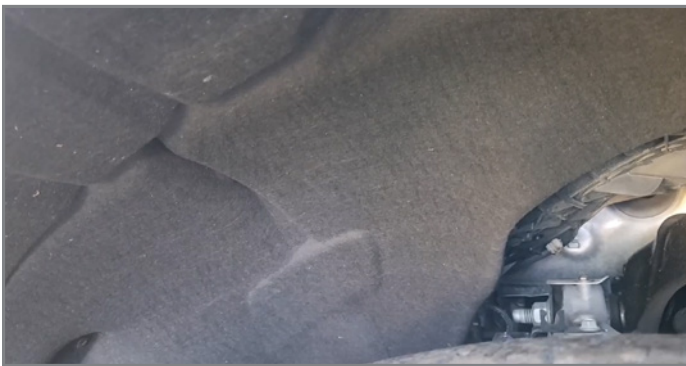
The engine tick can be heard from the front wheel well area.

The tick sound, which may be more noticeable when the engine oil is cold (following a cold soak), can last up to 10 minutes before subsiding. Frequency also can vary with engine speed and from vehicle to vehicle. The sound is typically most audible from the front wheel well area and may be localized to the transmission bell housing or oil pan region.

Refer to Bulletin #26-NA-021 for examples of the audible sound from a normally operating engine. The tick sound does not indicate any mechanical malfunction and does not adversely affect engine performance, reliability or durability. It is a normal operating characteristic of these V8 engines and has no short- or long-term impact on engine operation.

Do not perform any diagnostic procedures or repairs to the engine for a normal tick sound condition.
