# GM TECHNICAL ASSISTANCE CENTER (TAC)

## Dealer Tips and New Information Newsletter

APRIL 22, 2026

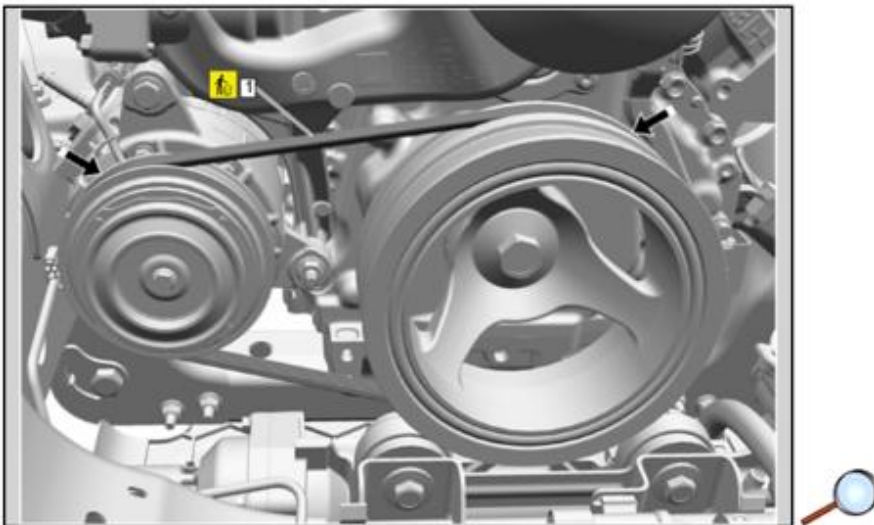
Upon review of the Engine Removal and Installation service procedure and to help prevent bearing damage, the Engine Prelubing step has been moved before the installation of the accessory drive belts. The reason this change was made is to ensure the lower crankshaft bearings and journals have an adequate amount of oil before rotating the engine dry during drive belt installation.

231. Prelube is necessary if the engine is replaced or overhauled. [Engine Prelubing](#)

232. Install the accessory drive auxiliary belt (1) following the instructions included with the accessory drive auxiliary belt.

233. Inspect the accessory drive auxiliary belt (1) for proper installation and alignment.

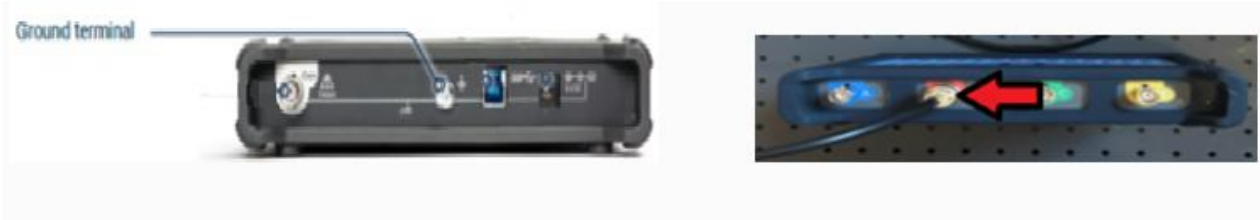
**Concern:** An electrical noise error message may be seen when performing the PICO test during #N252494000.

**Correction Tips:** Make sure the laptop is disconnected from the AC charging cord. Also verify no aftermarket accessories are installed.

If the PICO box has a ground screw present (see photo), you can run a wire from the PICO ground screw to the vehicle's negative battery terminal. If the PICO does not have a ground screw, the dealer can ground the BNC (metal portion) of the cable connection (shown below) to the vehicle's negative battery terminal.
