Engine Oil Consumption Guidelines

High Resistance in Glass Breakage Loop

Camshaft Position Sensor Performance Diagnosis

TECH LINK

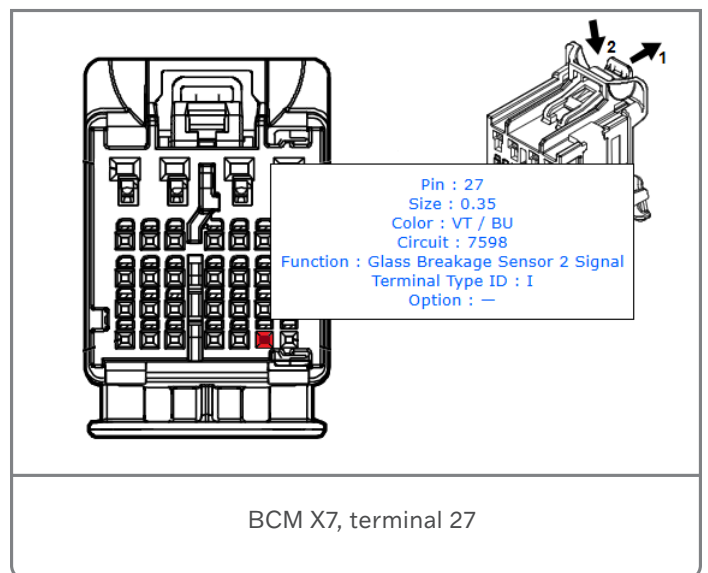
If the resistance to ground is greater than 20 ohms, inspect the glass breakage loop for poor connections, which could occur at any point in the series circuit. The most common areas to check are the connections at either of the rear quarter glass assemblies.

In some cases, it has been found that connection issues at the rear quarter glasses were caused by the installation of aftermarket window tint, decals, stickers, etc. These types of failures are not covered under warranty.

If the resistance to ground is less than 20 ohms, the loop resistance is within specification and there may be an intermittent issue. Inspect and manipulate the glass breakage loop connections and wiring to see if the resistance increases. Repair any points of high resistance.

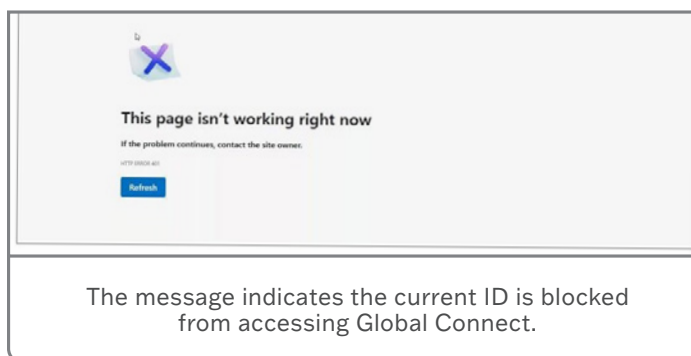
The message indicates that the current ID is blocked from accessing Global Connect. This can be for several reasons but typically is due to a counterfeit MDI device.

To unblock the account, reach out to TCSC via CX Connect with the following information:

TCSC will be able to reach out to the Cybersecurity team that will be able to determine the cause of the block and may be able to unblock the account. In the case of a counterfeit MDI, the counterfeit tool must be destroyed, and a legitimate Bosch device must be used to ensure the ID is not blocked again. Repeat offenders may not be unblocked from access.

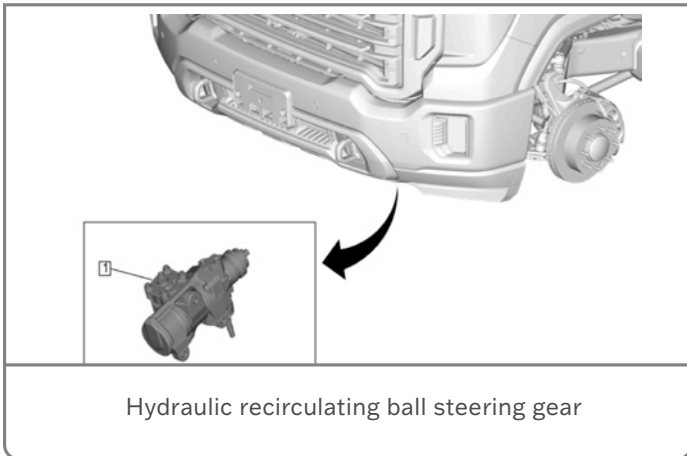
A fluid leak may be visible on the steering gear or power steering fluid lines on some 2015-2026 Silverado 2500HD/3500HD and Sierra 2500HD/3500HD trucks. The leak may be due to a damaged seal or leaking lines.

Fluorescent dye can be used to determine the source of the leak. Clean off any residual oil from the steering gear using an oil/grease cleaner.

Next, add a bottle (1 oz; 30 cc) of fluorescent dye to the power steering reservoir and operate the vehicle for 10 minutes. Use a black light to check for any signs of dye leaking past the seals, lines, coolers, gear and hydraulic brake booster. Mark the location of any leaks. Also check for any fluid dripping from the reservoir/pump.

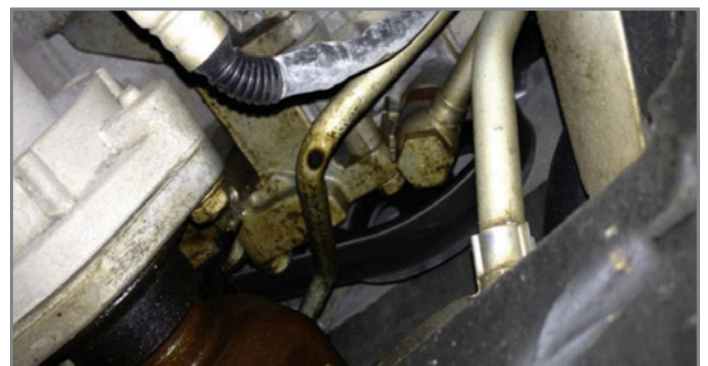
A leak leaves a droplet of fluid on the bottom of the power steering line and fluid has dampened the drive axle.

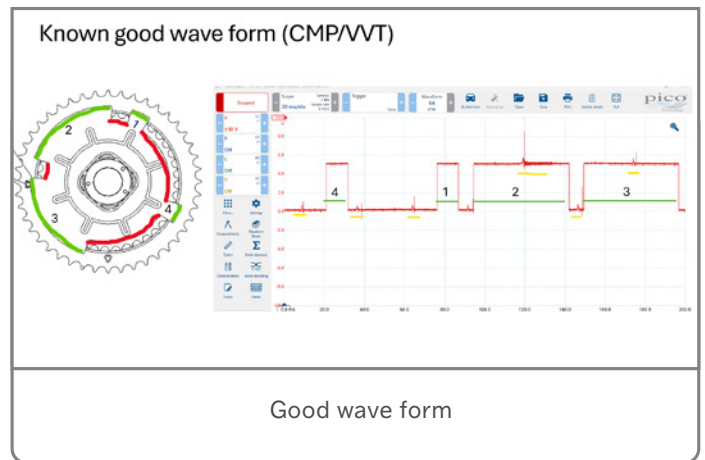
Following is a good wave form (CMP/VVT).

- Red is sensor off time, or 0V.
- Green is on time, or at 5v.
- Noise in the signal, underlined in yellow, is normal and does not affect ECM interpretation of the signal.

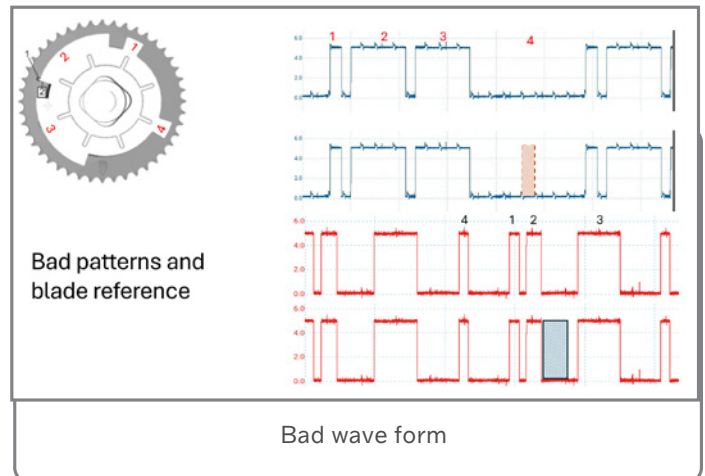
Following is a bad wave form pattern.

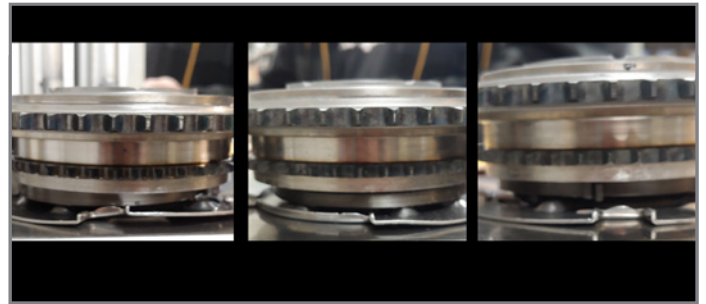
Damage to reluctor rings can be seen easily with the actuator placed on a flat work surface. The damage may not be as easy to identify when viewing from the face of the actuator.

Damaged reluctor rings

All new actuators should be carefully inspected on a bench for flatness before installation to ensure a damaged part is not installed in an engine. TAC has seen some damaged actuators in reman engines.

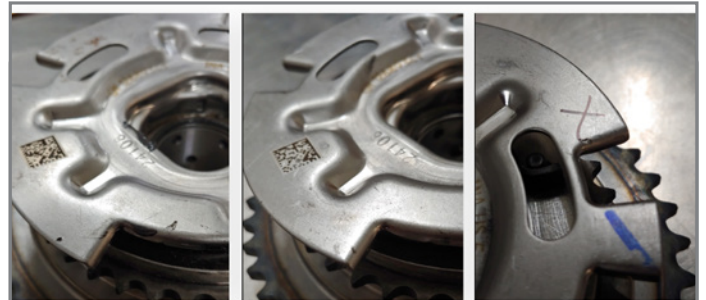
Check for excessive clearance of the actuator ring.
