2nd-Row Rear Seat Operation and Diagnostic Tips for Full-Size SUVs

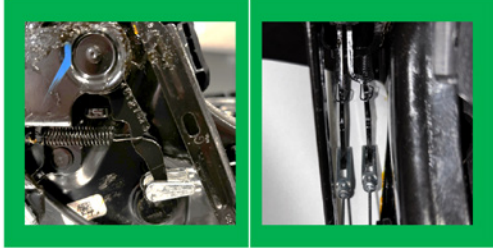
If the rear seat won't return from the folded position, only goes up partially, or the seat won't tumble forward, check for any damage that may impair the seat from folding or tumbling properly. The seat links or latch levers may be misaligned or bent, or the cables may be damaged or not connected at the cable attachment points.

Good - Links aligned and not bent

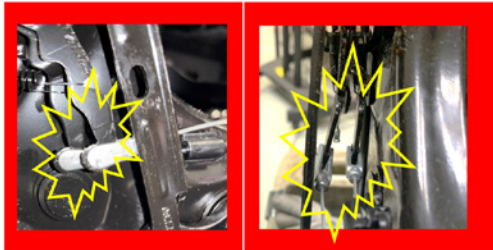
Bad - Links misaligned with visible bends

Seat links or latch levers may be misaligned or bent.

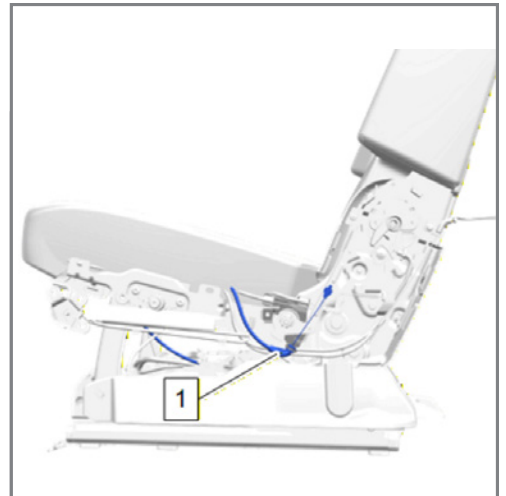
Actuator cable

If the 2nd-row seat will not release or fold down, or multiple attempts are required to get the seat to release, the actuator

cable may be disconnected or there may be interference with the quarter lower rear trim panel.

If the power operation is not functional, verify the cable is connected and that the adjuster on the recliner sync cable is either open or partially open.

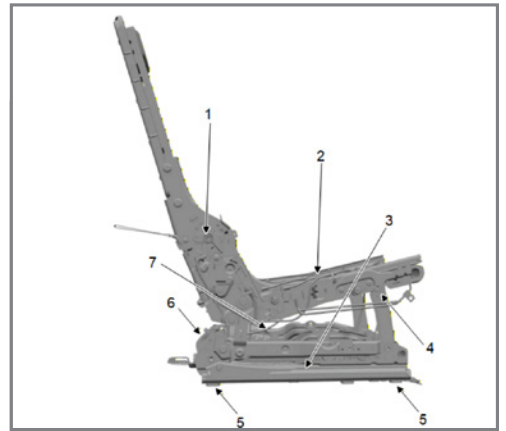
Any noise coming from the 2nd-row seats, such as a squeak noise when driving or a rattle noise in the upright position but not when folded, may be due to an obstruction in the seat mechanisms or improperly torqued fasteners.

Possible suspect areas for noise concerns.

Cables should be checked for proper routing and secure connections as well.

Apply lubricant to any suspect areas. It also may be necessary to loosen and then torque the rear seat bolts according to the rear seat bolt sequence.

In addition, cycle the seat from stow to tumble several times, ensuring the floor latch assembly secures to the striker and the floor latch spring engages.

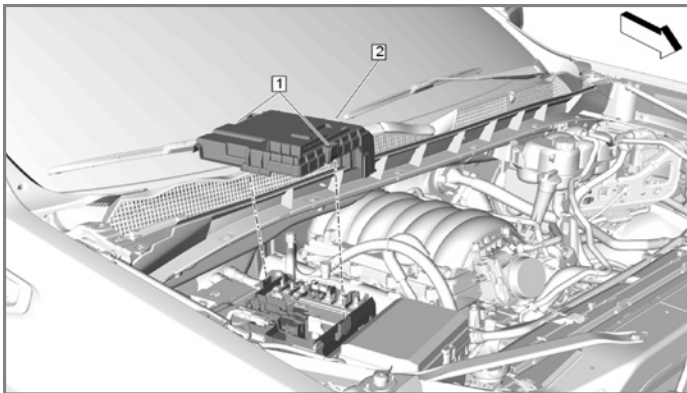
BDU Fuse Assembly in the engine compartment

These DTCs may be caused by a blown fuse or a bent terminal in the X950D 55-way (Engine Wiring Harness Chassis-to-Engine Wiring Harness) connector.

If fuse F5 (F5BA) is open, it will result in cylinders 1, 4, 6 and 7 all setting DTCs simultaneously. If fuse F6 (F6BA) is open, it will result in cylinders 2,3,5 and 8 all setting DTCs simultaneously.

TIP: Do not replace or disturb any glow plugs before checking the Battery Distribution Unit (BDU) Fuse Assembly for a bent terminal in the X950D 55-way connector.

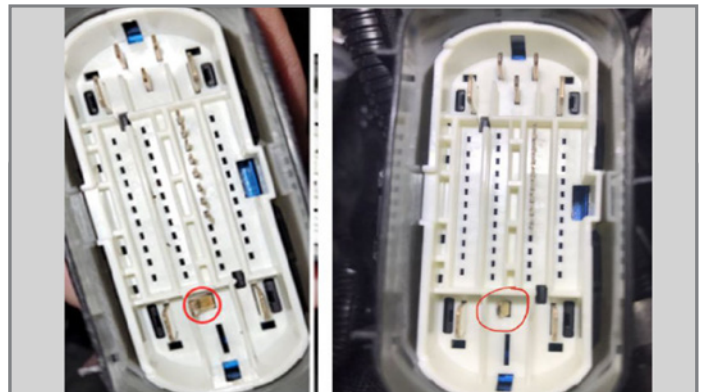
Terminal damage in the X950D 55-way connector also will result in individual DTCs setting.

Separate the X950D connector by disengaging the red CPA and squeezing the corners of the connector. Look for bent terminals in the X950D connector that may result in individual Glow Plug Control Circuit DTCs P0671, P0672, P0673, P0674, P0675, P0676, P0677 and/or P0678 setting.

Bent terminals in the X950D connector

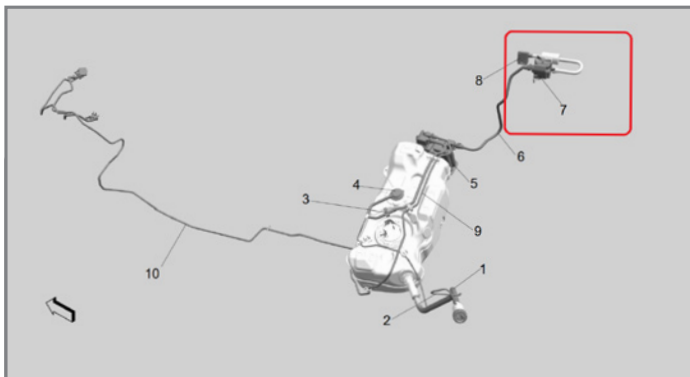
EVAP system and the G34 EVAP Leak Detection Pump (#7)

disconnected, smoke oil could collect in the pump, leading to pump failure. Do not allow smoke to enter the pump.

Failure to follow the updated service procedures will require pump replacement since the EVAP leak detection pump is highly susceptible to damage if exposed to smoke or mineral oil used in OEM and aftermarket smoke testers.

Before performing EVAP system leak diagnostics based on DTC P0442 (Evaporative Emission System Small Leak Detected) or P0455 (Evaporative Emission System Large Leak Detected), the G34 EVAP Leak Detection Pump must be disconnected to prevent damage. Typical EVAP system testing is performed from the front of the vehicle to the back. For the 1.2L engine, the leak check pump is at the end of the line at the rear of the vehicle. If not

Using the necessary special tools, including the GE-41413-A/B/C Evaporative Emissions System Tester (EEST), the updated leak diagnostic procedures for DTCs P0442 and P0455 instruct technicians to disconnect the leak detection pump from the EVAP system before testing. Refer to Document ID 6496657 in the appropriate Service Information for complete information.
