## Updated Transfer Case Input Shaft Seal Installation

*DT-53018  
Seal Installer  
Now an  
Essential Tool*

# Updated Transfer Case Input Shaft Seal Installation

## DT-53018 SEAL INSTALLER NOW AN ESSENTIAL TOOL

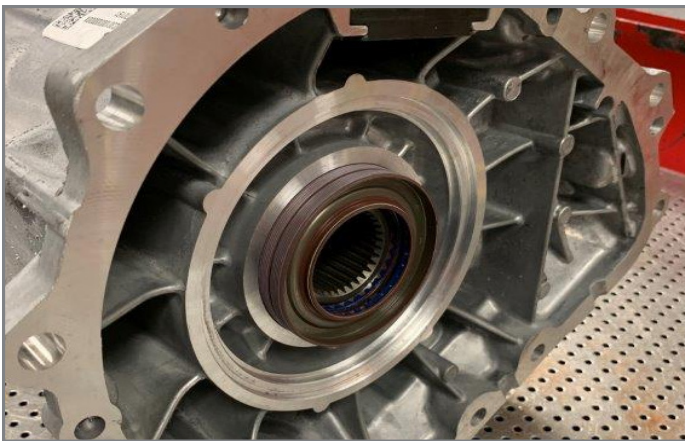
Seal installation depth is critical when replacing the transfer case front input shaft seal between the transmission and transfer case on 2020-2026 Silverado 2500HD/3500HD and Sierra 2500HD/3500HD trucks equipped with the RPO NQF or NQH transfer case.

Transfer case front input shaft seal in position to be installed.

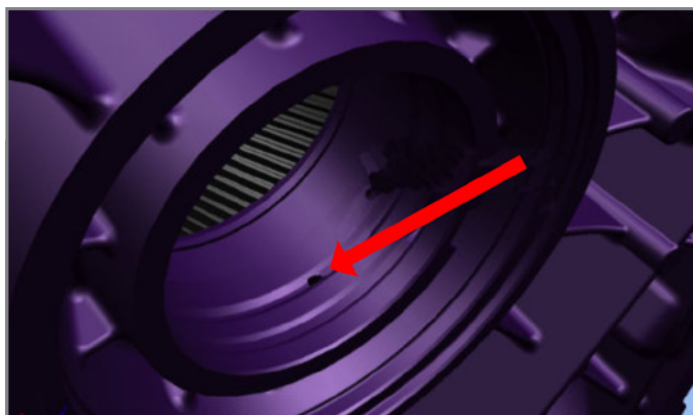
The transfer case has a gap around the outer portion of the seal that needs to be centered over a weep hole in the transfer case. The weep hole is drilled in the center of a groove machined into the case. The DT-50648-A Seal Installer will not work for these applications.

Weep hole in the center of the case groove.

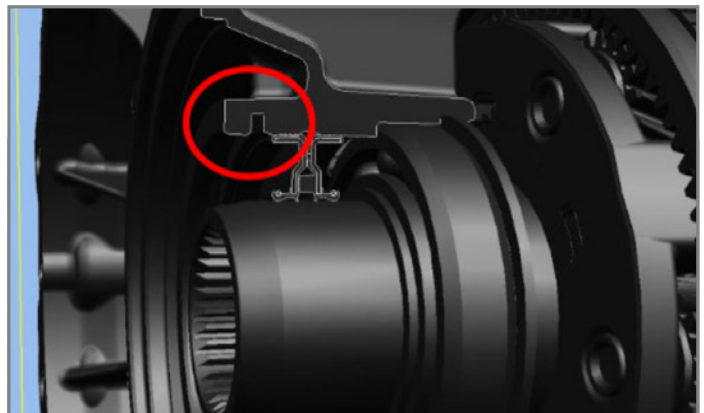
First design transfer case

To identify each design, look for a machined groove where the seal is installed (circled as shown). If there is a defined machined groove in the case, it is a first design case.

For the first design transfer case used on early 2020 model year vehicles, refer to Transfer Case Assemble (VIN LF263576 and Earlier – with MGM or MGU) in the Transfer Case – Off Vehicle repair instructions in the 2020 model year Service Information. Seal installer DT-53017 (GM-53017) should be used for these applications.

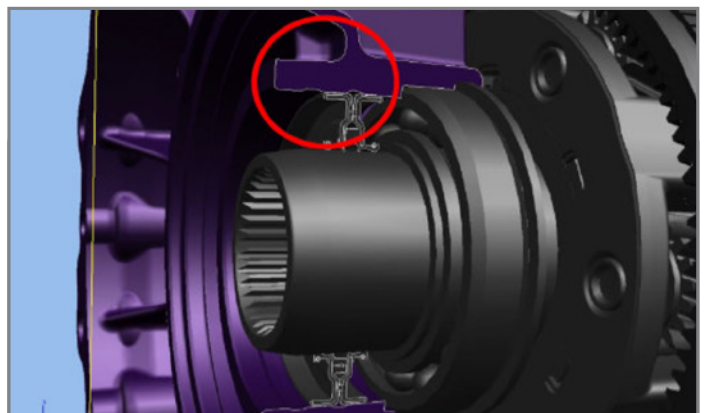
Second design transfer case

If there is not a defined groove machined into the case, it is a second design case.

For the second design transfer case, which was introduced later in the 2020 model year and used on 2020–current model year vehicles, follow either the Transfer Case Assemble (VIN LF263577 and Later – with MGM or MGU) in the Transfer Case – Off-Vehicle repair instructions in the 2020 model year Service Information or the year of the vehicle being repaired. The DT-53018 (GM-53018) Seal Installer should be used for these applications.

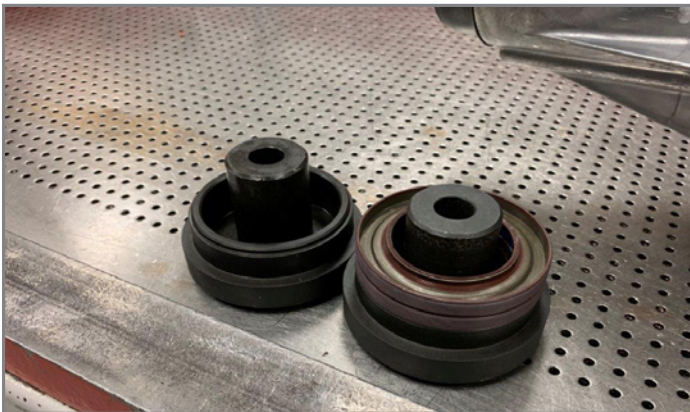
DT-53018 (GM-53018) Seal Installer

**TIP:** Using the incorrect tool will create a repeat leak as the seal may not be at the correct depth or may not be installed straight.

The DT-53018 tool is an Essential tool and will be identified as GM-53018. It will begin being shipped to all dealerships that have not already purchased the tool.

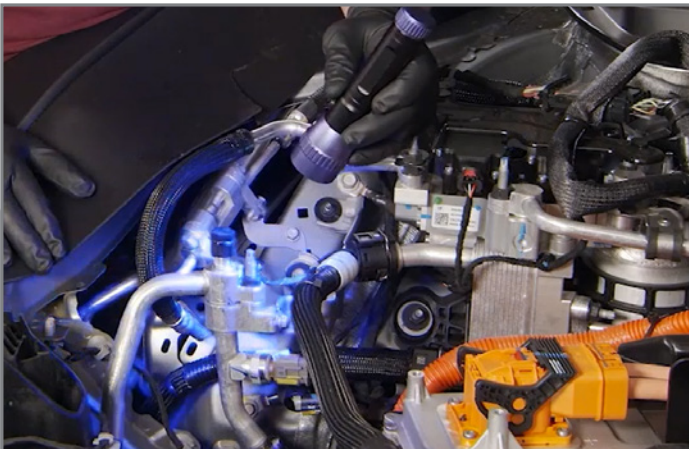
The updated A/C leak diagnosis requires a different fluorescent dye process than used on earlier systems. Instead of adding 0.25 oz. of PAG-based dye by free-pour, a sealed injection process is now used with a newly released Polyol ester Oil (POE)-based dye that is designed for these electrified applications.

Updated A/C leak diagnosis requires a different fluorescent dye process than used on earlier systems.

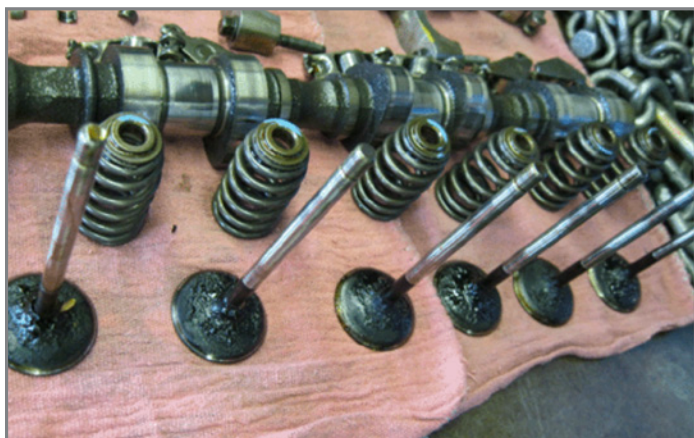
Valve deposits

The first step to address fuel-related engine performance conditions is to use quality fuel, especially to help prevent deposit-related concerns. In gasoline applications, TOP TIER Detergent Gasoline at the recommended octane level helps maintain injector cleanliness and reduce intake valve deposits. In diesel applications, TOP TIER Approved Diesel Fuel meeting ULSD requirements provides the preferred baseline. If quality fuel is used consistently and the vehicle does not have any drivability issues, an additive typically is not necessary.

For gasoline vehicles, ACDelco Fuel System Cleaner 44K provides detergent deposit control for intake valves, fuel injectors and combustion chambers. It may be used as a tank additive when drivability concerns point to deposit-related issues or when preventive maintenance is needed because TOP TIER gasoline is not consistently available. Symptoms such as loss of power, stalling, hard starting, or reduced fuel economy still require normal diagnosis first. Additives should support the repair process, not replace it. When carbon buildup is confirmed, upper-engine cleaning procedures also may be required, but only as directed in the appropriate Service Information. Refer to Bulletin #16-NA-383 for more information.
